REPORT OF INVESTIGATION

Fatal Powered Haulage Accident
January 30, 2025

Salado Operations, Florence
Salado Operations
Florence, Williamson County, Texas
ID No. 41-04216

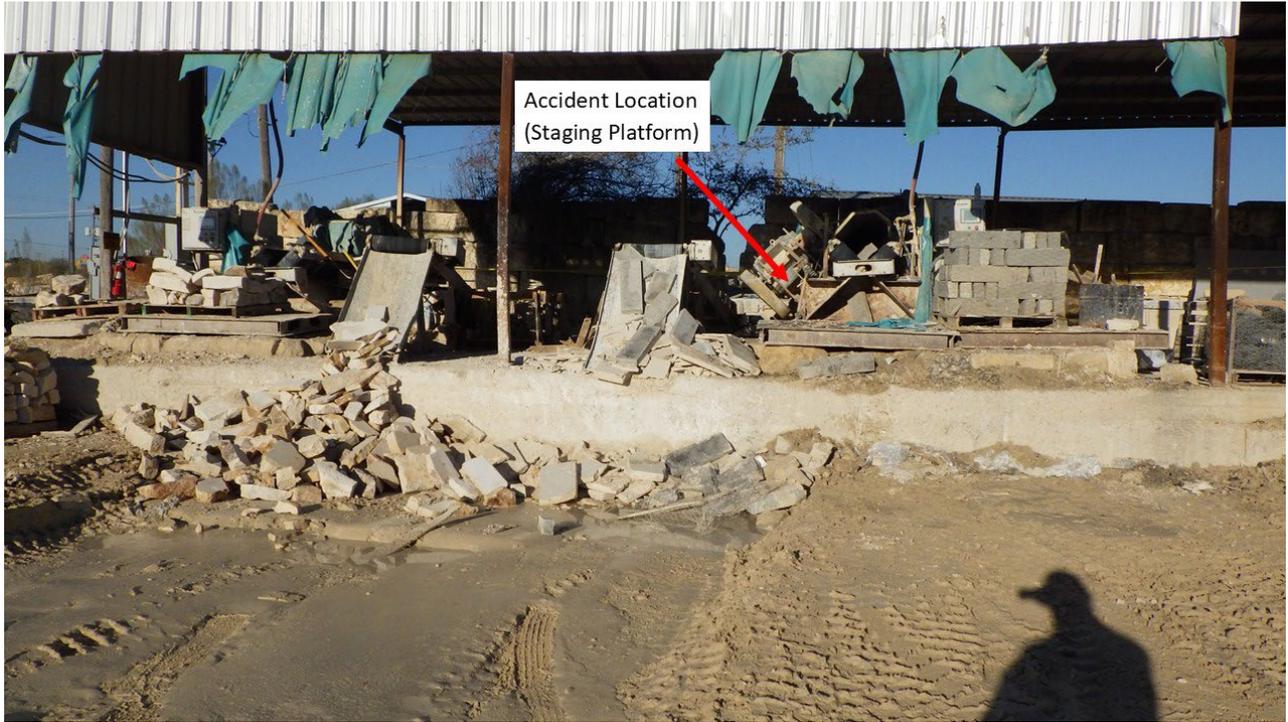
APPENDIX B – Veneer Saw No. 2 Staging Platform

The accident occurred at the staging platform in thin-veneer saw No. 2 area (see Appendix B).

Corrective Action: The mine operator developed, implemented and trained miners on a procedure that would ensure that miners are not in the staging platform area when palletized stone is being loaded onto the staging platform of the thin-veneer saw area.

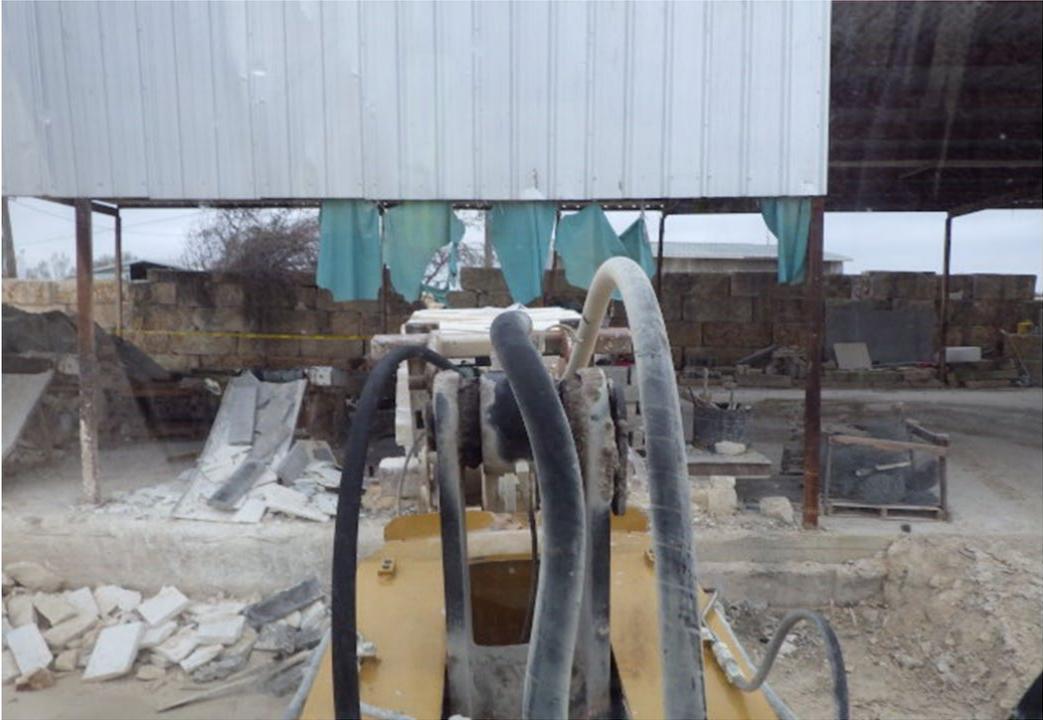
APPENDIX C – View from Front-end Loader Approaching the Staging Platform While Transporting a Loaded Pallet

At the time of the accident, the front-end loader was carrying a pallet of stone that was 39 ½ inches high, 50 inches long, 41 ½ inches wide, and weighed approximately 4,700 pounds. The forks of the loader were approximately four feet off the ground while the pallet of stone was being moved. As Gonzalez approached the staging platform, the pallet of stone was in his line of sight and blocked his visibility of the staging platform and Sanchez-Robles (see Appendix C). Investigators determined this contributed to the accident.

Root Cause: The accident occurred because the loader operator was moving the loader in a manner that caused the pallet of stone to block his visibility of the staging platform and the miner.
