REPORT OF INVESTIGATION

Fatal Powered Haulage Accident
November 5, 2024

Cactus
DelHur Industries, Inc.
McCamey, Crane County, Texas
ID No. 41-05396

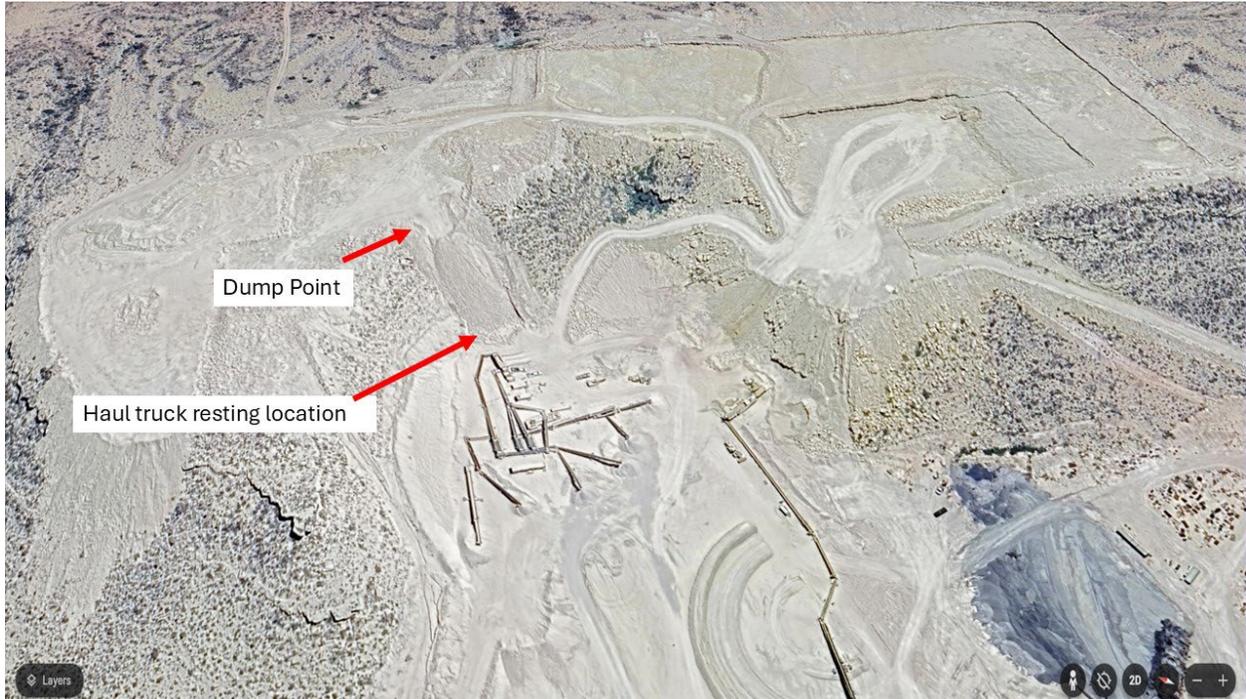
APPENDIX C – Accident Location

The accident occurred at the primary dump point above the primary crusher (see Appendices B and C). The ground failed beneath the haul truck causing it to overturn multiple times down the approximately one-hundred foot of the face of the stockpile, coming to rest at the base.

Investigators determined the top of the dump point had extended approximately 80 feet beyond the solid rock of the plateau due to continuous dumping of unconsolidated material. The front-end loader loading from the base of the stockpile undermined the integrity of the slope. These two factors created obvious and extensive hazardous conditions at the dump point. The haul truck should have dumped the material a safe distance back, and a bulldozer should have pushed the material over the edge of the dump point. A bulldozer was available for use at the top of the dump point but was not used on the day of the accident. The weight of the loaded haul truck on the unconsolidated material caused the dump point to fail. The mine operator did not ensure the dump point could support the weight of the loaded haul truck, which contributed to the accident.

Corrective Action: The existing dumping point has been eliminated. It has been replaced by a dumping location that does not require dumping from the top of the pile.

Corrective Action: A new dumping location has been established which does not require dumping from the top of a pile. Therefore, the edge of a dumping point is eliminated.
