Hurricane Katrina Wind Investigation Report

HURRICANE KATRINA INVESTIGATION REPORT

August 2007

The Roofing Industry Committee on Weather Issues, Inc. deployed six teams to investigate damage caused by Hurricane Katrina in the landfall regions in Louisiana and Mississippi. This report covers investigations conducted between September 7 and September 9, 2005.

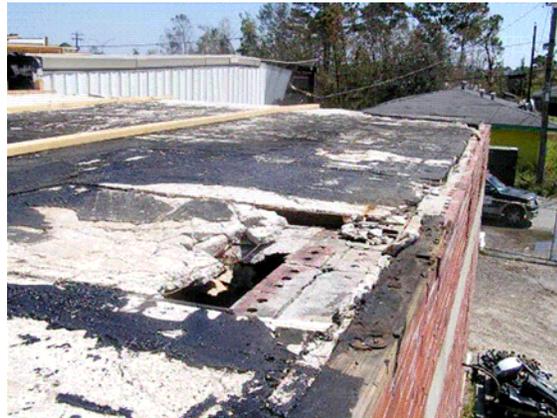
1.02.4. Commercial building. Metal edging and plywood decking were damaged at this windward corner.

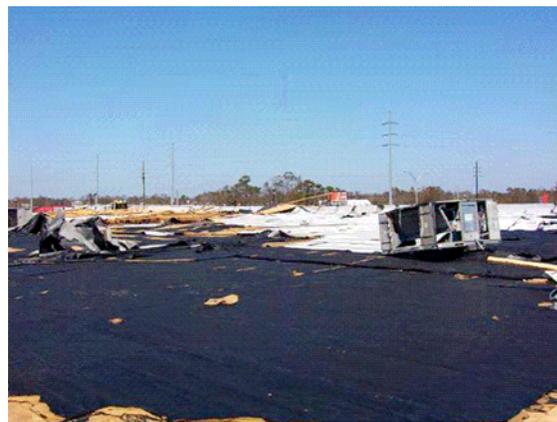
1.02-6. Commercial building. Damage shown here is separation of the plies.

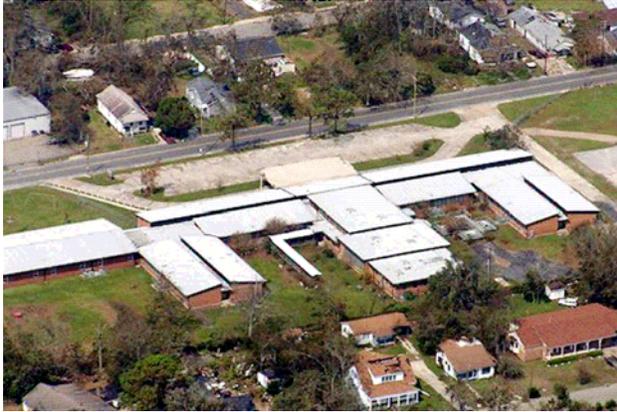
1.04-1. Central Elementary School. Aerial view shows an undamaged SBS membrane system.

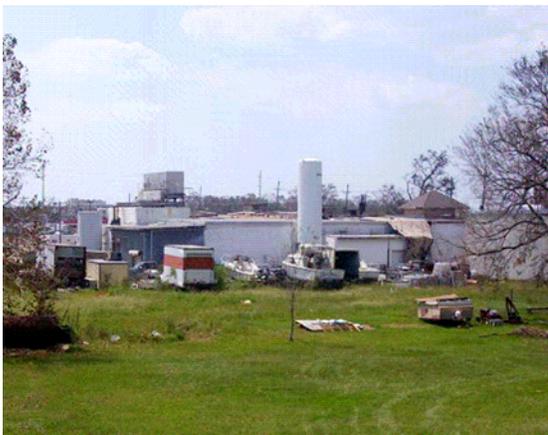
1.15(a)-1. Freezer plant. View of the commercial freezer plant shows damaged membrane hanging over the side of the building.

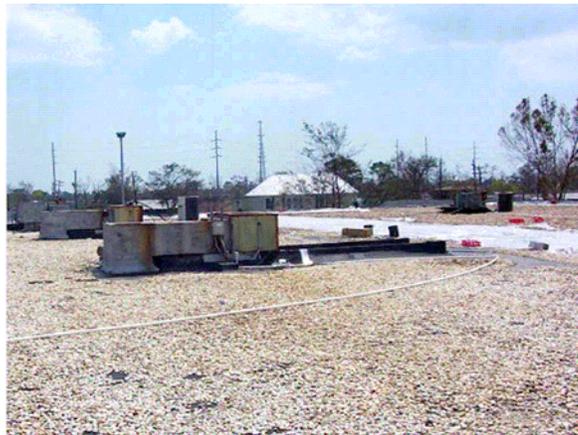
1.16-5. Pascagoula supermarket. View of the ballasted roof system. The plastic sheet covers a seam leak that occurred prior to the hurricane.

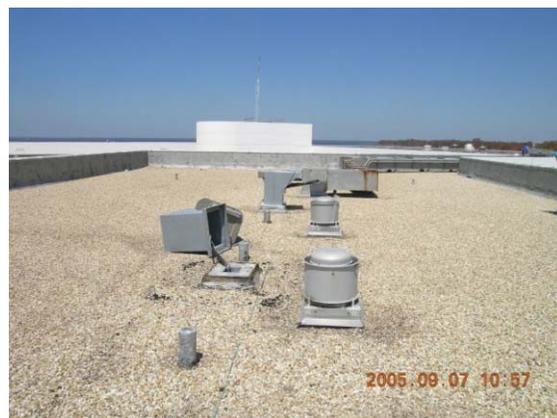
2.01-6. Gulfshore Assembly. This was typical of air-handler damage. Note the limited aggregate-surfacing scuff.

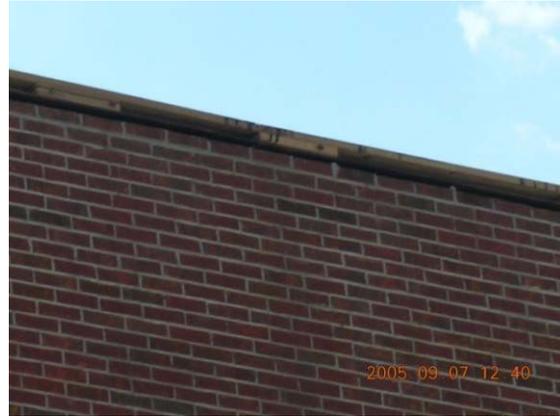
2.02(a)-2. Pass Christian HS. A look at the gym's east side shows where brick, spaced up nailer blocks, and edge metal are missing.

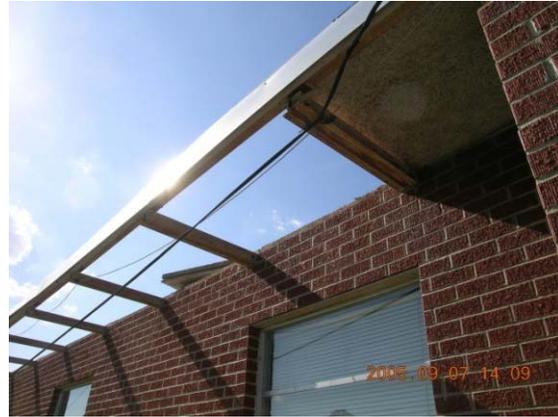
2.03(a)-6. Pineville Elementary. Panels were displaced from this overhang.

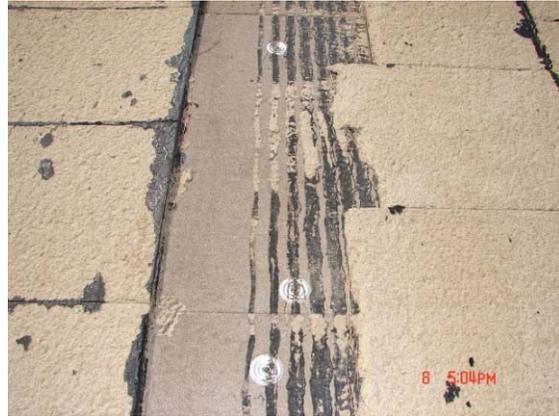
2.07-2. MaGee Auditorium. The bottom layer of perlite was screwed down; the top layer was strip-mopped with asphalt. Excessive uplift force probably caused adhesive failure of the asphalt.

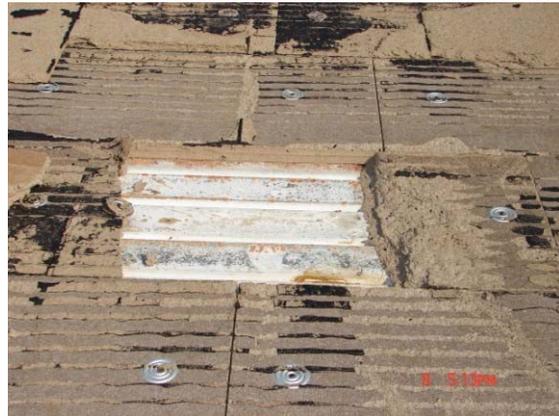
2.07-4. MaGee Auditorium. Only perlite insulation and decking remain on this roof; i.e., no membrane.

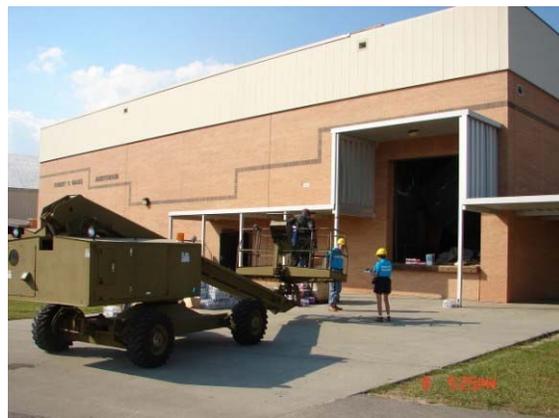
2.07-6. MaGee Auditorium. This garage door was blown in.

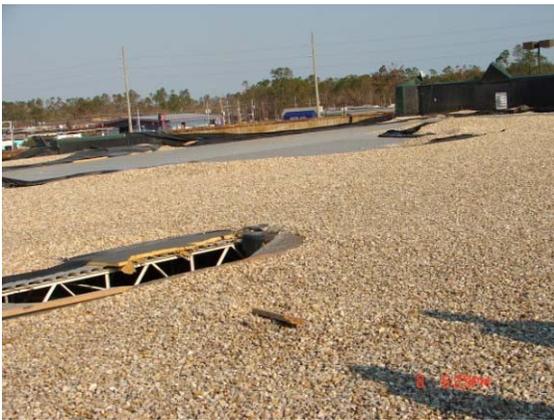
2.09-1. Sav-A-Center. Significant damage can be seen on this ballasted roof.

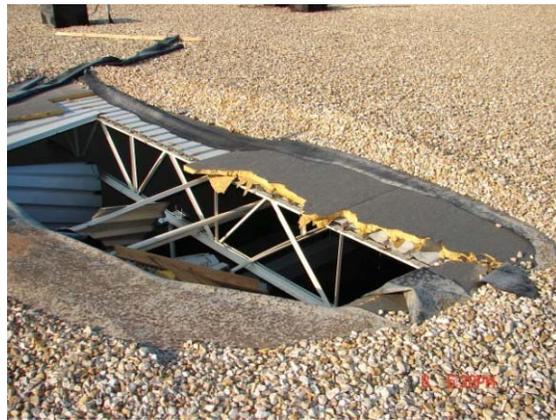
2.09-2. Sav-A-Center. The large hole was apparently caused by part of a mansard that traveled about 100 ft.

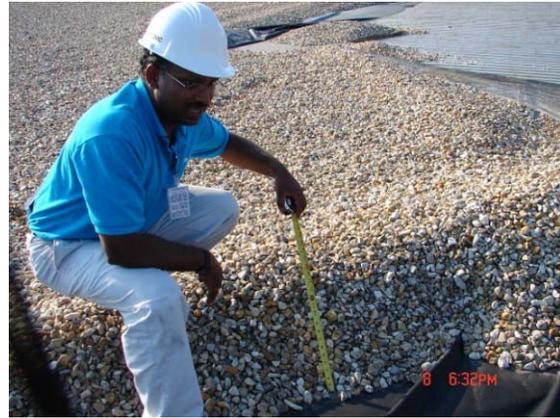
2.09-4. Sav-A-Center. This photo shows the way gravel accumulates near scoured areas. The gravel's weight helps limit the exposed damage area.

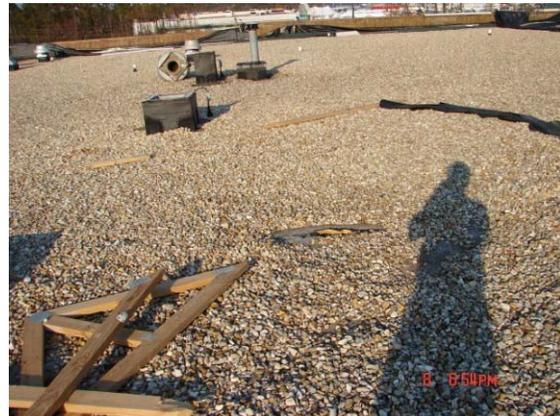
2.09-6. Sav-A-Center. Debris and related punctures were found in this area.

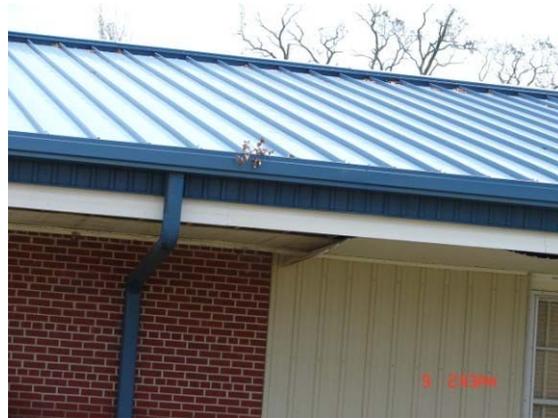
2.11-4. H. McCoughan Elementary. This was a typical roof condition at this site.

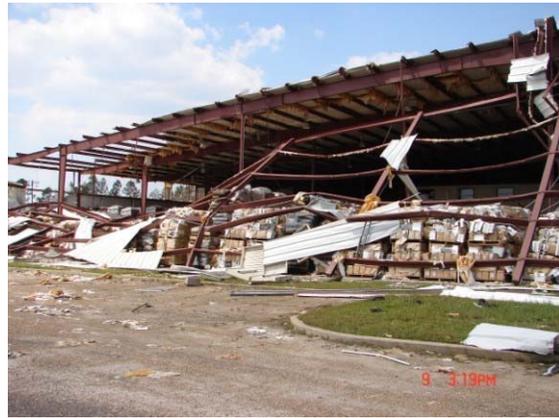
2.12-2. Commercial Exchange. Missing roof and wall sections are conspicuous here.

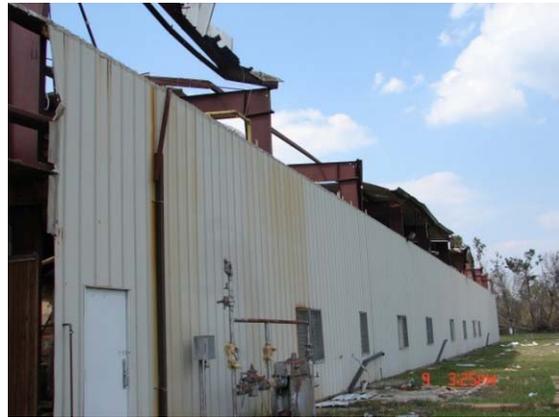
2.12-4. Commercial Exchange. Portions of the sidewall and roof are missing from this building.

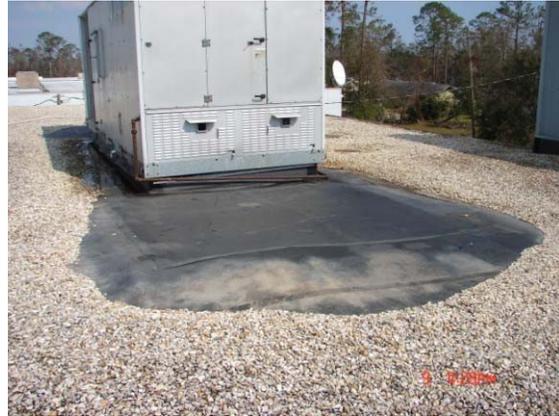
2.13-2. Sav-A-Center. This scour pattern was typical of what was found here. Wind blowing from the far side united to displace gravel on the near side.

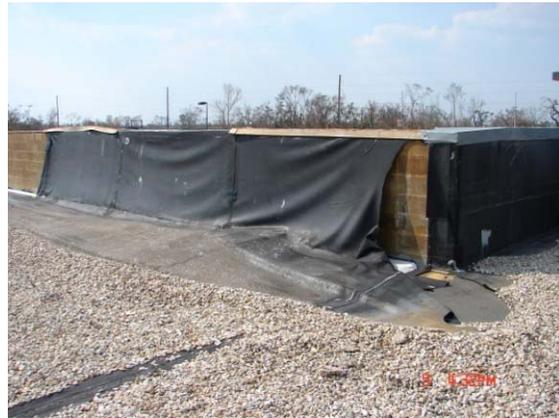
2.13-4. Sav-A-Center. Damaged wall flashing and coping are visible here.

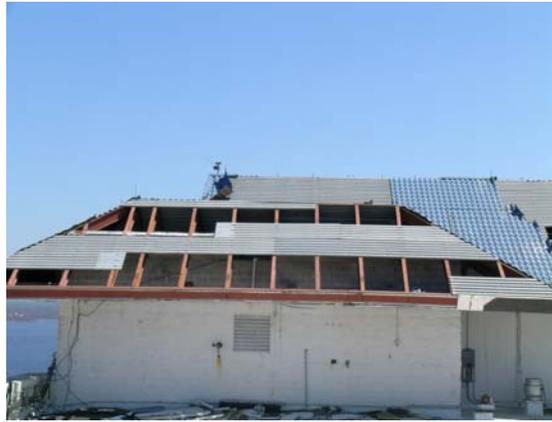
4.03-3. Imperial Palace Hotel Building 3. Steel decking and roof panel blew off. Welds failed, and steel decking and the mechanical fasteners failed at the roof panels.

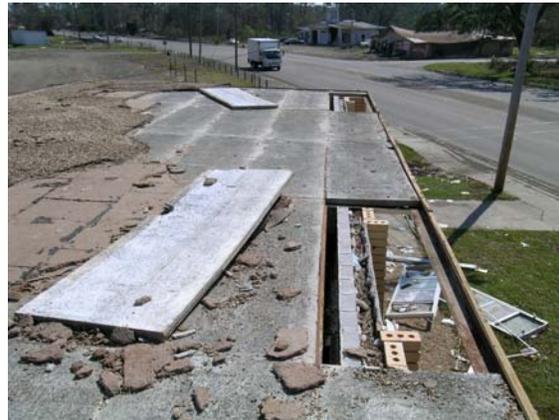
4.05-2. Saint Martin Middle School. Roof blew off along southern exposure toward the Gulf. CWF deck panel was blown off with the sheet metal at the perimeter.

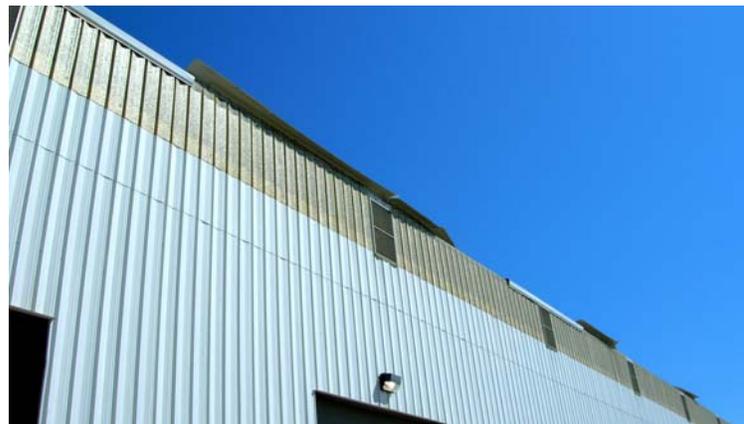
5.01-3. Keith Huber, Inc. Edge flashing failures (south wall) are visible here, but there was no damage to through-fastened roof.

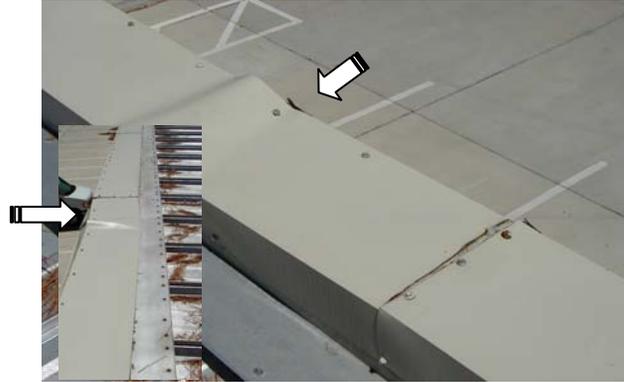
5.03-3. Kid Academy. East parapet cap flashing damage—perhaps from impact.

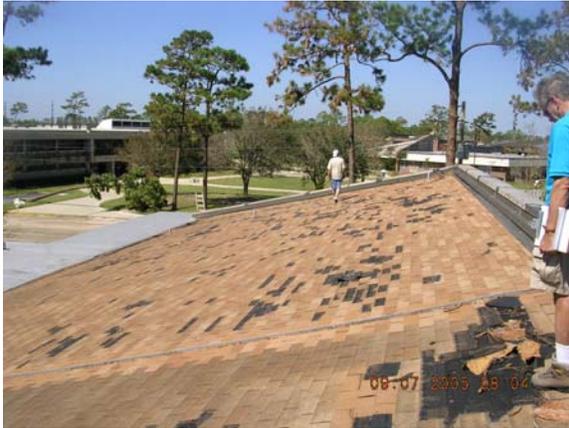
3.01-1. Gautier Library. This view of the older library roof shows damage to alternate courses. “Racking” method of installation was used; i.e., alternating courses of shingles attached with three, then four nails.

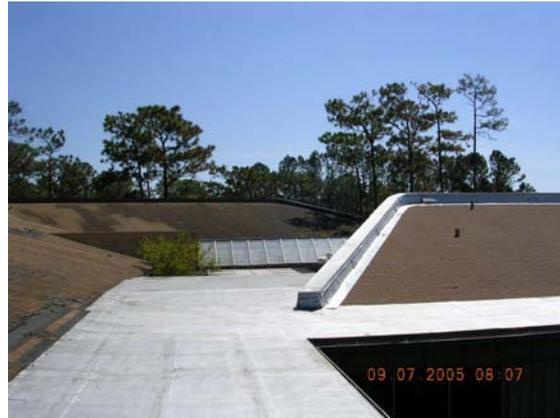
3.01-2. Gautier Library. This is the newer, undamaged library roof next to the older (damaged) roof.

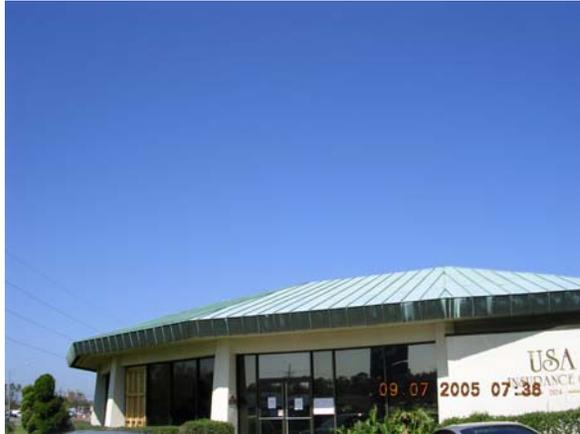
3.02-1. USA Insurance Building. An undamaged raised-seam copper roof. Neighboring roofs did sustain damage.

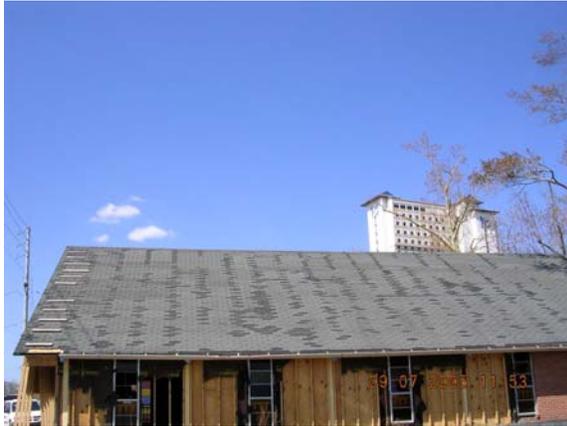
3.03-1. Living Waters Church. Torn tabs at unattached ends of shingles follow a vertical pattern.

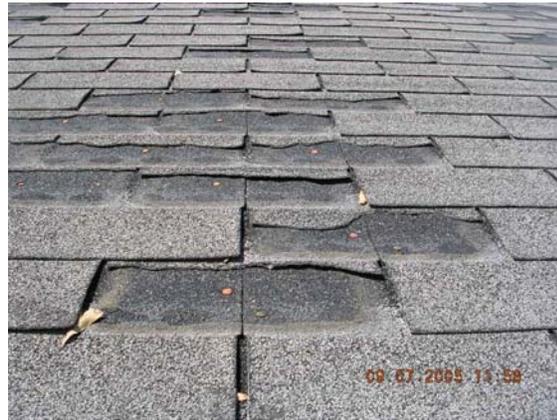
3.03-2. Living Waters Church. A closer view of torn shingles shows missing nails in alternating courses.

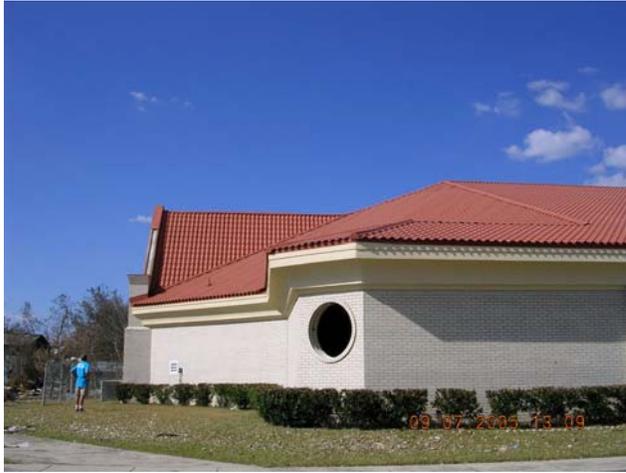
3.04-1. Church of the Vietnamese Martyrs. A steel “simulated tile” roof was installed on this church. Damage was limited to a missing coping flashing.

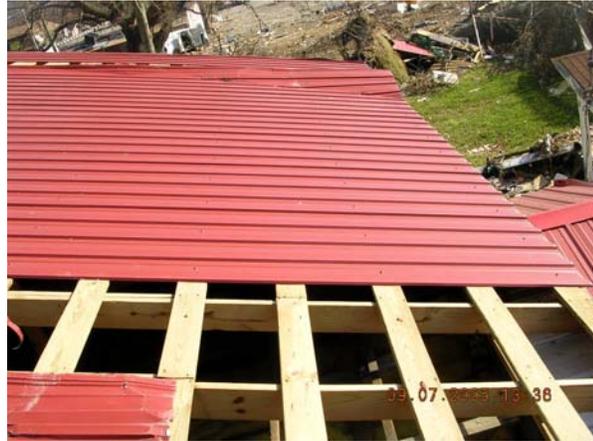
3.05-2. Church of the Vietnamese Martyrs. Three screws per panel spaced on every other board was inadequate attachment and did not resist the internal and external wind pressures of hurricane Katrina.

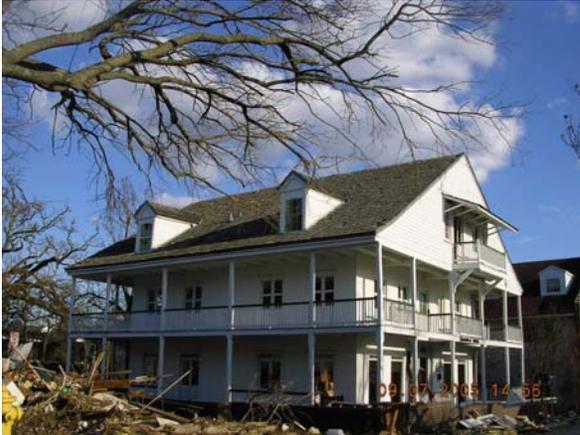
The only wood shake roof observed had sporadic loss of wood shakes as a result of improper nailing.

3.06-1. Magnolia Hotel. Sporadic wood shake loss was noted on this historic hotel.

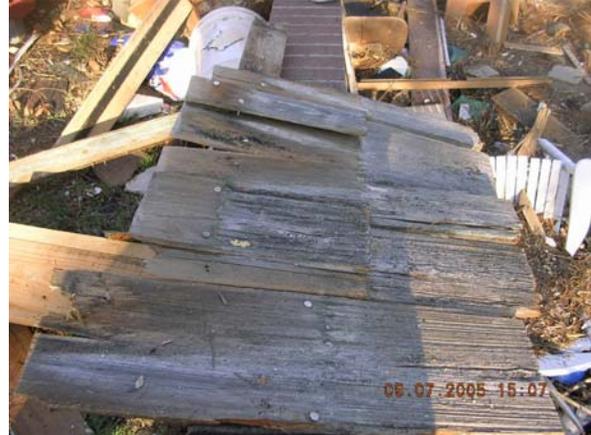
3.06-2. Magnolia Hotel. These wood shakes were installed in a way that appears to be a compromise in favor of aesthetics, rather than in a structurally sound manner.

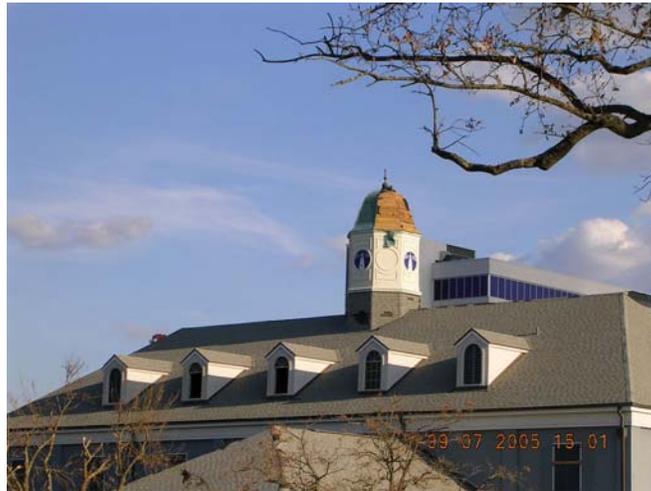
3.07-1. Hancock Bank. Damage at hips, ridges, dormers, and leading edges was noted on this shingle roof.

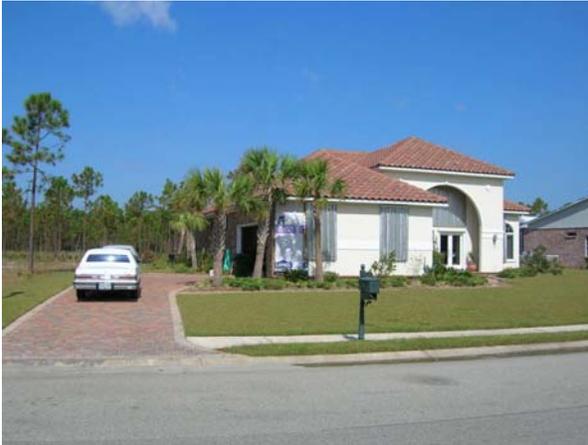
3.08-1. Residence. A surviving concrete tile roof is shown here.

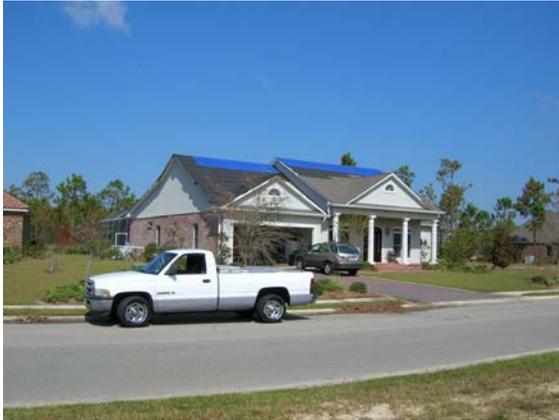
3.09-1. Residence. This is a residence with missing laminated asphalt shingles.

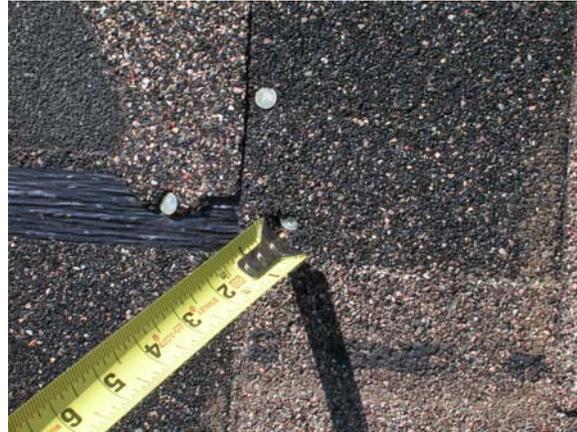
3.09-2. Residence. This is an example of inconsistent fastener placement and overdriven nails.

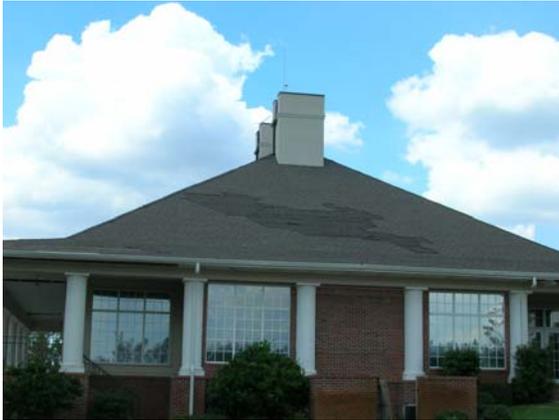
3.10-1. Gulf Landing CC Clubhouse. This clubhouse roof lost shingles between the eave and the chimney.

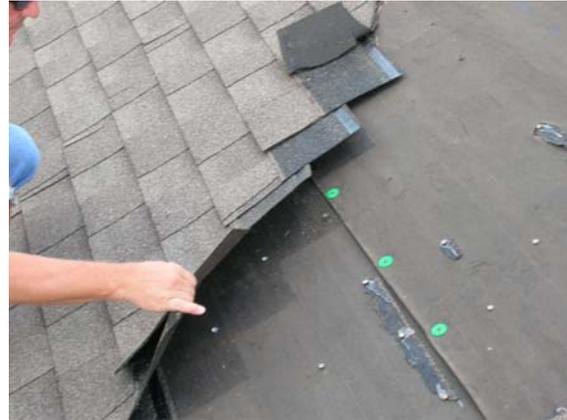
3.10-2. Gulf Landing CC Clubhouse. Shingles in the field of this roof were loose because of missing nails.

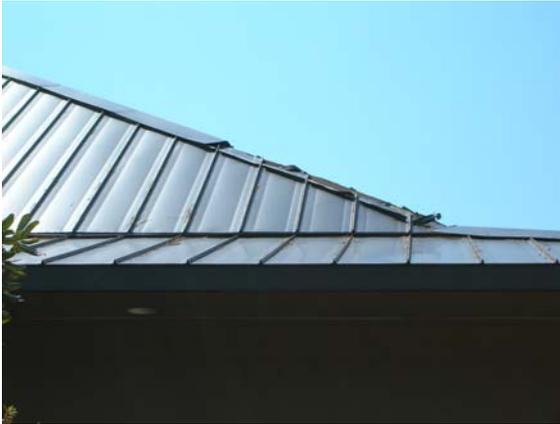
3.11-1. News Office Building. This “snap-lock” standing seam roof survived mostly intact, other than losing two hip panels.

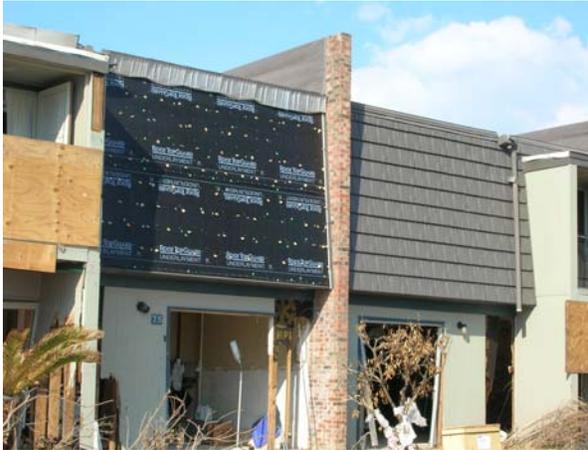
3.12-1. Gulf Oaks Multi-family Housing. Aluminum formed shake panels were missing from the mansard roof on this condominium.

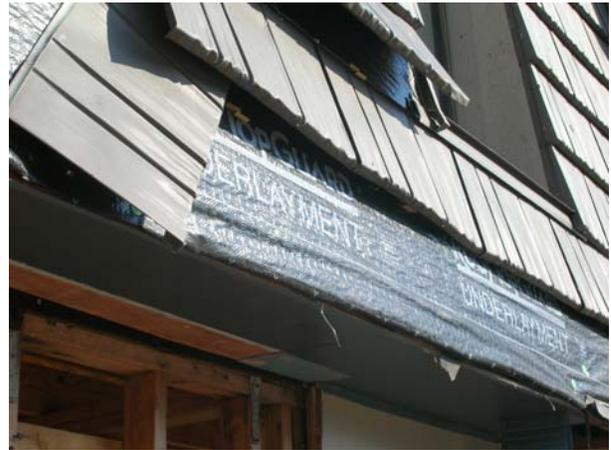
3.12-2. Gulf Oaks Multi-family Housing. Shingles disengaged at the front lip from edge metal and the rear of lapped panels.

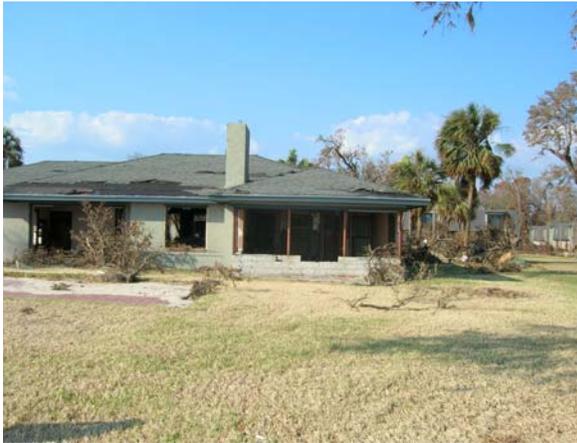
3.13-1. Residence. Ocean-front building with some shingles lost on windward side.

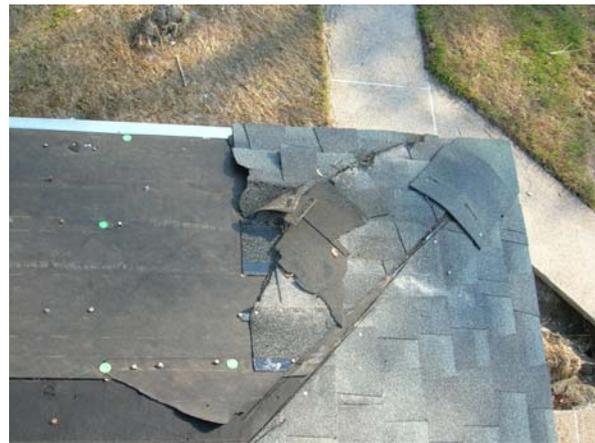
3.13-2. Residence. On this roof, shingles were torn loose from metal edge on the windward side.

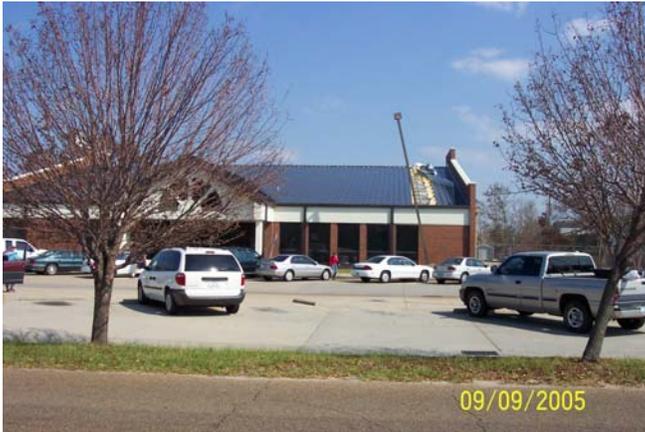
3.14-1. Post Office. This standing seam roof was missing three panels near the raised gable end wall.

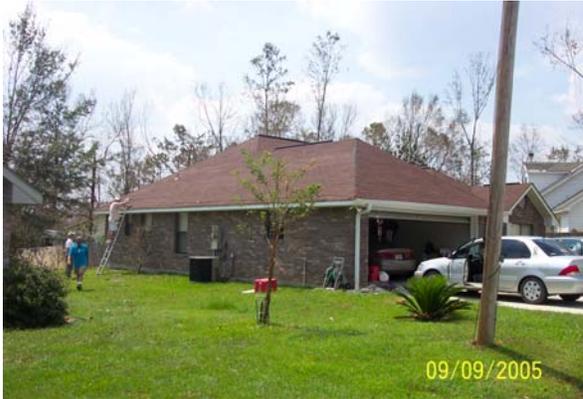
3.16-1. Residence. This overlay shingled roof lost shingles from leading edges and hips.

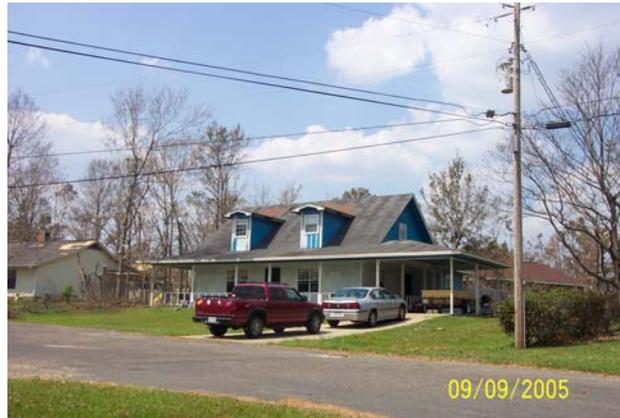
3.18-1. Residence. The vertical (“racking”) method of installation caused tearing of shingles at alternating courses.

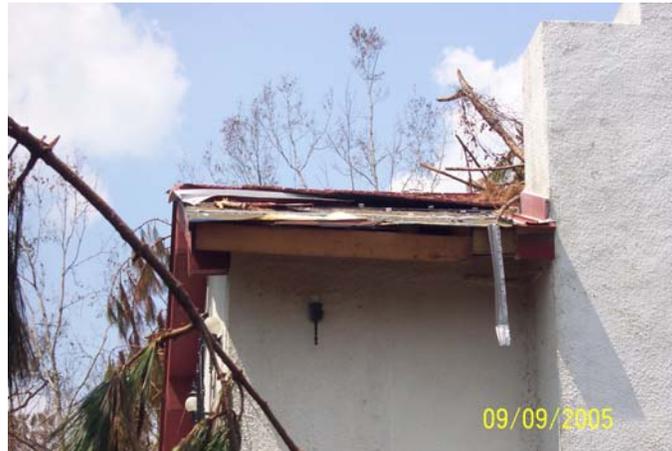
3.19-1. Residence. Metal shingles came loose when this metal edging was deformed by strong winds.

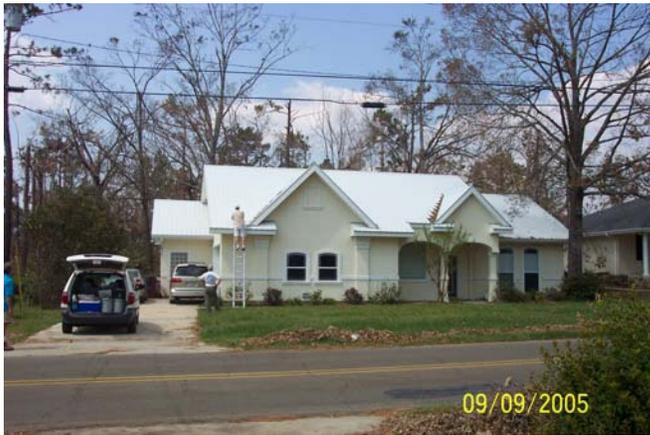
3.20-1. Residence. This steel panel roof appears to be undamaged.

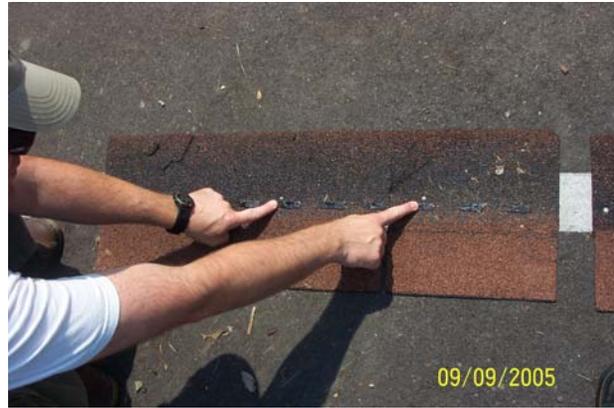
3.21-2. Lanai Village HOA. Shingles were not fastened at one end. Overdriven nails were noted in other places. Both anomalies contributed to blowoff and other damage.

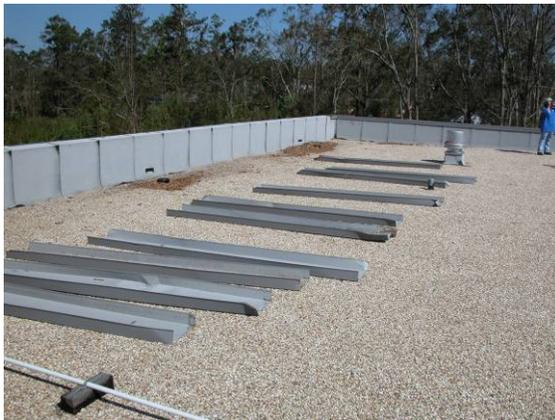
6.01-3. Community Medical Center. Recovered sheet metal coping pieces were stored on the roof.

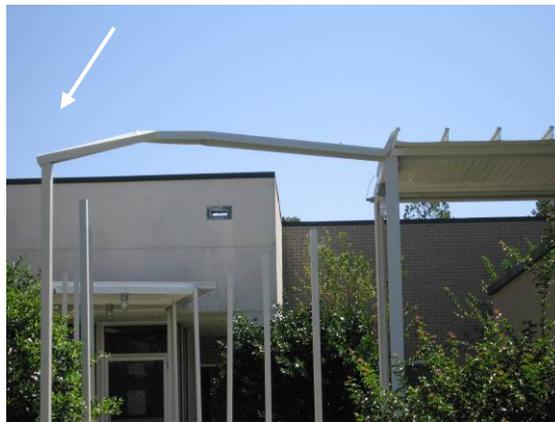
6.02-3. George County Hospital. Close-up of the covered walkway structure, showing both intact and missing roof covering sections.

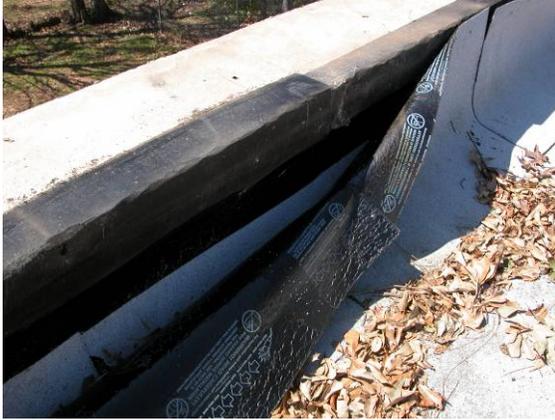
6.03-3. George County Hospital Maintenance Building. Adhesive failure of the flashing membrane to the parapet is visible.

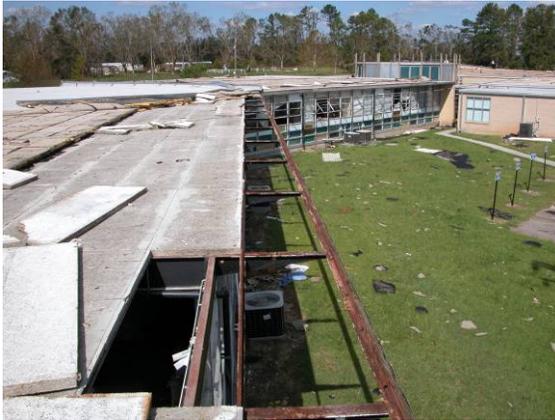
6.04 (a)-1. Stone Elementary School roof A. Southwest corner damage is visible, including missing deck panels. (Note: the gymnasium is located to the right, just out of this photo.)

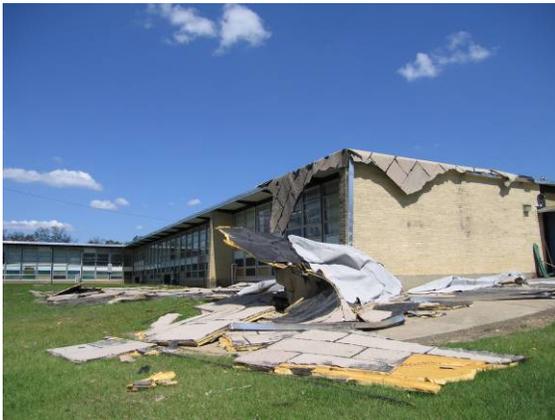
6.04 (a)-3. Stone Elementary School roof A. Roof membrane and decking material in this photo are draped over the roof edge, and lying on the ground.

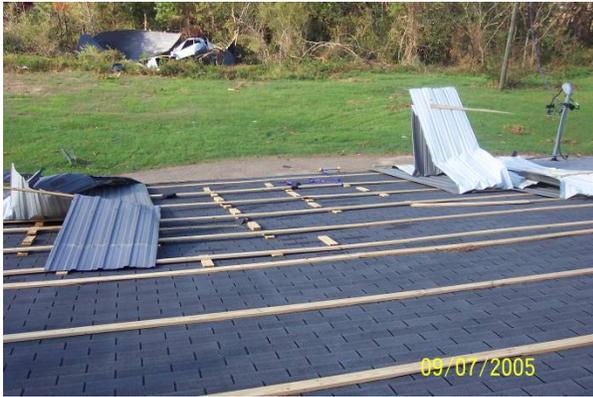
6.10-1. Baptist Church. Nailers are seen still attached to the metal roof sections on the leeward side.

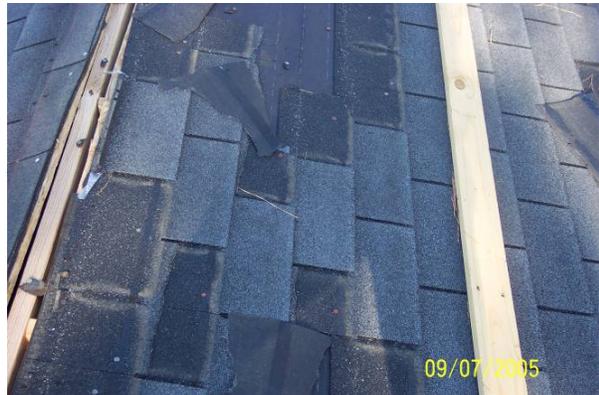
6.10-4. Baptist Church. Nails securing these wood nailers and stiffeners missed framing members, reducing pull-out strength.
