REPORT OF INVESTIGATION

Fatal Powered Haulage Accident
November 5, 2024

Cactus
DelHur Industries, Inc.
McCamey, Crane County, Texas
ID No. 41-05396

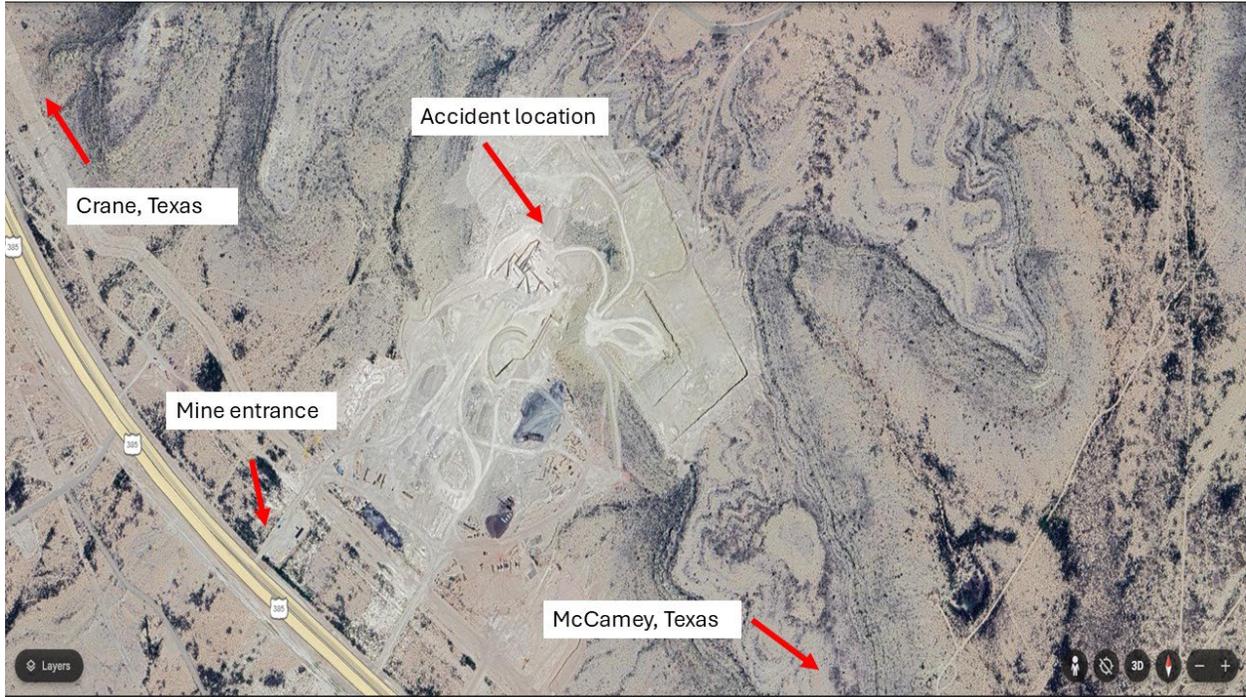
APPENDIX B – Map of Mine

The accident occurred at the primary dump point above the primary crusher (see Appendices B and C). The ground failed beneath the haul truck causing it to overturn multiple times down the approximately one-hundred foot of the face of the stockpile, coming to rest at the base.
