Hurricane Katrina Wind Investigation Report

HURRICANE KATRINA INVESTIGATION REPORT

August 2007

The Roofing Industry Committee on Weather Issues, Inc. deployed six teams to investigate damage caused by Hurricane Katrina in the landfall regions in Louisiana and Mississippi. This report covers investigations conducted between September 7 and September 9, 2005.

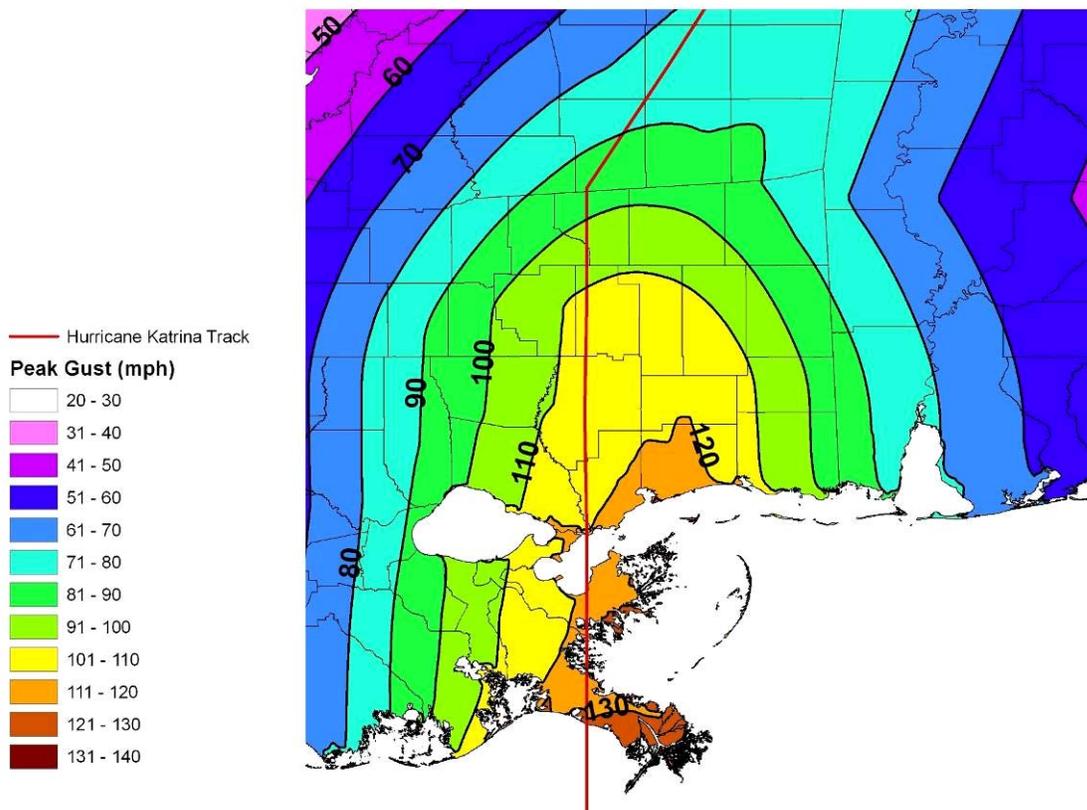
Figure 1. Hurricane Katrina 3-second peak gust wind speed map. Map used courtesy of Applied Research Associates (www.ara.com).

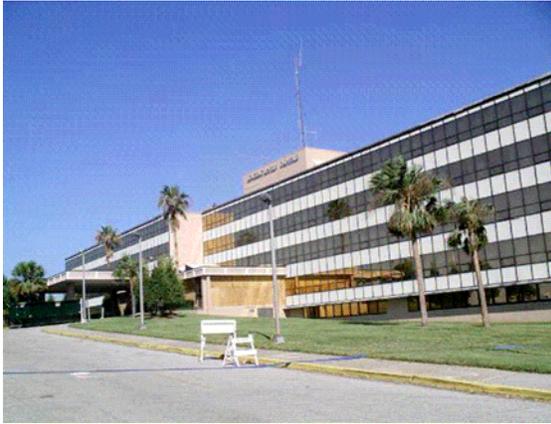
1.01-1. Singing River Hospital. View of the south face.

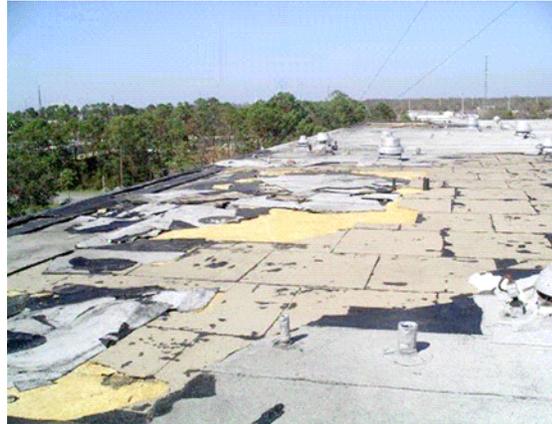
1.01-2. Singing River Hospital. Loss of the APP membrane and some perlite insulation boards is shown here.

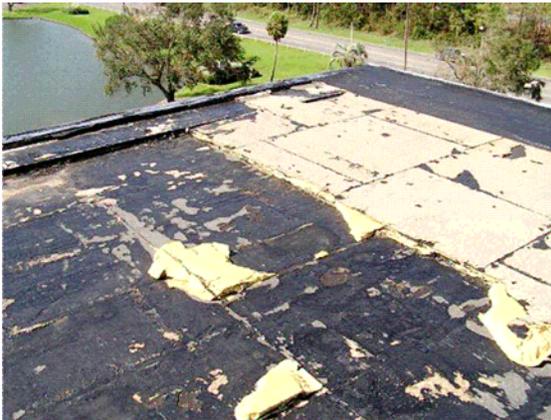
1.01-3. Singing River Hospital. Damaged insulation is all that's left after loss of the APP membrane at this roof corner.

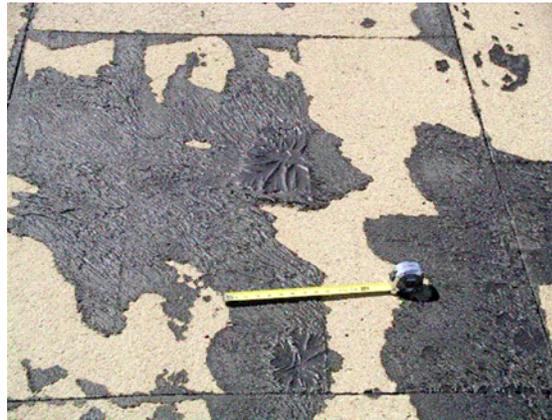
1.01-4. Singing River Hospital. Evidence of cold asphalt application. Note the shiny, wrinkled texture.

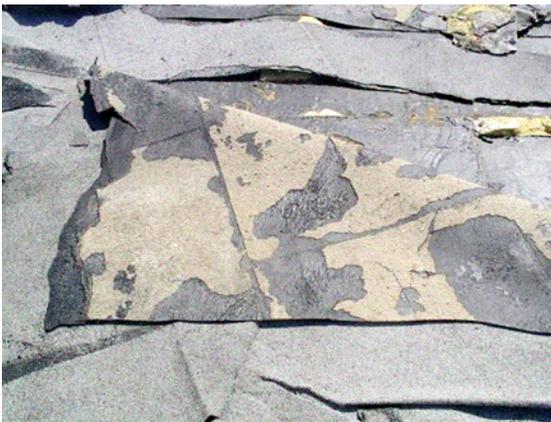
1.01-5. Singing River Hospital. A thin layer of perlite insulation is still adhered to this detached APP membrane.

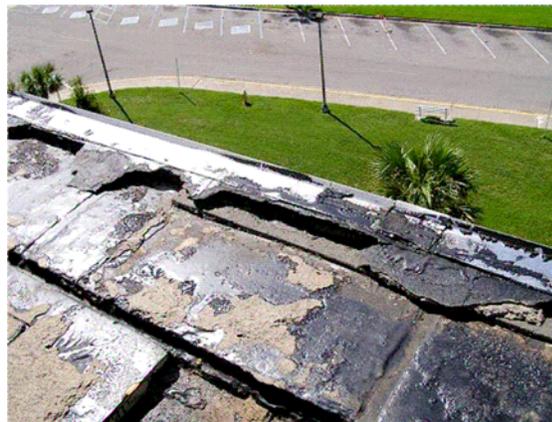
1.01-6. Singing River Hospital. Although the roof membrane blew off, the metal edge remained intact.

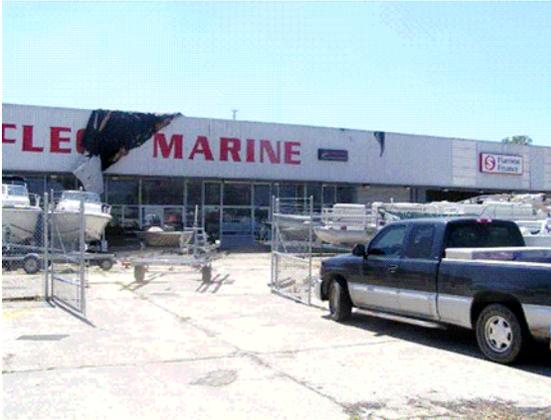
1.02-1. Commercial building. View of the front side of the marine showroom.

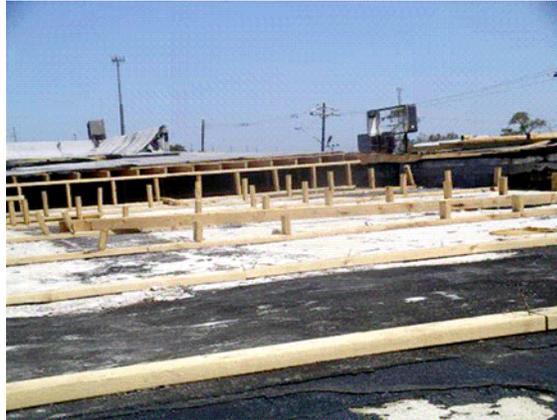
ADDITIONAL COMMENTS—According to the building owner, this roof experienced considerable damage during Hurricane Georges in 1998. As part of the roof repairs, the plywood deck was installed over the concrete deck to provide slope.

1.02-2. Commercial building. This is what is left of a plywood decking system retrofitted over the original roof to provide more slope.

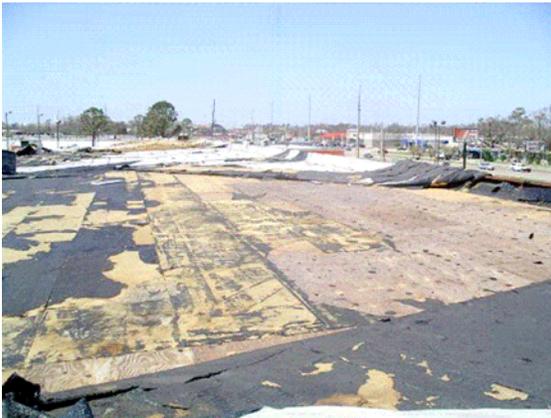
1.02.3. Commercial building. Three types of damage are shown here: tearing of felt nailed to the plywood, cohesive failure of insulation board, and delamination of the membrane.

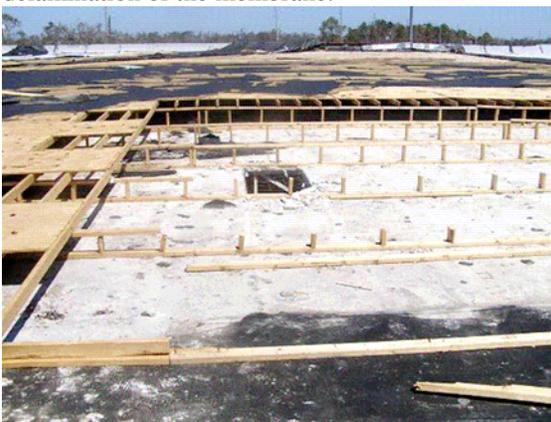
1.02-5. Commercial building. Damaged lightweight concrete decking is visible in this photo.

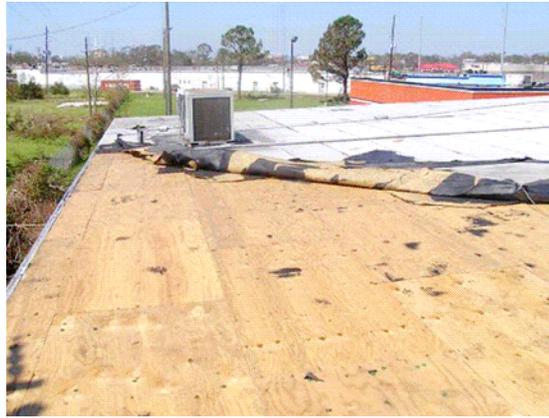
1.02-7. Commercial building. The roof assembly in this area was torn loose from the plywood deck.

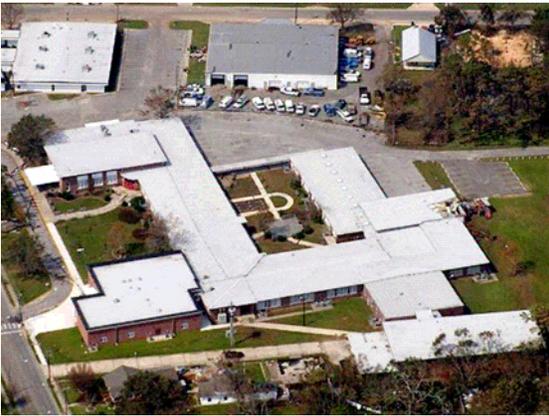
1.03-1. Trent Lott Middle School. Aerial view of Trent Lott Middle School.

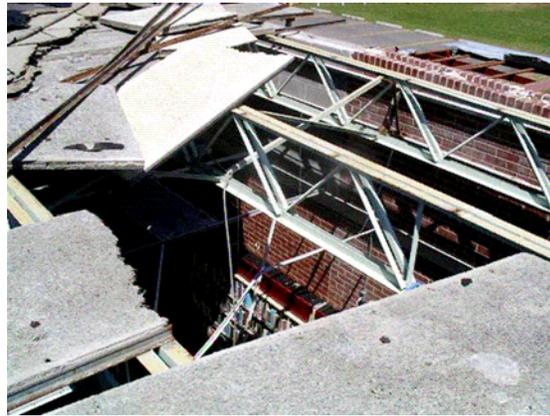
1.03-2. Trent Lott Middle School. CWF deck panels and bulb Ts were displaced because they were not anchored to the joists.

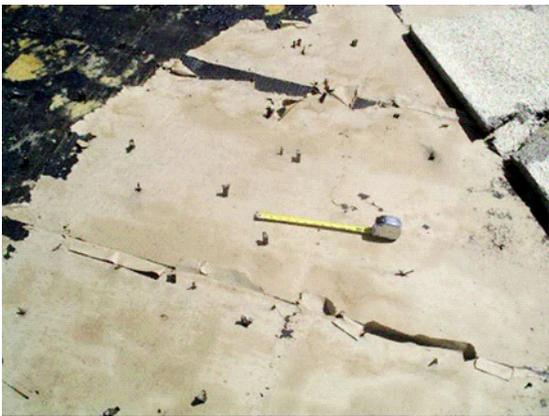
1.03-3. Trent Lott Middle School. Underside of the membrane-insulation assembly that peeled from the deck.

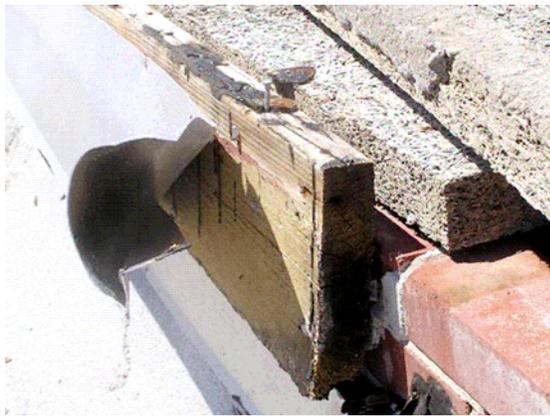
A two-piece metal edge detail may also have played a role in the blowoff of the roof section, as its fascia was not well secured to the wall. First, a bottom fascia strip was nailed along the wall to a 2 × 8 ft wood nailer, which was also installed along the side of the wall. The second metal edge assembly consisted of a coping and fascia section that was secured to the coping with its fascia section. It was secured along the coping with its fascia section clipped to the bottom fascia strip, which was nailed to the 2 × 8 ft nailer.

1.03-4. Trent Lott Middle School. Damaged edge flashing.

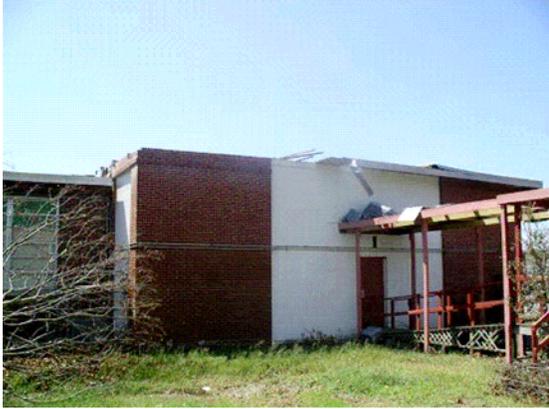
1.03-5. Trent Lott Middle School. The wall area at the damaged roof section showed no evidence of flashing attachment.

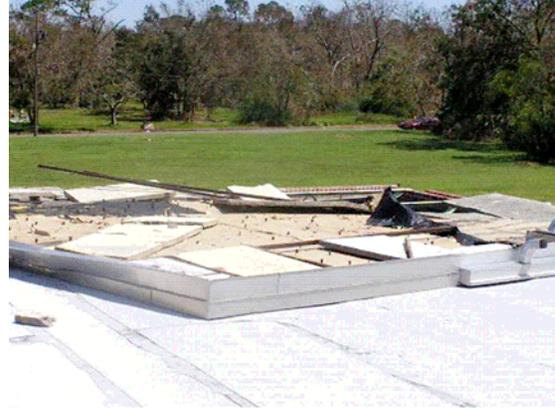
NOTED DAMAGE—Membrane, insulation, and deck were displaced.

1.03-6. Trent Lott Middle School. Overall view of the damaged roof section.

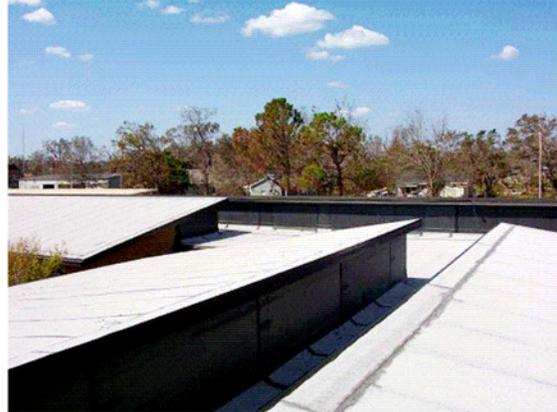
1.04-2. Central Elementary School. This photo shows a closer view of the undamaged SBS membrane system.

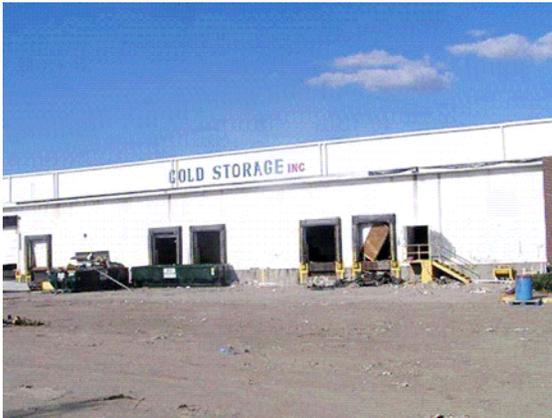
1.05.1. Commercial building. Front view of the commercial freezer plant.

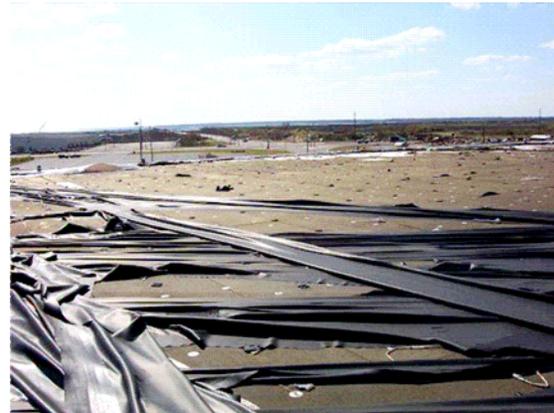
1.05-2. Commercial building. Overview of the roof damage.

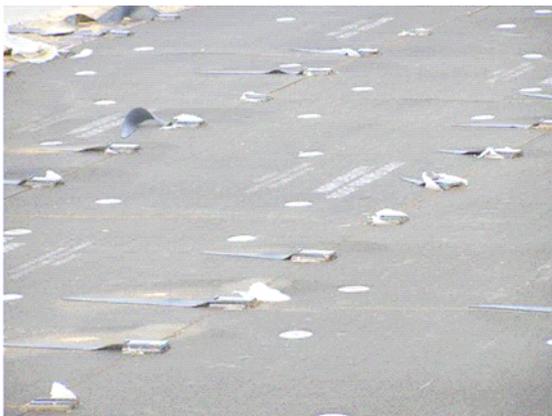
1.05-3. Commercial building. Only small, shredded strips of damaged membrane remain from where blowoff occurred. The EPDM either tore around fasteners or pulled the top sections of the fasteners loose.

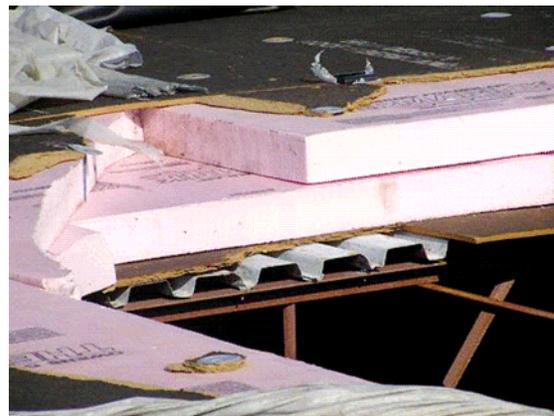
1.05-4. Commercial building. Exposed insulation is visible in this photo showing where decking was blown off.

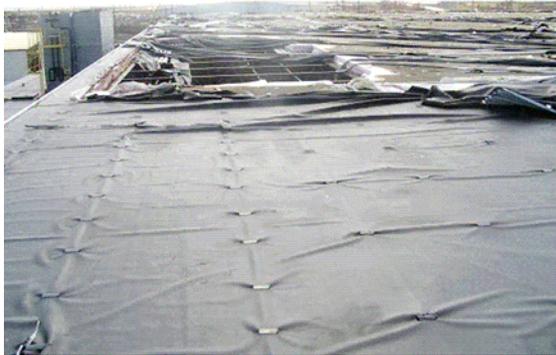
1.05-5. Commercial building. Section of undamaged membrane (with non-penetrating fasteners in place) next to a section of blown-off decking.

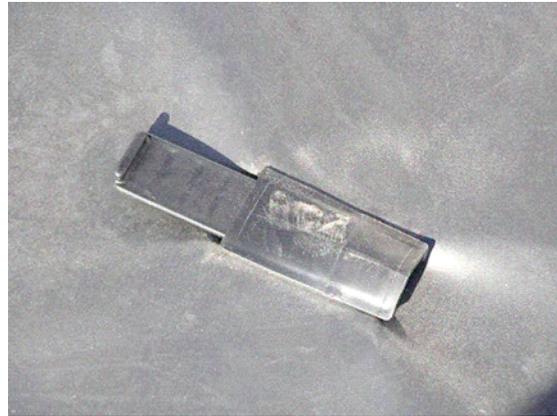
1.05-6. Commercial building. Top view of a non-penetrating fastener.

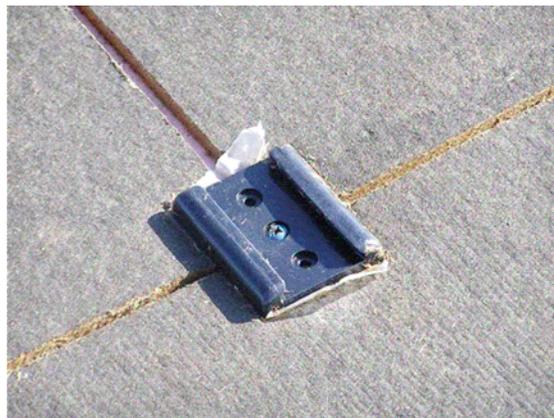
1.05-7. Commercial Building. Bottom piece of a damaged non-penetrating fastener secured to the steel deck.

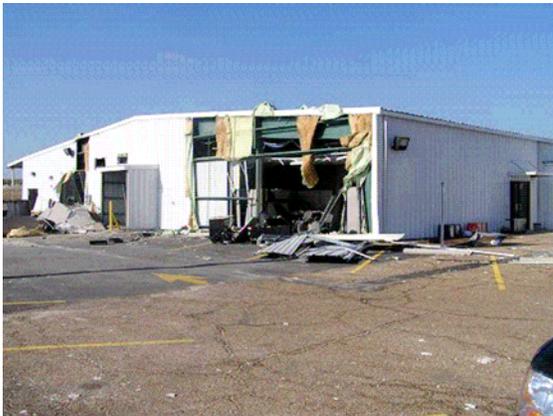
The building was apparently pressurized, as evidenced by a blow-out of a section of the east wall.

1.06(a)-1. Commercial building. Blown-out east wall of this commercial computer facility.

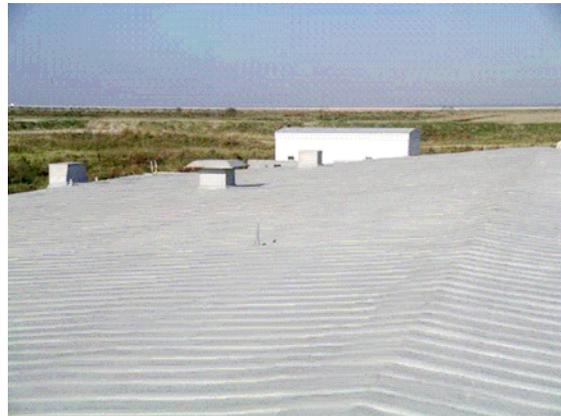
1.06(a)-2. Commercial building. View of the undamaged SPF roof, which had been well maintained.

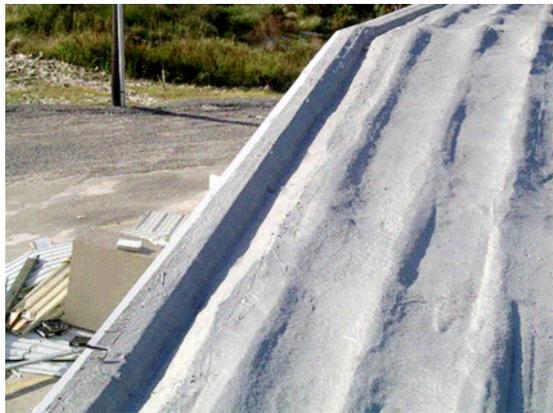
1.06(a)-3. Commercial building. Edge detail of the undamaged SPF roof.

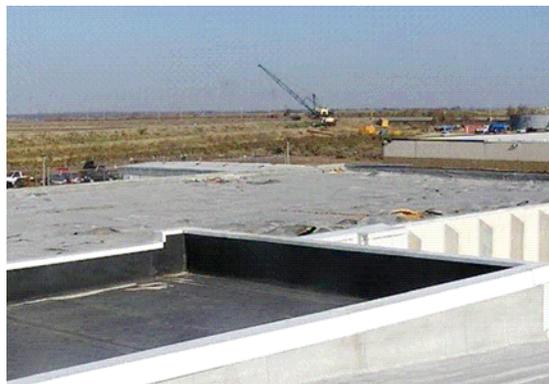
ADDITIONAL COMMENTS—The spray foam on this roof was the original installation, over 20 years ago. Little roof maintenance had been performed over the years, as evidenced from its deteriorated condition, which included large interlaminar blisters and sections of delaminated coating.

1.06(b).1. Commercial building. View of the undamaged, but poorly maintained, SPF roof covering.

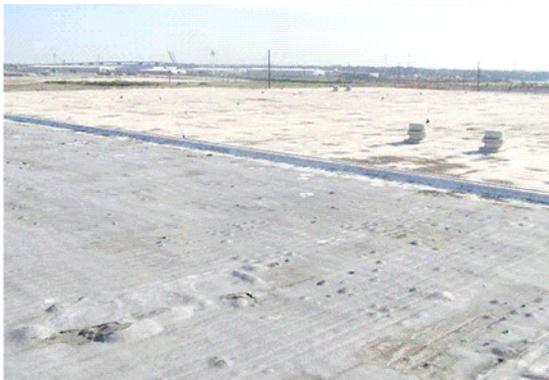
ADDITIONAL COMMENTS—This SPF roof was more than 20 years old, and some sections had been poorly maintained. In those sections, the roof showed evidence of SPF sprayed over moisture and exhibited blistering and UV degradation. Hurricane-induced damage was not observed in those areas.

1.07-1. Commercial building. Well maintained SPF (background) and poorly maintained SPF (foreground) roofing on the administration building.

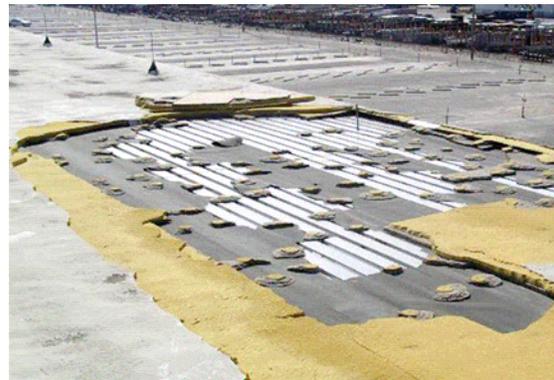
1.07-2. Commercial building. Damaged section where SPF had been applied over mechanically attached wood fiber board. No fasteners were installed in the far corner of the damaged area.

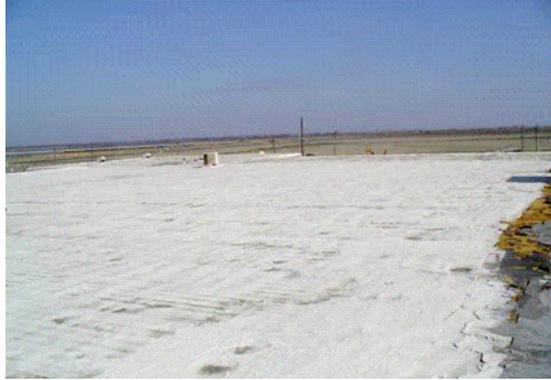
1.07-3. Commercial building. An area of well maintained SPF roof lies next to a section that was poorly maintained. However, the poorly maintained areas were not damaged by Katrina.

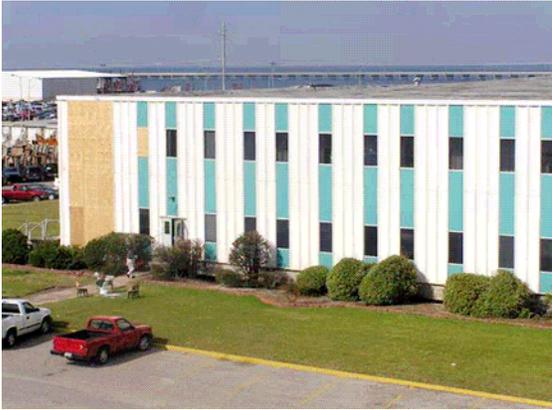
1.08-1. Commercial building. East wall of building.

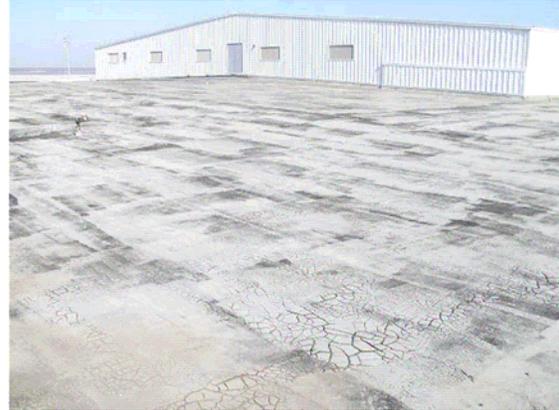
1.08-2. Commercial building. View of the undamaged BUR membrane with coating.

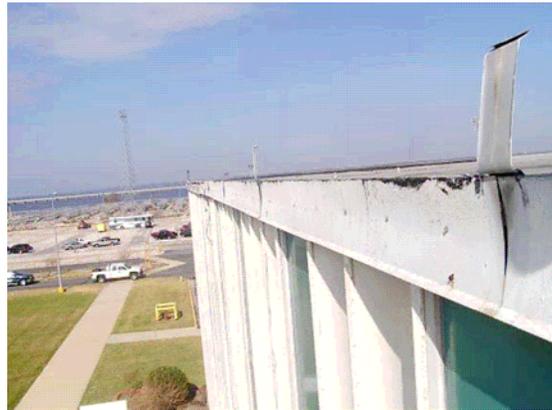
1.08-3. Commercial building. Bent cover strips at joints between sections of metal fascia.

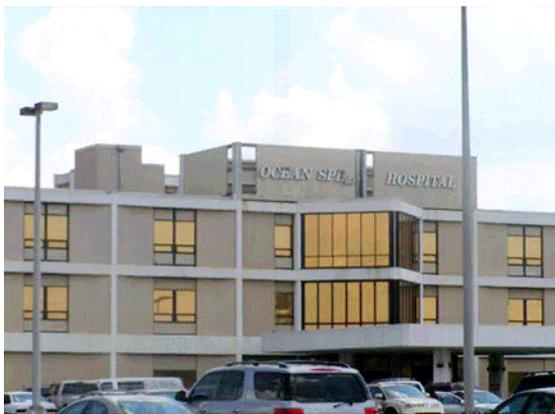
1.09(a)-2. Ocean Springs Hospital (front side). The screen at the top of this building (surrounding rooftop mechanical equipment) was damaged.

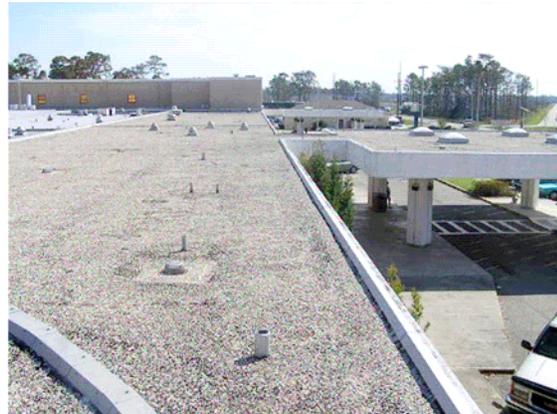
1.09(a)-3. Ocean Springs Hospital. Overview of the undamaged aggregate-surface BUR.

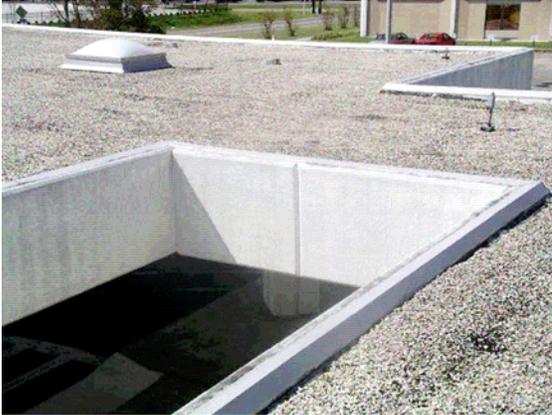
ADDITIONAL COMMENTS—No Katrina storm damage was observed on this roof section. The aggregate-surface BUR was judged to be in very good condition with very good edge details. The gravel guard was well secured in a reglet on top of a curbed concrete-panel fascia. A 2 in. thick nailer was secured to the inside face of the curb. A cleat nailer was fastened to this nailer for securement of counter-flashing.

1.09(a)-4. Ocean Springs Hospital. View of a typical perimeter edge detail.

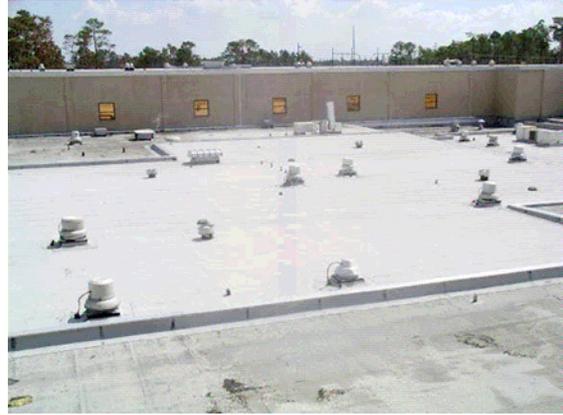
1.09(a)-5. Ocean Springs Hospital. This photo shows an SBS modified bitumen membrane system that was undamaged.

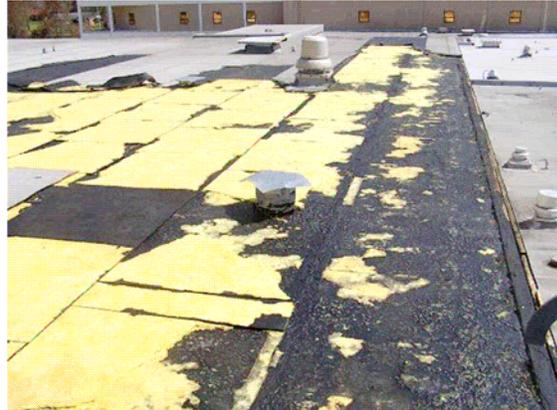
NOTED DAMAGE—Edge flashing was detached at the corner. Sections of membrane and re-cover board were also blown off.

About 20% of the SBS membrane system was damaged. Damage consisted of peeling of the membrane at the southwest corner, extending 50 ft along the western side and 60 ft along the southern side. Three modes of membrane-system damage were observed: (1) the glass fiber re-cover boards

1.09(b)-2. Ocean Springs Hospital. Damage to the SBS membrane and edge flashings.

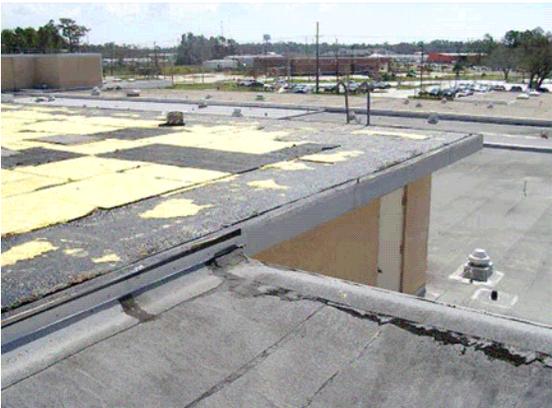
detached from the original BUR (over about 20% of the damaged area), (2) the bottom ply of the recover membrane detached from the fiberglass cover board over about 75% of the damaged area, and (3) the cap sheet peeled away from the ply sheet below it, apparently as a result of cold asphalt application (over about 5% of the damaged area).

1.09(b)-3. Ocean Springs Hospital. The roof at left shows loss of re-cover board, as well as of flashing details along the edge of the SBS roof assembly.

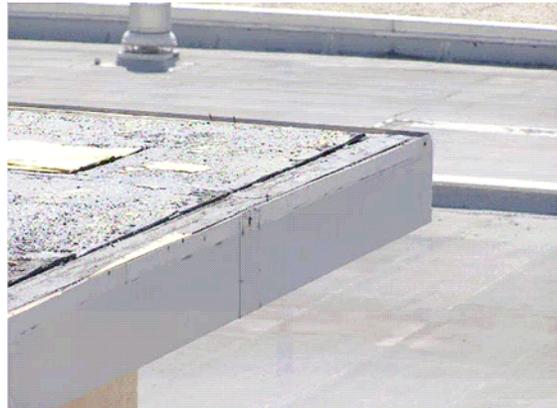
DAMAGE INITIATION AND PROPAGATION—The damage may have started at the edge flashing, which was not well attached at the perimeter. Where the edge detail blew off, there were two contributing causes: (1) inadequate nailing of the 1 × 4 in. nailer to the 2 × 8 in. wood fascia board and (2) no face attachment of the metal, i.e., no cleats.

1.09(b)-4. Ocean Springs Hospital. No evidence of face attachment (cleats) of the edge flashing.

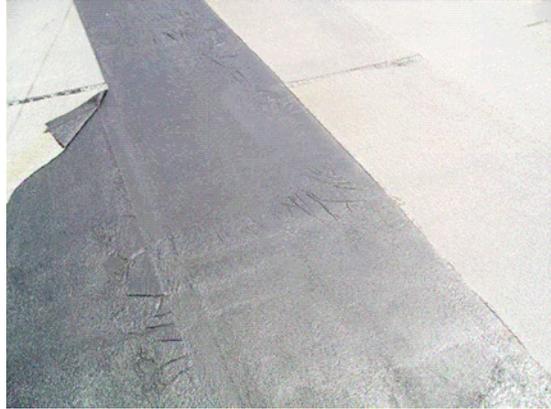
1.09(b)-5. Ocean Springs Hospital. Example of SBS cap sheet that delaminated from the built-up roofing plies below it. This appeared to be due to improper (too cold) asphalt application.

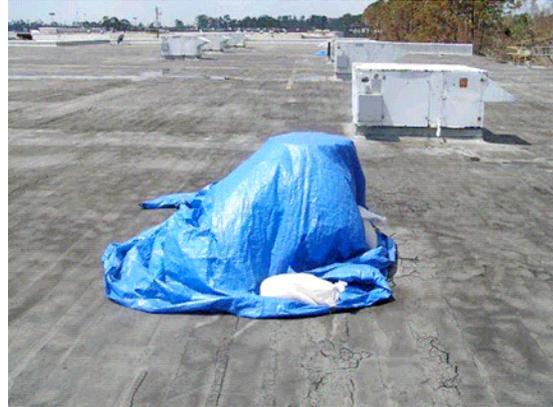
1.10-2. Commercial building. Damaged rooftop equipment was covered with plastic.

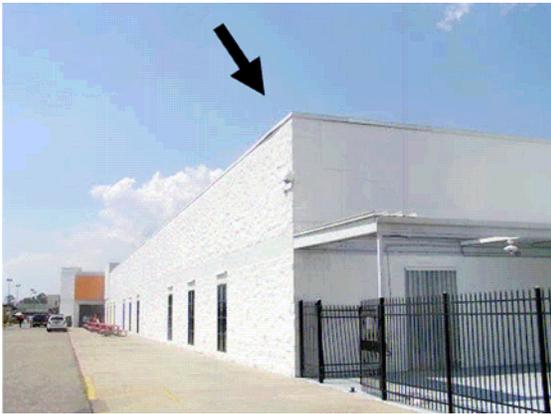
NOTED DAMAGE—No damage to the membrane system was observed. A 5 ft section of metal edge fascia on the windward southeast corner bowed slightly outward. Some rooftop equipment was also damaged.

1.10-3. Commercial building. Outward bowing of the edge metal (arrow) can be seen in this photo of the southeast corner.

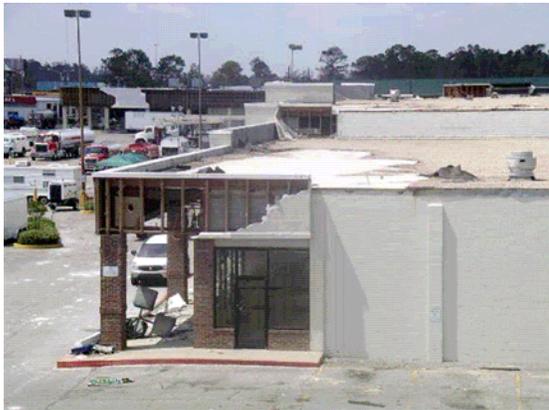
NOTED DAMAGE—Glass at the front of the building was blown out. The membrane above the glass damage was blown off.

1.11-1. Strip mall. Damaged roofing is visible.

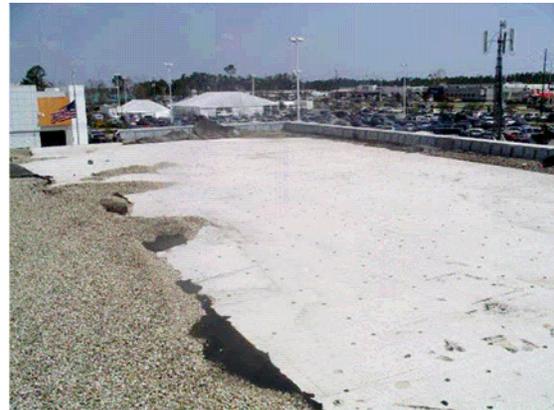
A contributing factor may have been the pressurization at the corner due to loss of the glass wall. There was an opening between the roof and the room below at the southeast corner of the building. This opening may have allowed the underside of the roof membrane to be pressurized. It was noted that the edge flashing at the damaged section was mostly intact with the exception of a short length of base flashing that may have pulled away when the membrane released.

1.11-2. Strip mall. Damaged corner section. Note the exposed lightweight concrete decking.

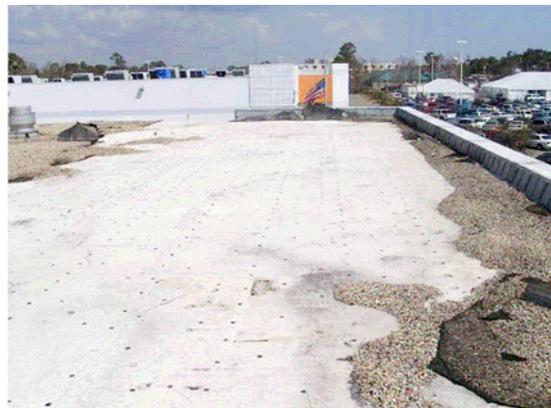
DAMAGE INITIATION AND PROPAGATION—The roof assembly lifted away from the deck, leaving most fasteners in place. Although little remained of the roof membrane for examination, it was apparent that the base sheet tore around the expandable fasteners, allowing the BUR to blow away.

1.11-3. Strip mall. Fasteners remained in the deck. Coping at parapet is intact.

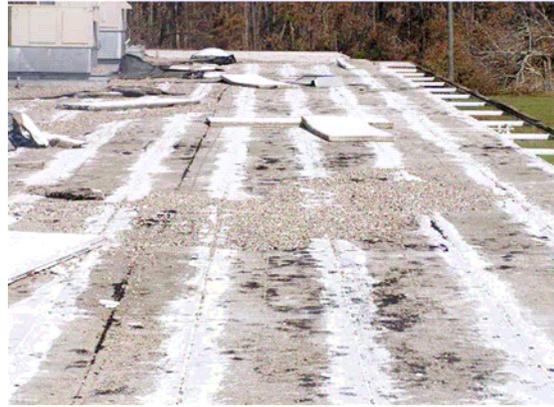
Along the south edge of an overhang, an entire row of CWF panels blew off. The damage was attributed to lack of attachment of panels to supports, since they were held in place only by their own weight. Back from the displaced panels at the overhang, the BUR detached from CWF panels, which remained in place. Fasteners holding the base sheet were severely corroded, causing most of them to pull loose from the CWF panels. It was noted that there were two rows of fasteners in some sheets. The individual fasteners were set 3 ft apart and staggered. Other sheets had an additional row of fasteners down the center, which also were set 3 ft apart.

1.12(a)-2. Pecan Park Elementary School.
Damage was found along the southern edge of the roof.

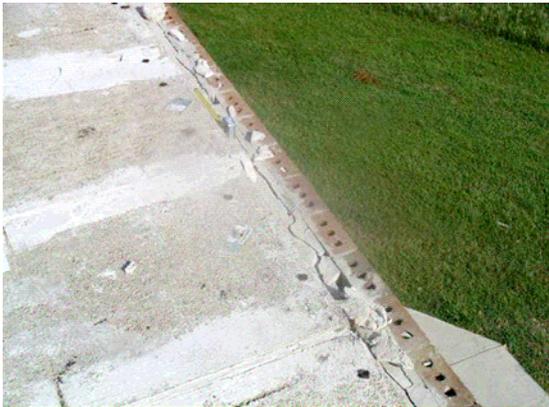
There was no overhang at the southeast corner of the damaged section. Here, the base nailer detached from the masonry wall because bolts pulled out of the mortar. The bolts were severely corroded. The CWF panels remained in place, but the membrane released.

1.12(a)-3. Pecan Park Elementary School.
Damage at the southeast corner of the building, where bolts attaching a nailer pulled out of the mortar.

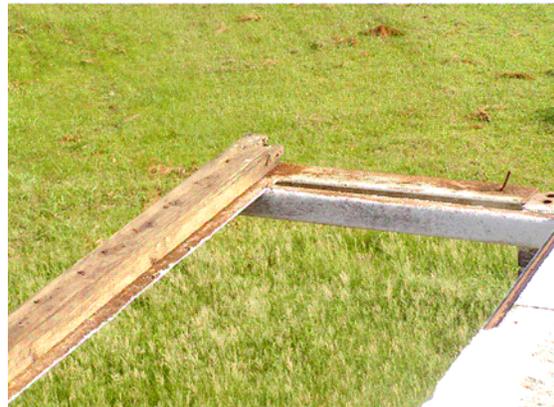
DAMAGE INITIATION AND PROPAGATION—There was poor attachment of the perimeter edge detail. At the overhang, four layers of nailers were observed. The nailer layer attached to the angle supports for the CWF panels remained attached because it was bolted in place. Damage typically occurred within the second layer of nailers, since they were not bolted in place. In fact, it was difficult to determine how the second nailer was attached to the bolted nailer. In addition, the metal frame supporting the CWF panels was severely corroded.

1.12(a)-4. Pecan Park Elementary School. This is an example of damaged edge detail at an overhang.

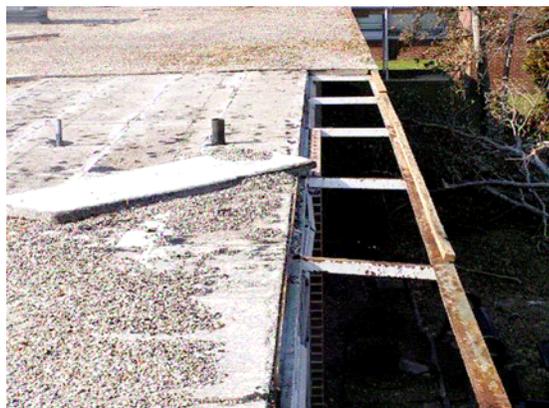
The east side of the roof section had a 2 ft overhang. A 25 × 20 ft wide section of BUR was damaged. The CWF panels and nailer assembly blew off along the overhang. It was unclear how the missing nailer was attached. There were no bolts in the metal angle support indicative of mechanical fastening of the nailer. There was window damage below this roof section, suggesting that the membrane peeled after the overhangs failed.

1.12(a)-5. Pecan Park Elementary School.
Damaged roof section at an overhang along the eastern edge of the building is shown here.

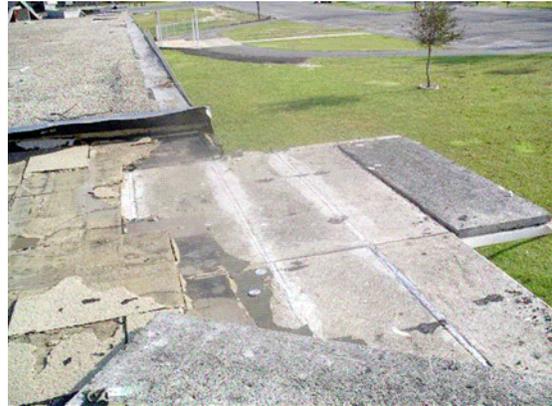
One cause was an inadequate edge detail at the overhang, which may have initiated the blowoff. Prior to blowoff, three wood nailers were attached to each other and to the base nailer bolted to the metal frame supporting the CWF panels. The bottom nailer appeared to be very old and was severely rotted in places. Only one severely corroded bolt was found securing the bottom nailer to the metal frame. However, bolt holes were observed that were 24–36 in. apart. Rust stains were observed in the bolt holes and structural metal. The middle and top nailers (1 × 4 and 2 × 4 in., respectively) were nailed to each other and appeared to be new wood. To these nailers, a 2 × 8 in. fascia board was nailed into the side of the 2 × 4 in. nailer. This nailer assembly came off in the damaged areas. Also, a 4 ft section of the southern wall at the southwest corner lost the edge nailer assembly, but two bolts set 3 ft apart in the brick mortar remained in place.

1.12(b)-2. Pecan Park Elementary School. Damage at the southwest corner occurred at the overhang shown here at upper right.

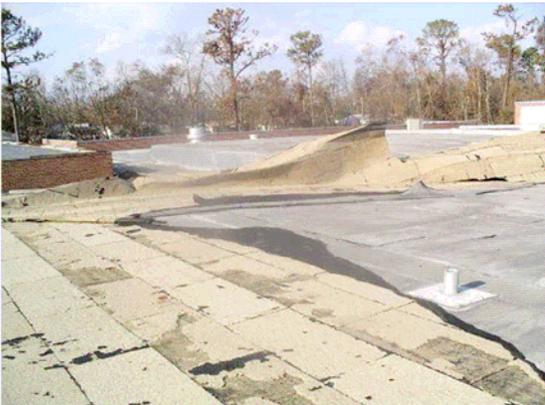
approximately 15% of the membrane damage. (3) There was a cohesive failure of the perlite insulation just below the top surface of the topmost board. Where this damage occurred, a thin layer of perlite insulation remained attached to the bottom of the membrane. This mode was approximately 70% of the membrane damage.

1.12(b)-3. Pecan Park Elementary School. Cohesive failure of the perlite insulation in this photo is associated with membrane blowoff.

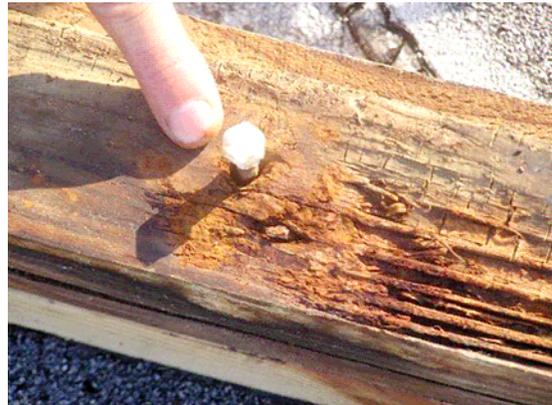
1.12(b)-4. Pecan Park Elementary School. A rotted section of this wood nailer could have instigated nailer detachment from the structural members.

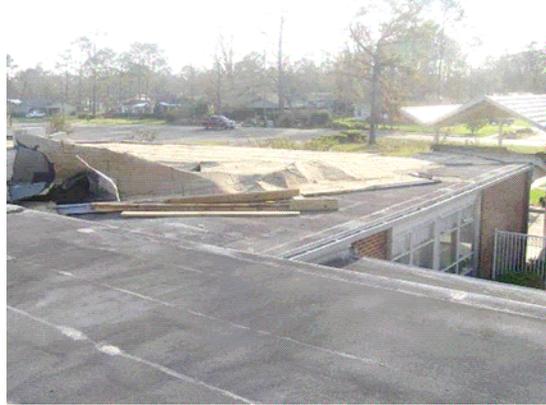
1.12(b)-5. Pecan Park Elementary School.
Sections of blown-off wood nailers from the western edge of this roof section.

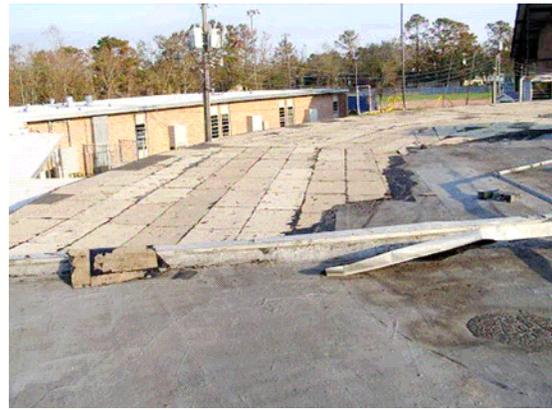
DAMAGE INITIATION AND PROPAGATION—Detailed analysis of roof system and damage modes was difficult because repairs were under way when the roof was inspected. Damage likely started as edge detail failure with subsequent peeling of the membrane. The majority of perlite insulation boards (about 90%) remained in place, although some replacement boards had been installed at the edge of the damaged section. Roof damage consisted of delamination within the top layer of the perlite boards (cohesive failure) just under the surface of the membrane.

1.13-2. Ocean Springs High School. Overview shows the damaged BUR assembly.

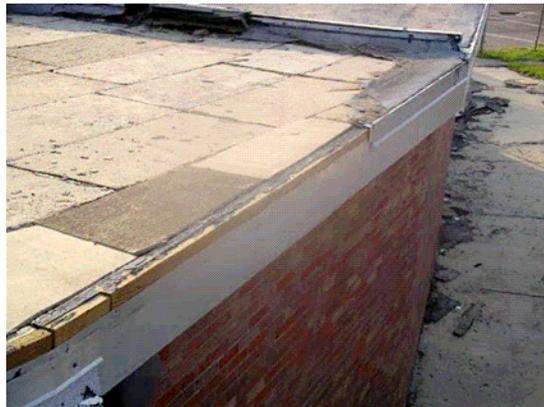
NOTED DAMAGE—Missing edge detail and roof membrane (on the circular building)

1.13-3. Ocean Springs High School. Damaged edge flashing is visible here. No evidence of proper fastening of the metal edge fascia to the wall was observed.

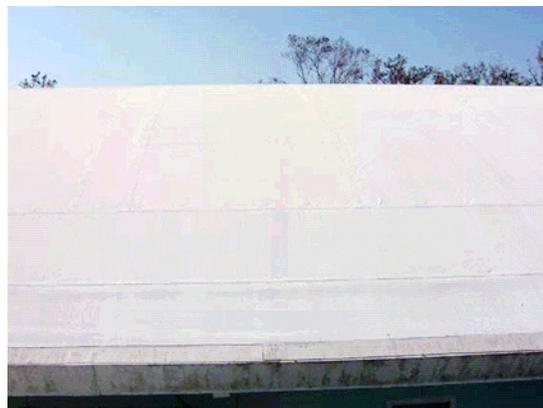
1.14-3. Beach Elementary School. Seams of the single ply membrane can be seen in this photo.

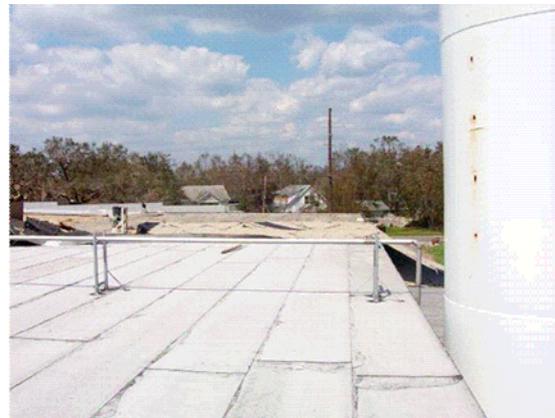
NOTED DAMAGE—Loss of edge detail and membrane system

1.15(a)-2. Freezer plant. Overview shows the damaged SBS membrane system.

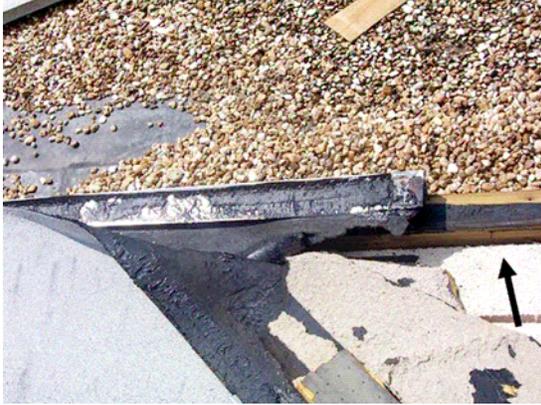
DAMAGE INITIATION AND PROPAGATION—In some areas, the edge metal failed as a result of inadequate attachment to the wood nailer. The fastening pattern was not determined. Additionally, the base sheet (and the insulation and membrane assembly attached to it) released from the CWF panels. The anchors pulled loose from the panels. In other sections of the damaged roof, the system failed because of cohesive failure within the perlite board.

1.15(a)-3. Freezer plant. Damaged edge metal is visible in this photo. Note that it released from the nailer (black arrow), which remained in place.

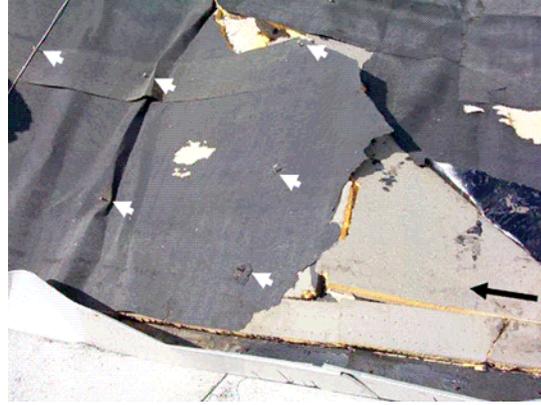
1.15(a)-4. Freezer plant. Underside of the membrane shows fasteners that remained in the base ply (white arrows). Note insulation board that is devoid of asphalt (black arrow) indicating spotty membrane attachment.

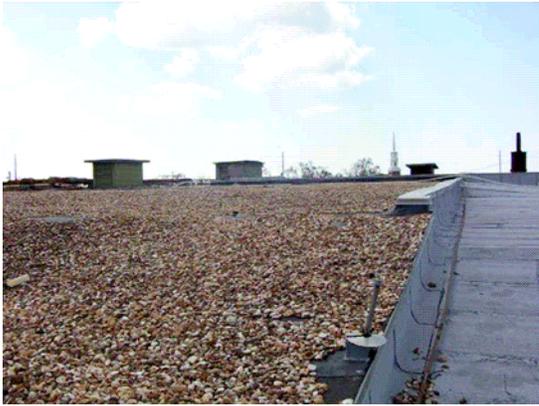
ADDITIONAL COMMENTS—This EPDM membrane system was approximately 20 years old and did not appear to be adequately maintained.

1.15(b)-1. Freezer plant. Overview of the ballasted EPDM system.

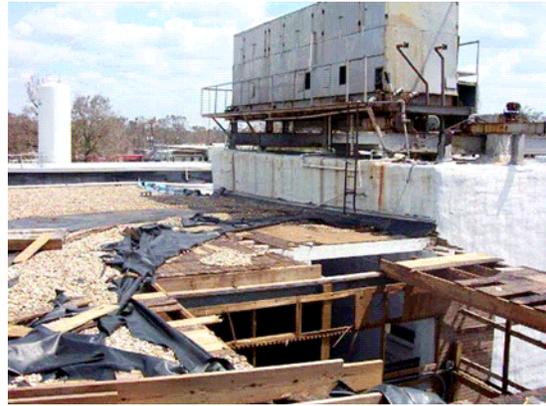
NOTED DAMAGE—The membrane and deck blew off a section of the roof; there was also loss of membrane and some gravel scour.

1.15(b)-2. Freezer plant. Photo shows an area where the decking and the roof assembly uplifted from the force of internal pressurization.

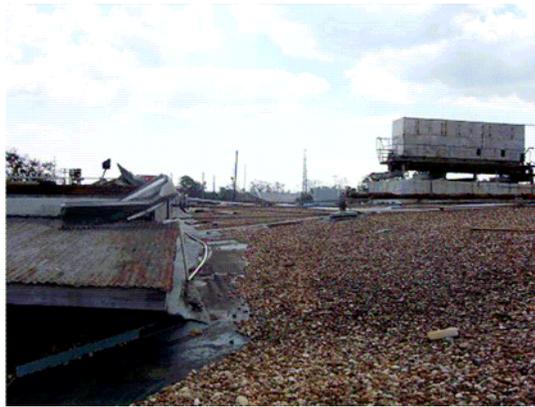
1.15(b)-3. Freezer plant. Ballast scour is visible here along the east edge of the roof system.

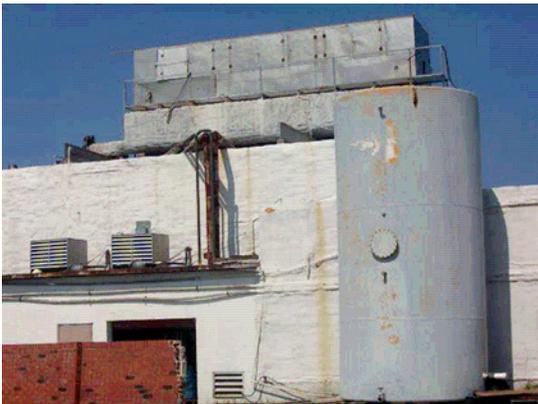
1.15(c)-1. Freezer plant. South side of the plant. SPF on these walls was estimated to be 15–20 years old.

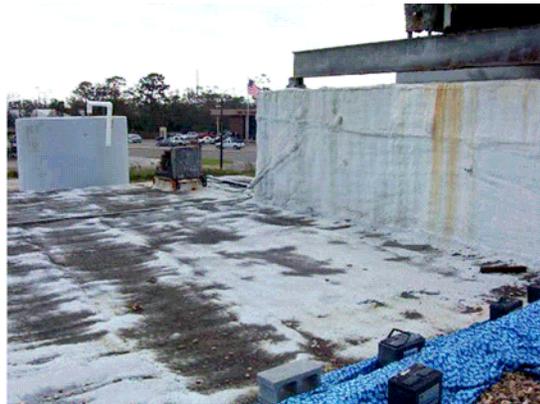
1.15(c)-2. Freezer plant. This is a view of the undamaged 15–20 year old SPF roof.

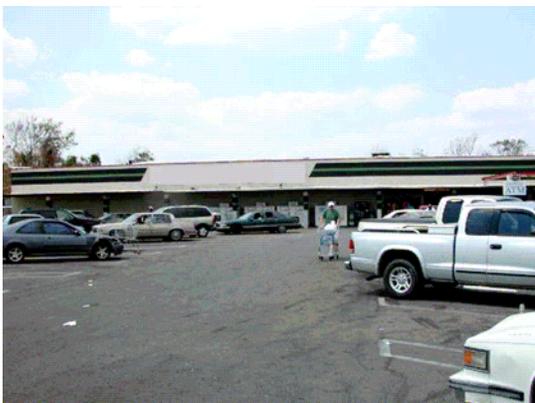
1.16-1. Pascagoula supermarket. Front view of the store.

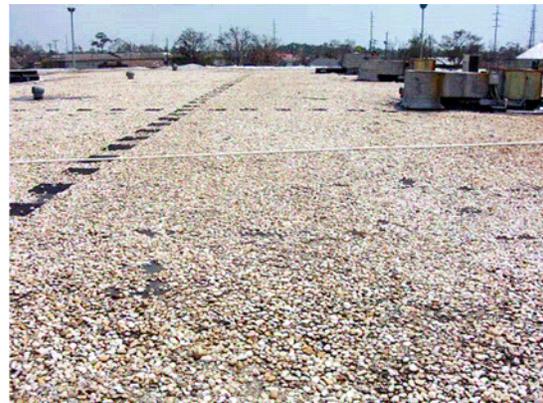
1.16-2. Pascagoula supermarket. Overview shows the field of the ballasted EPDM membrane system.

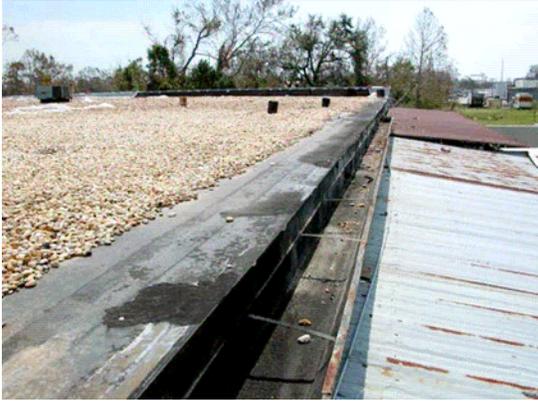
Ballast was missing in some areas. It appeared that the missing ballast had been pushed aside to look for or to repair leaks. It was not determined whether any displaced ballast was due to hurricane wind scour, as opposed to leak repair activities.

1.16-3. Pascagoula supermarket. View along the northern edge of the roof. Shows where ballast had apparently been pushed back to facilitate perimeter repair.

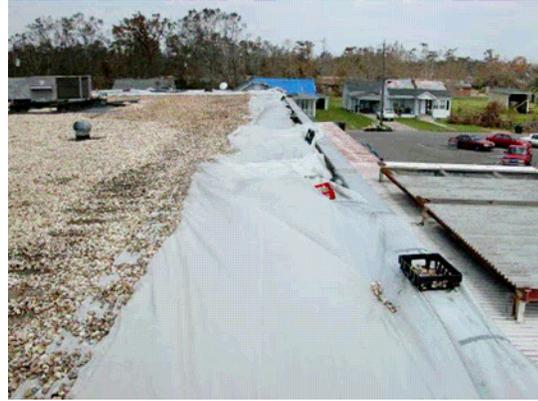
ADDITIONAL COMMENTS—There was considerable evidence of past and present leaks, which were attributed primarily to age, deterioration, and inadequate maintenance. Membrane shrinkage was noted at many perimeter locations. Leakage was obvious in these areas. Many repairs had been made, in all areas, to punctures, seam delaminations, and membrane tears. The types of repair materials were not always apparent. In some cases, asphaltic materials (i.e., felts and mastics) were used. Many seams, as well as penetrations and edge flashings, were covered with plastic sheets. The owner said sheets were used to stop leaks, which he said were not hurricane related.

1.16-4. Pascagoula supermarket. Plastic sheets were used to cover perimeter flashings. They were intended to protect against leaks that had not been caused by the hurricane.

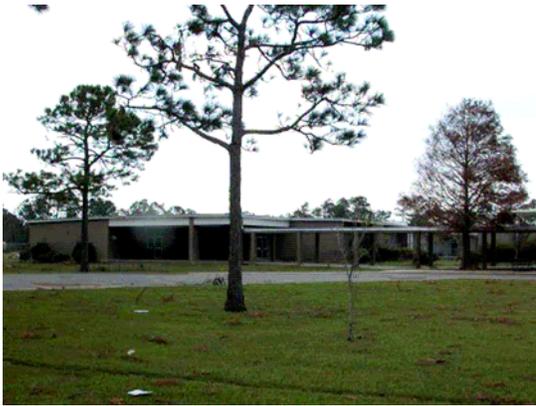
1.17-1. College Park Elementary. Front view of the campus.

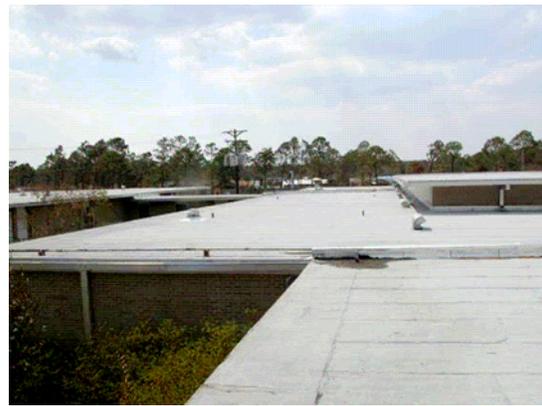
1.17-2. College Park Elementary. Undamaged SBS membranes were common on inspected buildings.

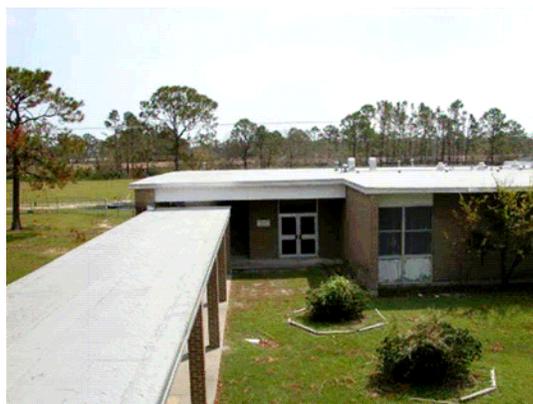
1.17-3. College Park Elementary. Walkway connecting two school buildings.
