Hurricane Katrina Wind Investigation Report

HURRICANE KATRINA INVESTIGATION REPORT

August 2007

The Roofing Industry Committee on Weather Issues, Inc. deployed six teams to investigate damage caused by Hurricane Katrina in the landfall regions in Louisiana and Mississippi. This report covers investigations conducted between September 7 and September 9, 2005.

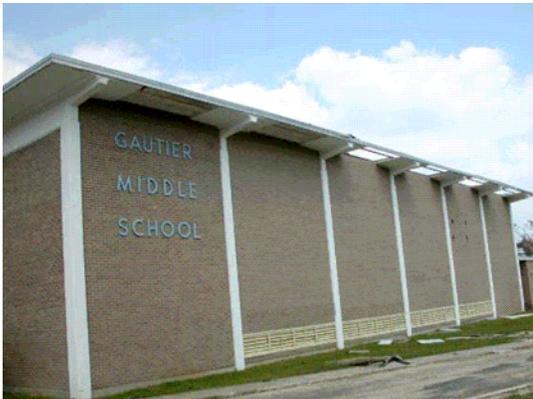
ROOF DAMAGE—Damage occurred at the windward southeast corner of the building. Perimeter edging on the south side of the roof was blown off, along with some CWF panels. The roof edge at this location had a 4 ft wide overhang. CWF panels were missing at the overhang or immediately next to it. On the east side of the roof, the edge metal was missing, although some loosely secured nailers were still in place on the concrete Ts. Also on the east side, a 4 ft wide roof section was missing the leveling fill, perhaps either LWC or perlite insulation board, on the pre-cast concrete Ts. The top surface of this concrete T was remarkably clean; i.e., it was not clear that the fill material had ever been adhered or fastened to the concrete T surfaces. In sections where the membrane blew off, failure occurred at the interface of the bottom ply sheet with the LWC or the CWF panels. Fasteners were pulled from these substrate materials along with the membrane. Some debris piles contained edge flashing nailers and metal gravel stops that were still connected to the displaced membrane.

1.18-1. Gautier Middle School. This is the south side of the damaged building.

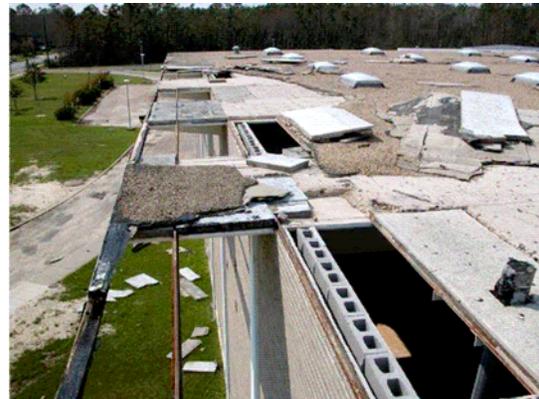
1.18-2. Gautier Middle School. Another view of roof damage along south side of the building.

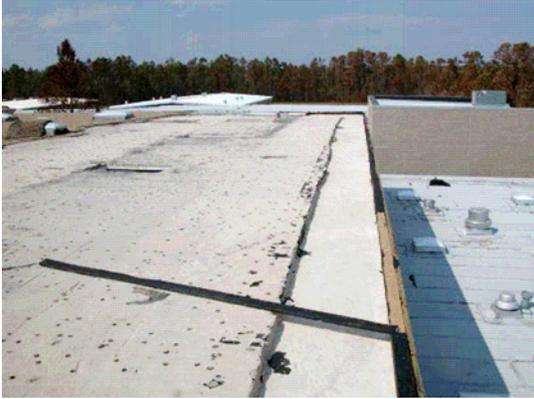
1.18-3. Gautier Middle School. Roof damage along the east side of the building is visible in this photo.

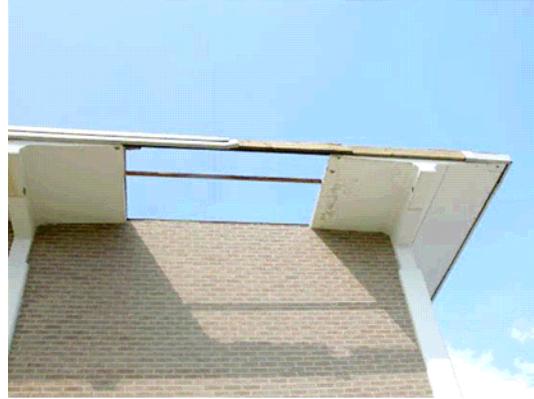
DAMAGE INITIATION AND PROPAGATION—In summary, the roof was damaged at the southeast corner because of the generally poor attachment of key system components, including weak attachment of upper layers of wood edge curb to the well-secured bottom nailer layer fastened to the deck; lack of attachment of CWF panels (held in place only by gravity); inadequate mechanical fastening of the bottom ply sheet to the LWC.

1.18-4. Gautier Middle School. Southeast corner of the roof. The CWF panels (forming the deck between the concrete single Ts) are missing.

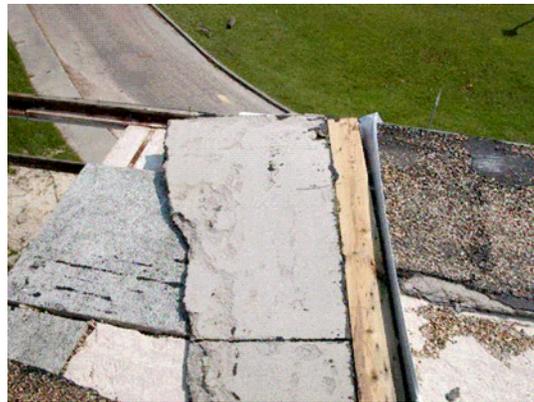
1.18-5. Gautier Middle School. Damage to the edge detail at the east side of the building is shown here. It was not apparent how the perlite board was secured to its substrate at this location.

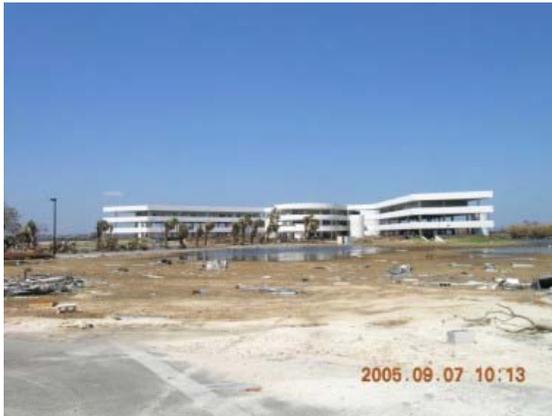
2.01-2. Gulfshore Assembly. This is a wide-angle view.

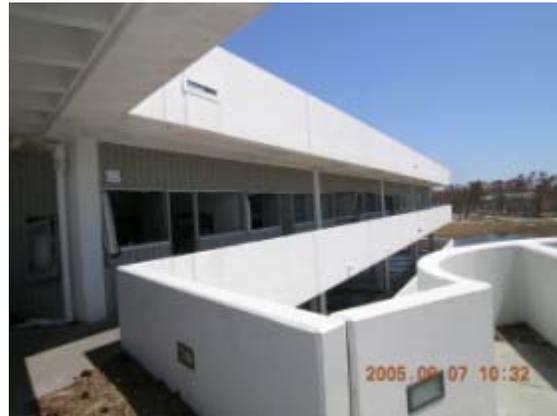
2.01-2. Gulfshore Assembly. The water line on this wall indicates a 28 ft storm surge.

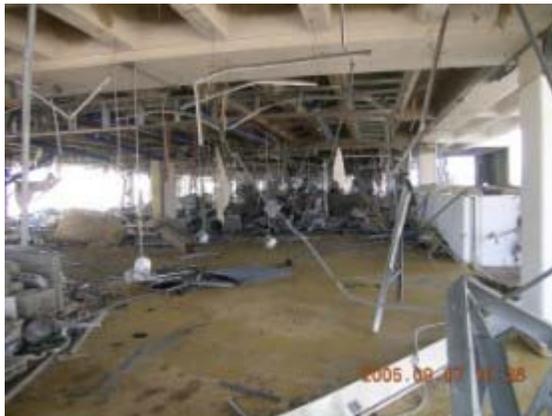
2.01-3. Gulfshore Assembly. Storm surge damaged this interior area.

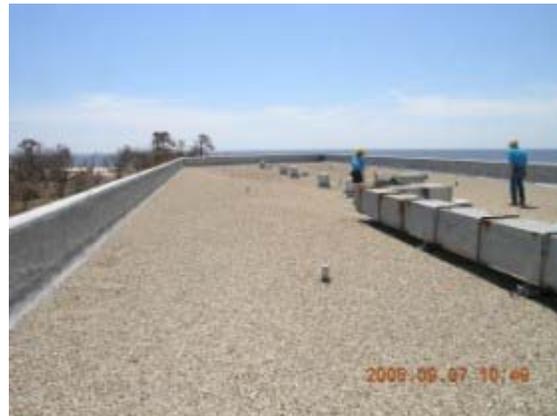
NOTED DAMAGE—Roof assembly was basically intact with no apparent wind damage to membrane. Medium-size aggregate surfacing was scoured on all roof areas, but there were no signs of gravel blown off roof. Aggregate scour was stopped by height of parapet and lower expected lift forces on the membrane and surfacing because of the parapet heights. Parapet heights ranged from 42 to 48 in. In the initial upwind direction, there were double parapets, with a unique grillwork between the first and second parapet. Scour patterns indicated that strong winds hit the building from several directions. Lightning air arresters in most cases were undamaged. Three exhaust fans were displaced from curbs, and several air conditioners were toppled. The two lower floors of the building interior were severely damaged from the storm surge, which was officially measured by the U.S. Geological Survey team at 28 ft from ground level (5 ft above sea level), with water at least ½ in. deep on the third floor. The first two floors had 100% wall openings, and the third floor had 30% wall openings—all due to storm surge.

2.01-4. Gulfshore Assembly. An aggregate-surfacing scuff pattern and high parapet can be seen on this roof.

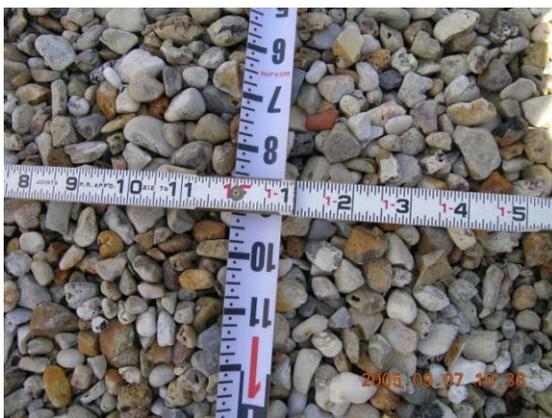
2.01-5. Gulfshore Assembly. Aggregate size was 1/2 in. or less.

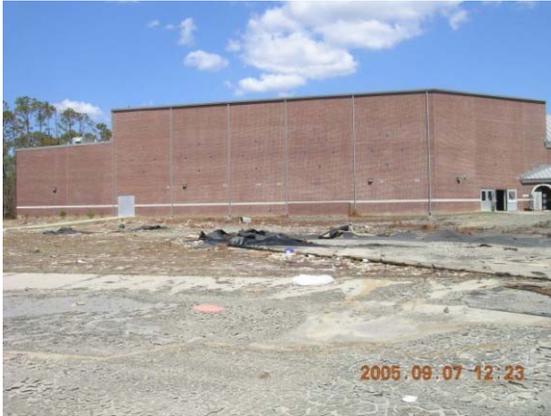
2.02(a)-1. Pass Christian HS. This is the west side of the gym, showing the roof membrane from the east slope on the ground.

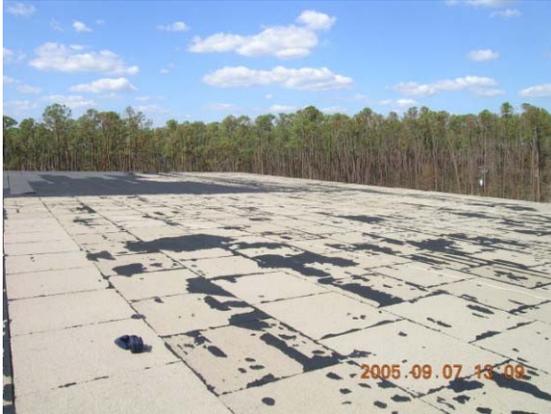
2.02(a)-3. Pass Christian HS. High winds caused the membrane to peel free from insulation in this area.

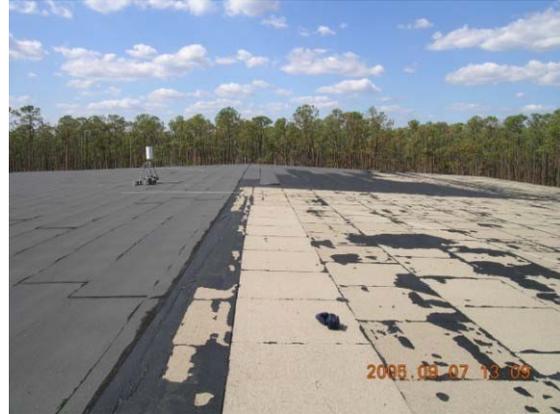
DAMAGE INITIATION AND PROPAGATION—It appears that edge failure led to peeling away of the membrane until a significant change in attachment occurred. The membrane peel stopped at the point of change from sloping toward the eastern edge of the roof to sloping toward the western edge. The east perimeter nailer was not well attached to the building. The metal gutter had spacer straps but no rigid supports; it relied on the gutter flange, which bent, creating a sail that caught the wind and pulled the nailer apart and off at the base. To further add to pressurization forces, the wood nailer was discontinuous—the installation used wood blocks approximately 2 ft long, over which was a continuous nailer. Therefore, the space between the brick and the blocked-up nailer could allow air flow infiltration. The top layer of the brick wall also became dislodged in the upwind northeast corner.

2.02(a)-4. Pass Christian HS. The membrane peel stopped at the center of this roof, likely a construction tie-in.

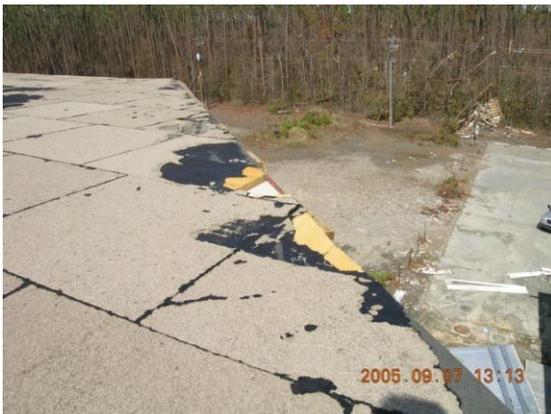
2.02(a)-5. Pass Christian HS. Edge failure typically begins at the weakest point, where the membrane peels free of the perlite insulation.

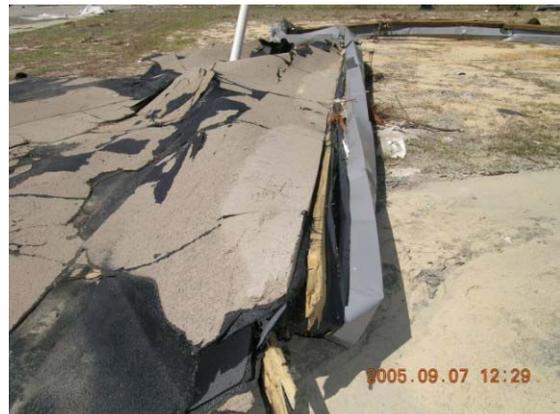
2.02(a)-6. Pass Christian HS. A common cause of edge failure is poor anchoring of wood blocking layers to each other or to the substrate. Membrane is on the ground to west of building.

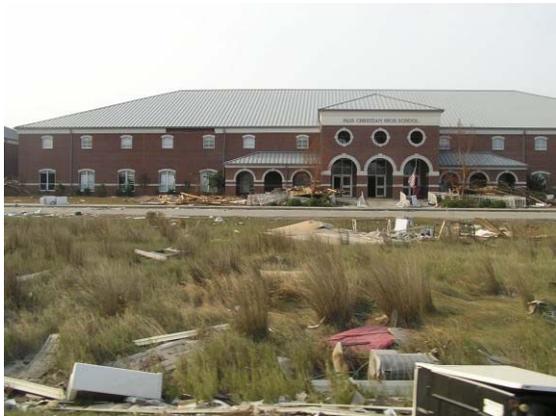
2.02(b)-1. Pass Christian HS. This is the southern exposure.

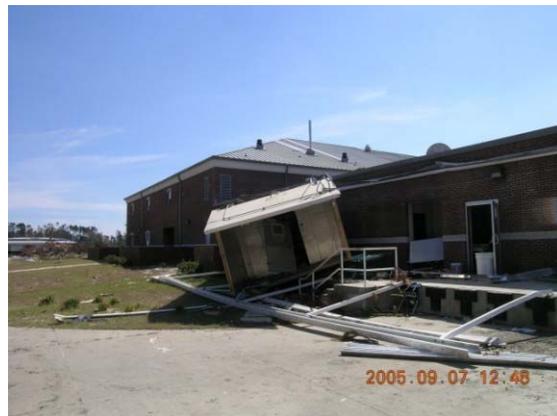
NOTED DAMAGE—Two 16½ in. snap-lock panels were blown off and there was a small amount of hip and ridge damage; remainder of field of roof was okay.

DAMAGE INITIATION AND PROPAGATION—Metal panels unzipped on exposed roof area.

2.02(b)-2. Pass Christian HS. A view of the north exposure toward the east side shows missing panels.

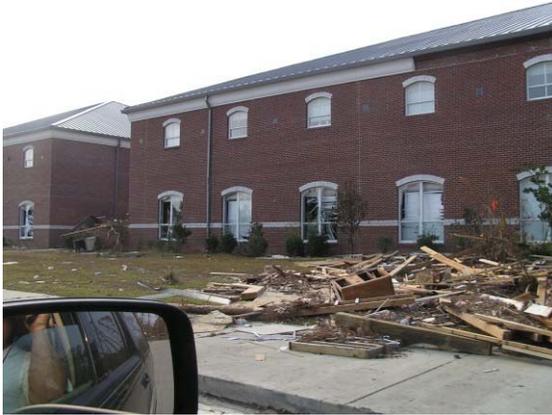
2.02(b)-3. Pass Christian HS. Soffit panels were missing on the south side.

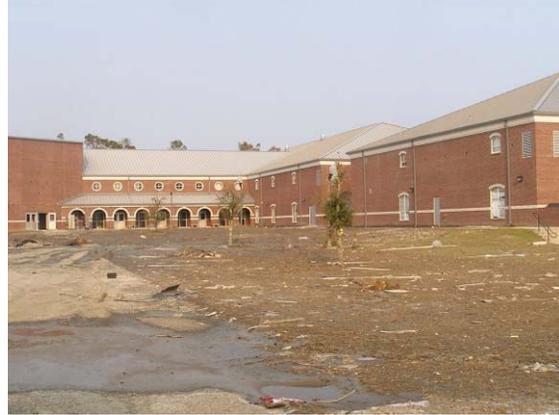
2.02(b)-4. Pass Christian HS. This is the west exposure of the building and north exposure on the right.

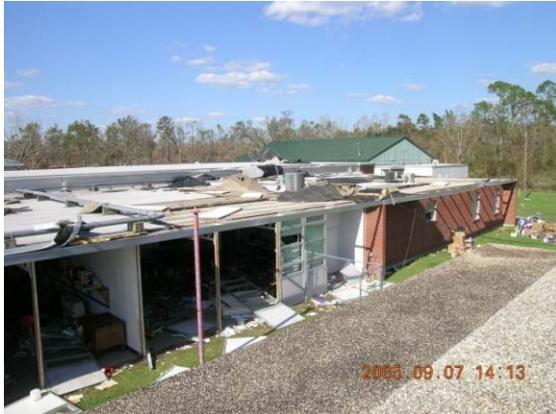
NOTED DAMAGE—Large area of complete displacement of membrane and insulation. Edge metal damaged, torn, and missing. Exhaust fans were displaced, building was subjected to a low-elevation storm surge. Debris from this roof damaged the upper elevation roof membrane and cooling equipment.

2.03(a)-1. Pineville Elementary. This photo shows a large area of the damaged roof and window and panel sections.

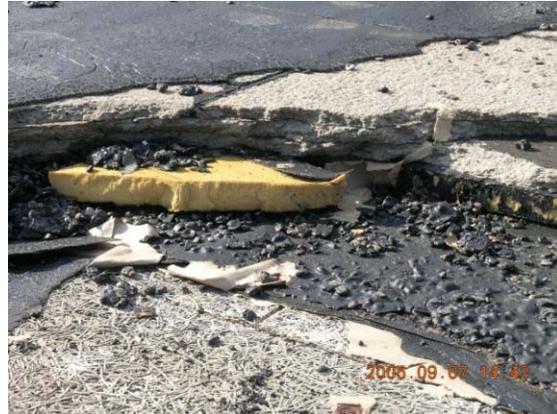
2.03(a)-2. Pineville Elementary. From the bottom up, this assembly consists of CWF decking, original membrane with aggregate surfacing, asphalt, polyisocyanurate foam insulation, perlite board and modified bitumen membrane.

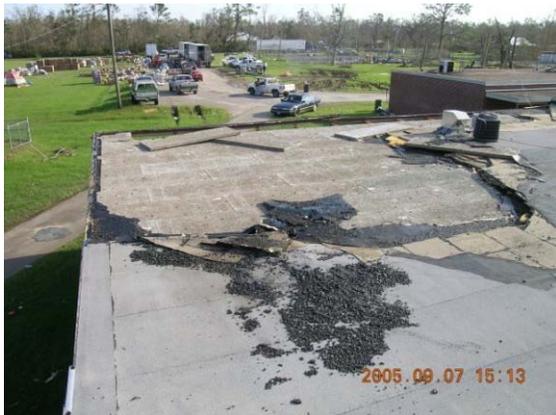
DAMAGE INITIATION AND PROPAGATION—CWF deck is somewhat air-permeable, resulting in pressure between the CWF and the membrane in the overhang area. The pressure on the underside of the membrane (positive pressure) and the uplift found the weakest link to be the rusted fasteners that secured the original membrane. Once there was an initial failure, the base sheet proved to have inadequate resistance to prevent nail pull-out (“pull-through”). The spread of the damage stopped where the uplift forces were reduced, e.g., away from the roof corner. Several of the CWF panels

were blown off in the overhang area, and in the corner, both the steel structure and the brick wall were damaged.

2.03(a)-3. Pineville Elementary. This corner view shows displacement of roof covering and CWF panels and SBS membrane delaminated from perlite.

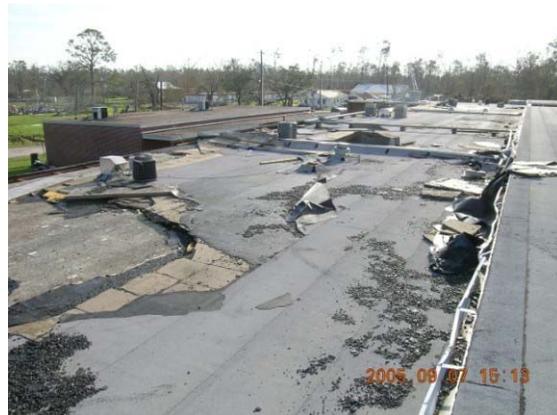
2.03(a)-4. Pineville Elementary. This damage pattern is what would be expected from an oblique cornering wind load.

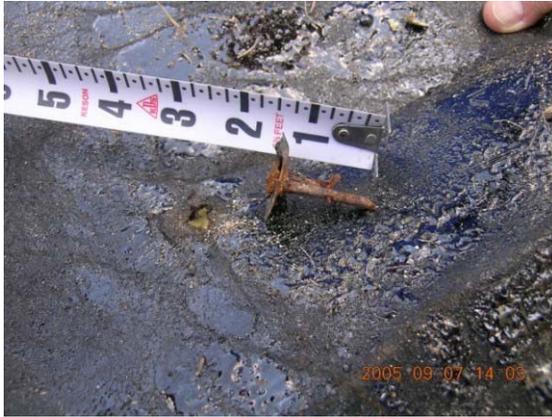
2.03(a)-5. Pineville Elementary. This is a typical corroded fastener.

ADDITIONAL COMMENTS—This re-covered roof demonstrates the need to assess the condition of the existing system before reroofing. The initial securement was rusted and not able to withstand the uplift loads because of the age of the original roof. A portable uplift tester might have identified this problem, and the problem might have been correctable with new fasteners, new base sheet, or a complete reroofing (tear off and replacement of the existing membrane with new materials).

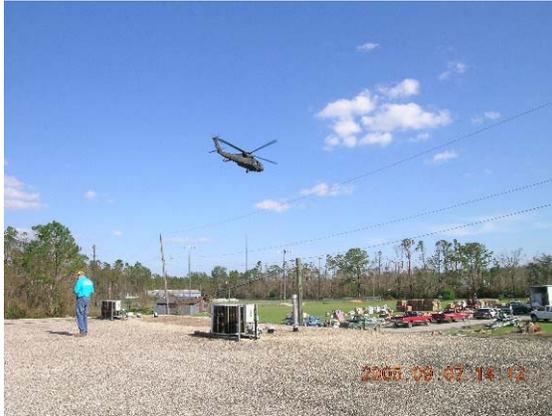
2.03(b)-1. Pineville Elementary. This is an overview of a roof where a cornering wind occurred.

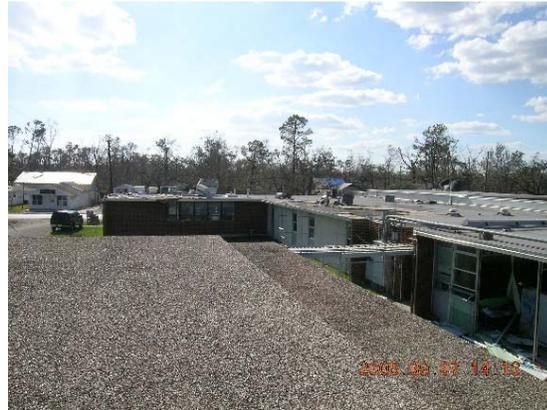
2.03(b)-2. Pineville Elementary. This is a view of the same roof from the opposite side.

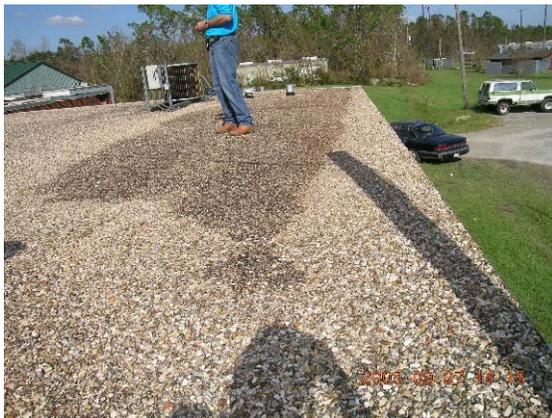
DAMAGE INITIATION AND PROPAGATION—Not all of the aggregate surfacing was embedded in asphalt. Some was displaced, but it was not noted where it went; since there were no parapets, the gravel may have left the roof.

2.03(b)-3. Pineville Elementary. This is a typical scour pattern.

ADDITIONAL COMMENTS—This roof was performing its main function of keeping the building watertight. There would be no need to repair this section, whereas adjacent roofs with less exposure had significant damage. Re-dispersing the aggregate surfacing would be recommended.

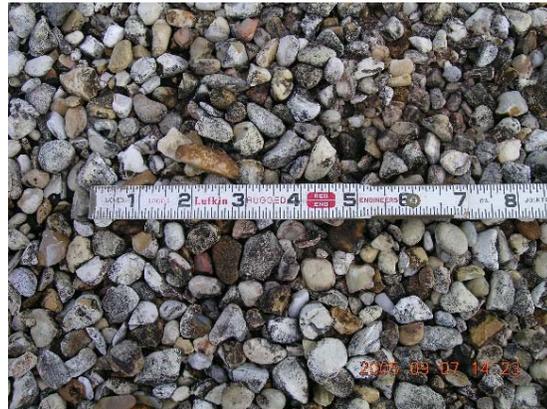
2.03(b)-4. Pineville Elementary. Average aggregate size about 1/2 in., a slightly larger than common aggregate for surfaced BUR.

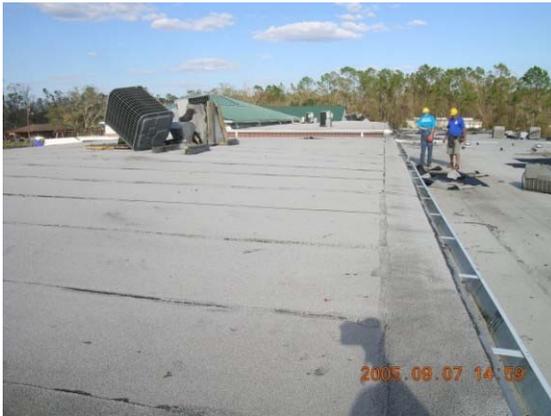
NOTED DAMAGE—Displaced evaporative coolers and two punctures

ADDITIONAL COMMENTS—The basic roof covering was intact and would require only minor repairs to relatively few damaged spots. An identical roof section was damaged in the same way. Both roofs could have been quickly made watertight. A nearby metal storage building was undamaged, and the architectural metal roof on the entrance of the building had only minor cosmetic damage.

2.03(c)-1. Pineville Elementary. This modified bitumen roof was in relatively good condition overall.

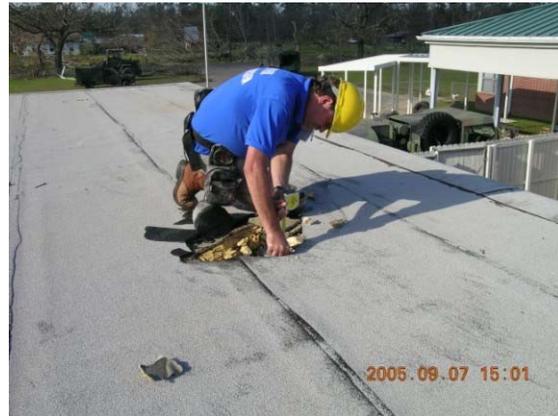
2.03(c)-2. Pineville Elementary. A gouge on this roof was apparently caused by windblown debris.

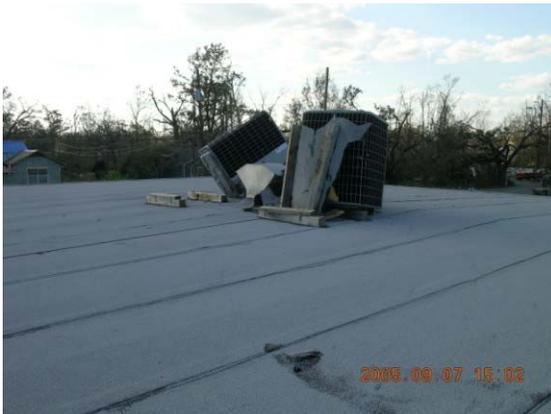
DAMAGE INITIATION AND PROPAGATION—Evaporative coolers were on exposed wood sleepers that were not attached to the deck. Large pieces of airborne debris from the lower-elevation roof membrane and deck described in 2.03(a) hit the gutter, cooler units, and membrane; punctured membrane and insulation; and landed beyond this roof on the ground.

2.03(c)-3. Pineville Elementary. Wood supports in this photo were not secured to the deck. This resulted in HVAC displacement and roof punctures.

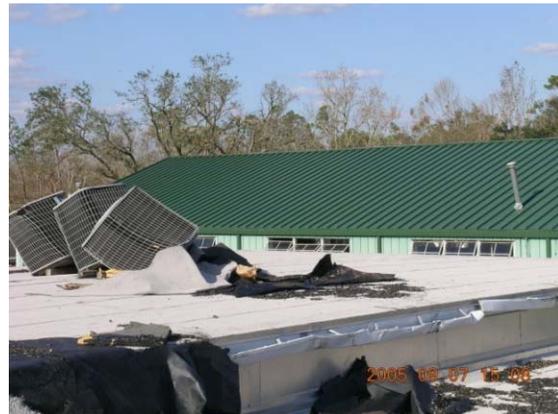
2.03(c)-4. Pineville Elementary. In foreground, edge damage, HVAC damage, and a membrane blown from an adjacent roof are all visible. In the background is an undamaged storage building roof.

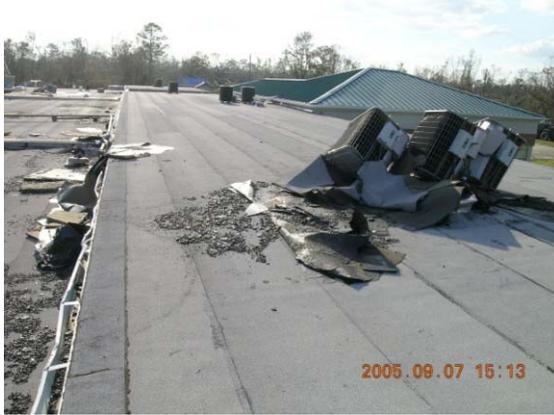
2.03(c)-5. Pineville Elementary. Evaporative coolers displaced by debris, including aggregate-surface membrane from the lower-elevation roof.

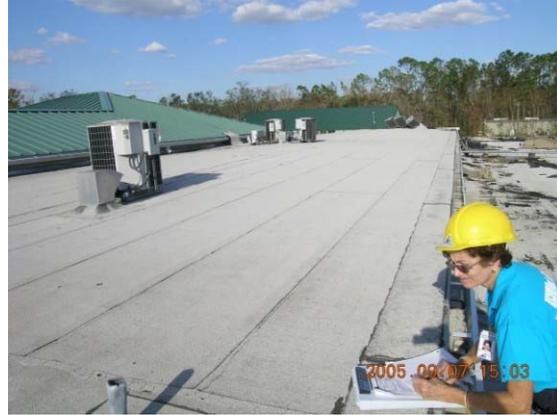
2.03(c)-6. Pineville Elementary. No damage is seen on this roof area.

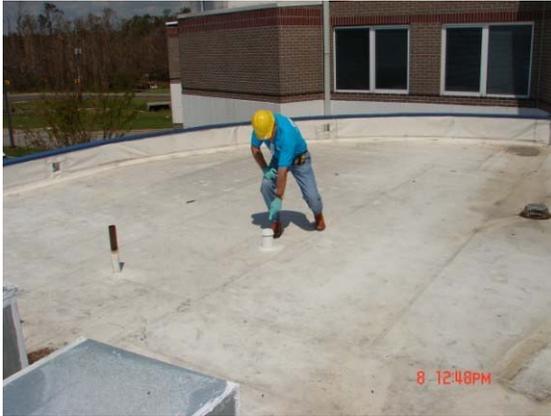
ADDITIONAL COMMENTS—This roof had some small sections exposed to the primary wind but was not damaged, even though the system does not appear to be secured to manufacturer's standards for this wind zone (120–130 mph). It apparently survived because there was little or no air infiltration.

2.04(a)-1. Hancock Medical Center. This photo shows a mechanically fastened thermoplastic single ply membrane with no damage.

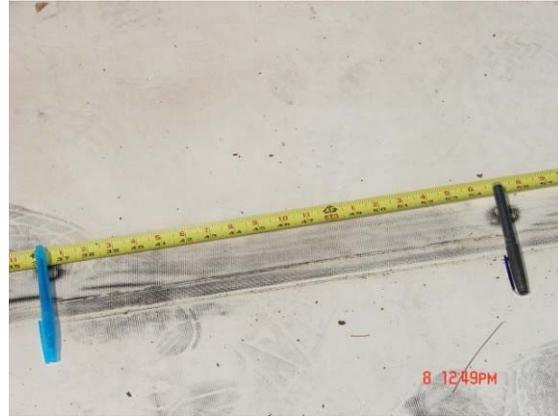
2.04(a)-2. Hancock Medical Center. Fastener spacing in this area was 18 in. o.c.

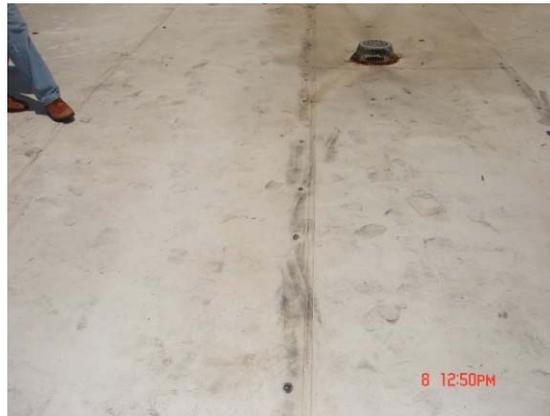
2.04(a)-3. Hancock Medical Center. Fastener rows were spaced 5 ft o.c.

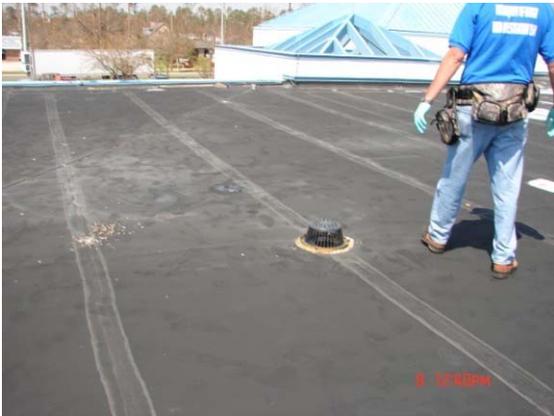
2.04(b)-1. Hancock Medical Center. A mechanically fastened single ply membrane.

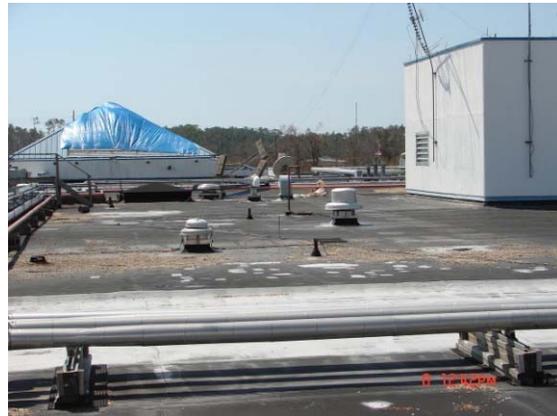
DAMAGE INITIATION AND PROPAGATION—Metal roofing over the entrance was damaged on the backside (leeward side), and metal blowing across the roof caused punctures. The punctures did not lead to rips or tears. This mechanically attached single ply was attached as recommended for a high-wind installation and the securement appeared to be undamaged. Most HVAC units were undamaged and still in place because they had better securement to their curbs.

2.04(b)-2. Hancock Medical Center. The white spots are temporary repairs to membrane punctures.

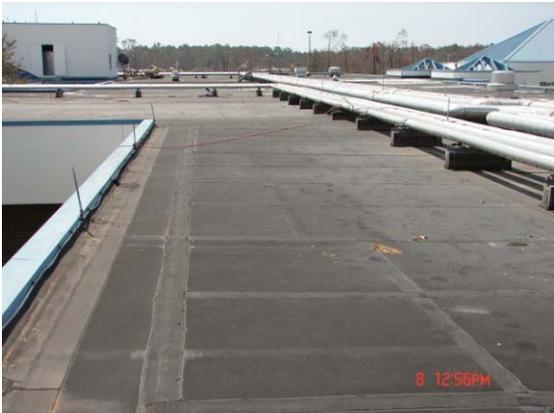
2.04(b)-3. Hancock Medical Center. This perimeter fastening is designed for high wind resistance.

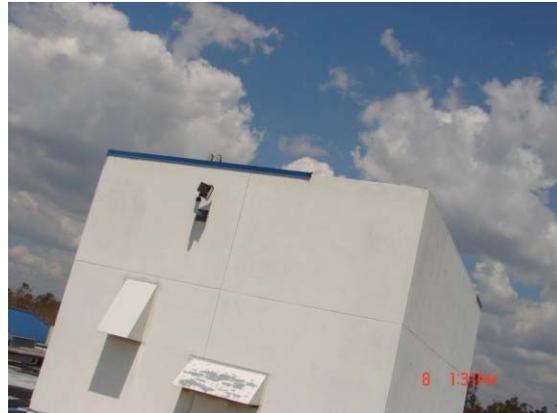
2.04(b)-4. Hancock Medical Center. Edge metal is missing from this penthouse.

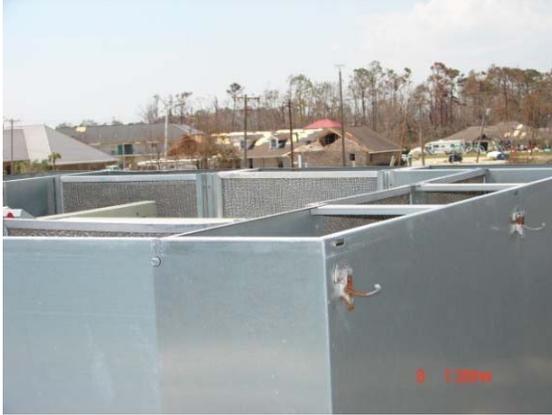
2.04(b)-5. Hancock Medical Center. The top was blown off of this air handling unit.

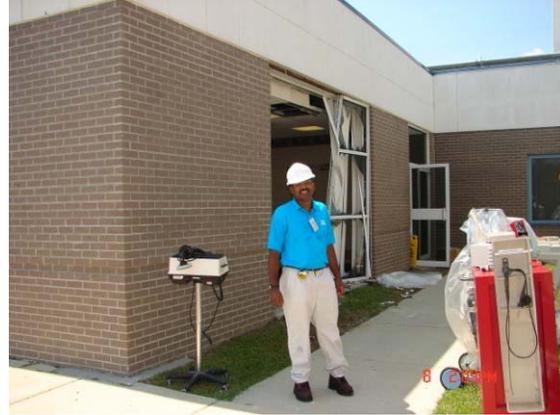
2.04(b)-6. This window wall failed as a result of excessive wind pressure.

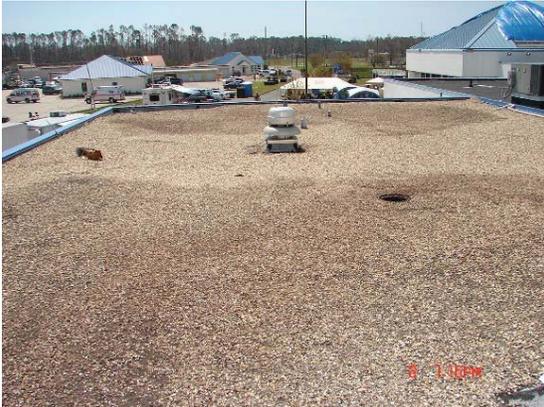
DAMAGE INITIATION AND PROPAGATION—Pea gravel was not fully embedded and was scoured from the high wind uplift areas.

2.04(c)-1. Hancock Medical Center. Gravel scour in this photo was caused by the change in direction and velocity of the wind hitting the roof edge and penthouse.

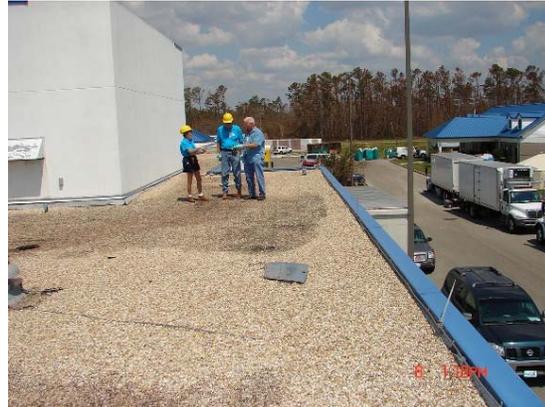
2.04(c)-2. Hancock Medical Center. Scour around the penthouse shows a wind burst pattern. This can occur when wind accelerates around the penthouse.

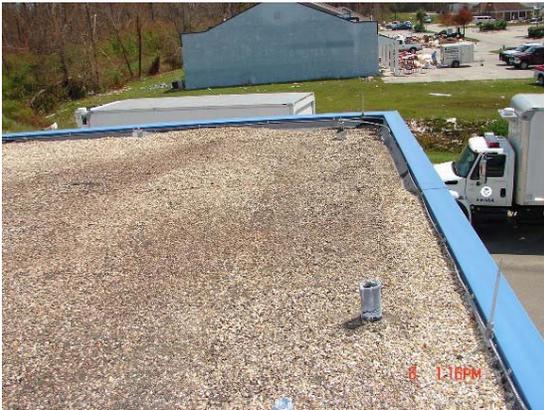
2.04(c)-3. Hancock Medical Center. Gravel scour in this photo shows a change in pattern from a second direction.

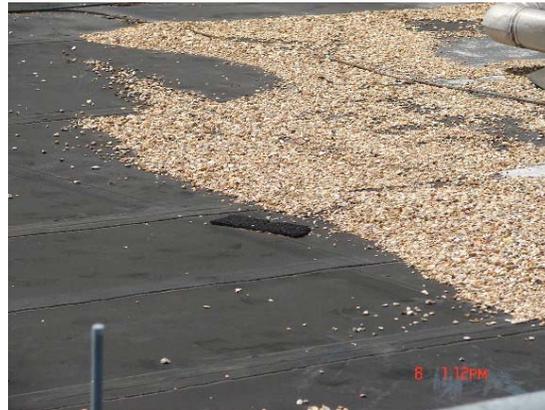
2.04(c)-4. This smooth-surface roof was downwind from the gravel-surface roofs.

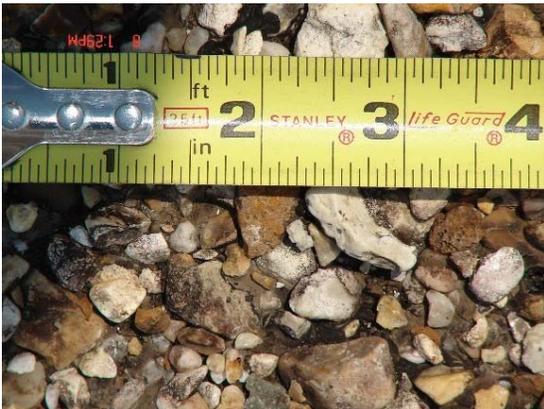
2.04(c)-5. Hancock Medical Center. The aggregate found here was larger than typical pea gravel.

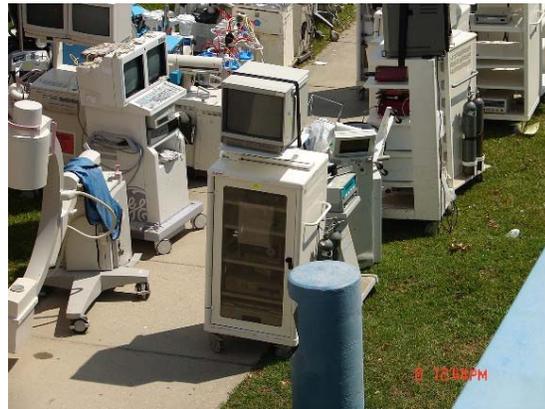
2.04(c)-6. Hancock Medical Center. Medical equipment removed because of the storm surge was being assessed for damage and possible refurbishing.

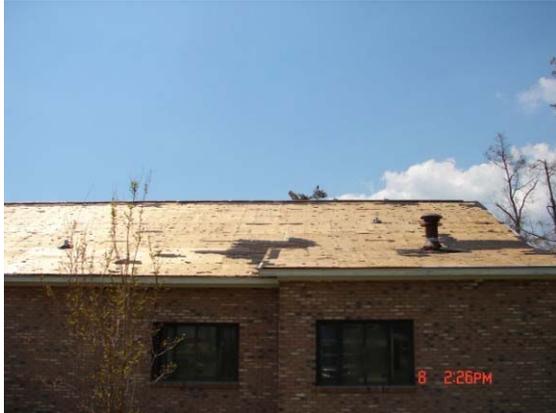
NOTED DAMAGE—All roof covering on windward side of roof was blown off; most roof covering on leeward side was blown off. Wall covering on gable ends was missing.

2.05-1. Fresenius Medical Kidney Center.
Almost every shingle was stripped.

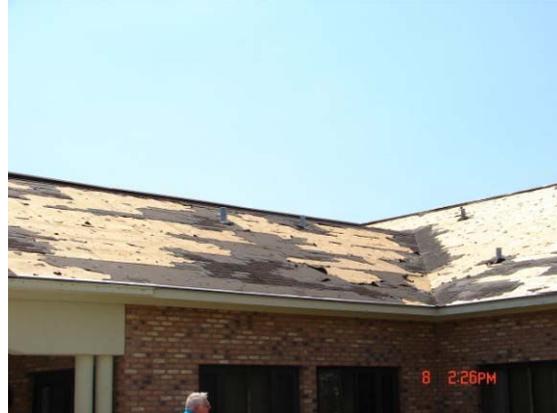
2.05-2. Fresenius Medical Kidney Center.
Shingles and underlayment missing from windward side.

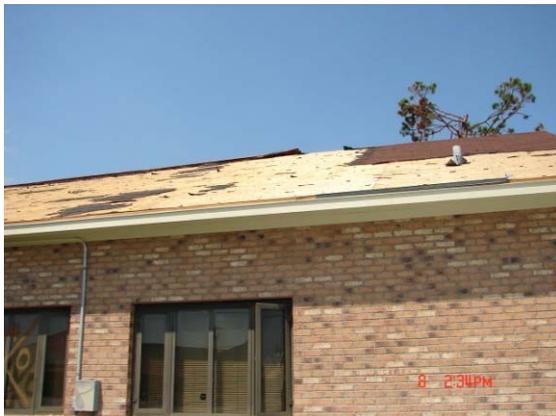
DAMAGE INITIATION AND PROPAGATION—Asphalt shingles lacked nails, and nails were improperly placed. The roof was installed using the racking method that often limits the shingles to three nails, whereas six nails were required by the building code when this roof was installed.

2.05-3. Fresenius Medical Kidney Center. Back (leeward) side of building; note straight line of shingle damage, indicating racked installation of shingles.

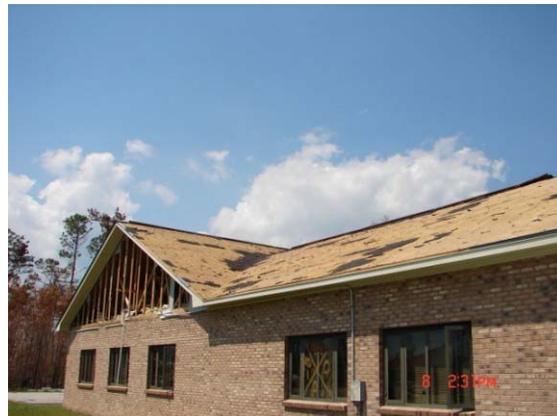
2.05-4. Fresenius Medical Kidney Center. Cladding removed from gable end; however, deck remains in place.

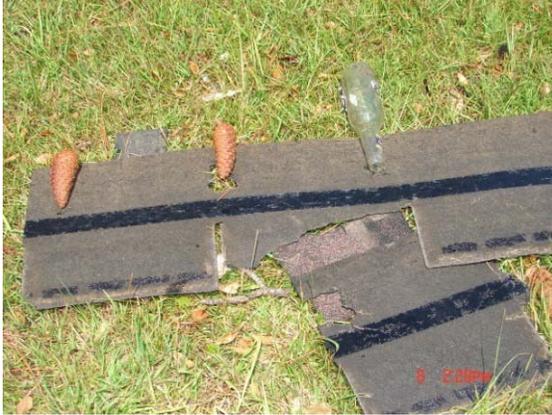
2.05-5. Fresenius Medical Kidney Center. Only three nails in shingles, high nailing.

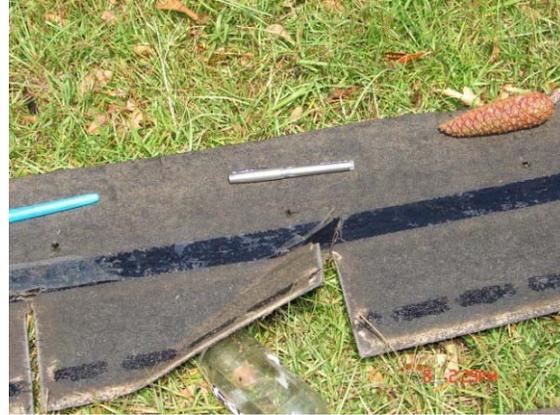
2.05-6. Fresenius Medical Kidney Center. Only three nails in shingles.

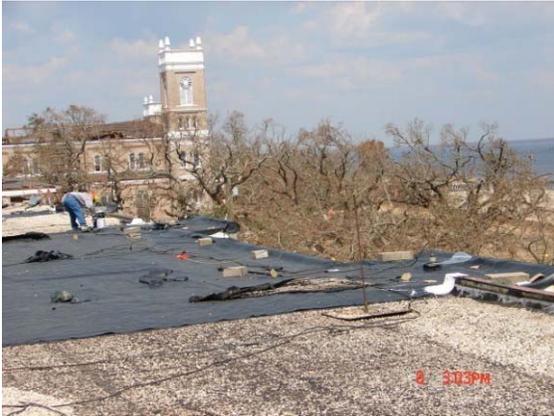
DAMAGE INITIATION AND PROPAGATION—Blowoff areas were due to roof edge failure. Typically, edge sections where blowoff occurred were not adequately fastened to roof deck.

2.06(a)-1. St. Stanislaus. This membrane blowoff was located at the center of the windward wall.

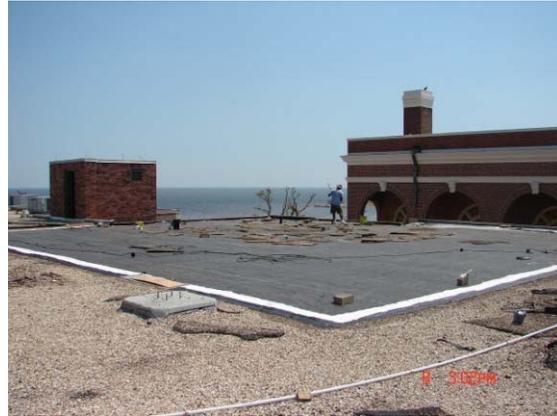
2.06(a)-2. St. Stanislaus. This large area is being temporarily repaired from the corner back. Note its proximity to the open ocean.

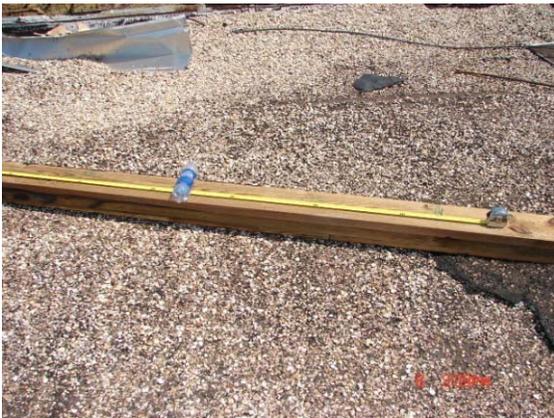
2.06(a)-3. St. Stanislaus. Wood blocking is shown here with fasteners spaced approximately 36 in. o.c.

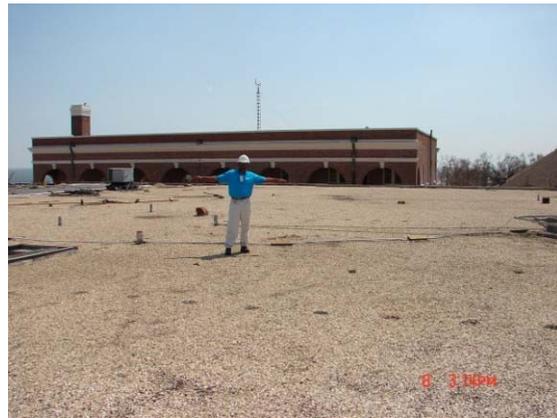
2.06(a)-4. St. Stanislaus. A large roof area appears undamaged, although an HVAC unit was displaced from attachment at left to spot at right.

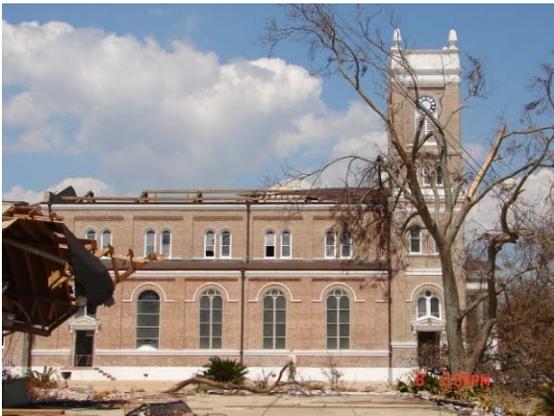
2.06(a)-5. St. Stanislaus. A nearby auditorium was missing its entire roof.

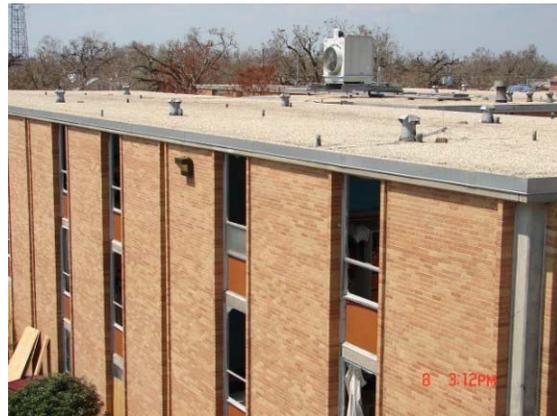
2.06(a)-6. St. Stanislaus. An adjacent building showed no apparent roof damage.

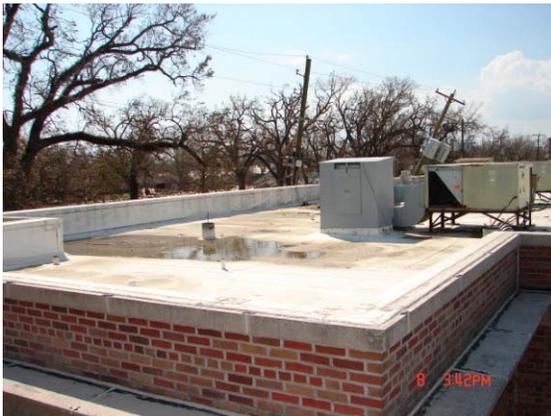
2.06(b)-1. St. Stanislaus. This mechanically fastened single ply membrane appeared undamaged.

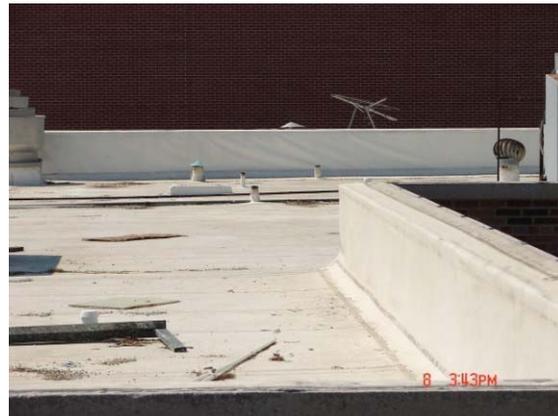
2.06(b)-2. St. Stanislaus. The debris shown here may have caused punctures to the roofing membrane.

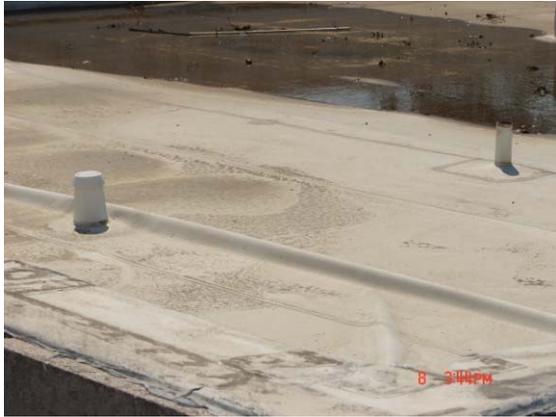
ADDITIONAL COMMENTS—This roof, somewhat protected, did not appear to have damage, although a few fasteners in the corner appear to have loosened.

2.06(b)-3. St. Stanislaus. The membrane wrinkling visible here may be the result of loose fasteners.

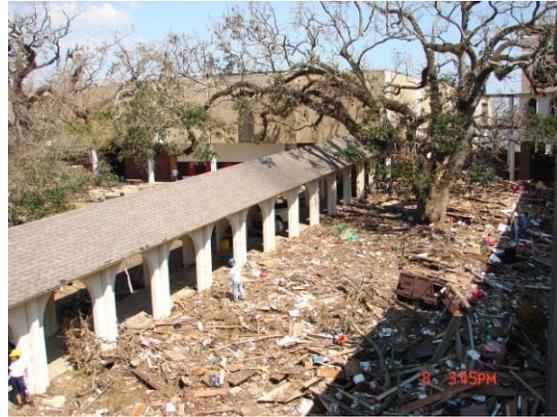
2.06(b)-4. St. Stanislaus. In the courtyard is storm debris, in contrast to an undamaged asphalt shingle roof over the relatively protected corridor.

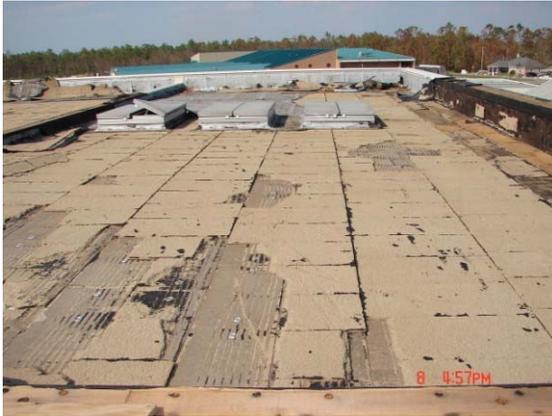
NOTED DAMAGE—The entire roof was damaged. In most areas, membrane and some insulation were blown completely off the roof. Coping was missing on entire upwind corner and one side.

DAMAGE INITIATION AND PROPAGATION—Garage door behind stage in auditorium was blown in, which pressurized the roof from the building interior. A drain directly above this area lifted and broke bonds in the system. The roof system failed primarily in the top perlite insulation layer as the weakest point. Fasteners were mostly intact, although the coping was blown off; it is unlikely that the latter initiated the roof damage.

2.07-1. MaGee Auditorium. The membrane has blown off the insulation layer in this area.

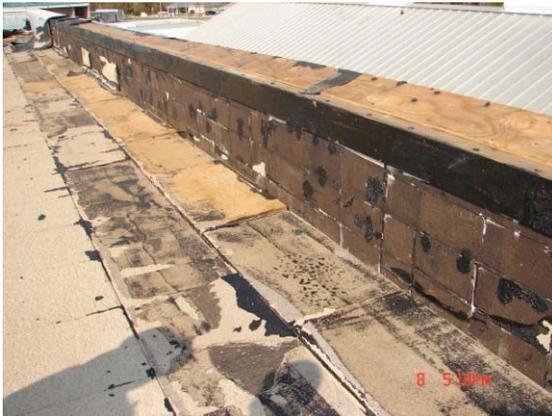
2.07-3. MaGee Auditorium. Coping and wall flashing are missing, likely blown off.

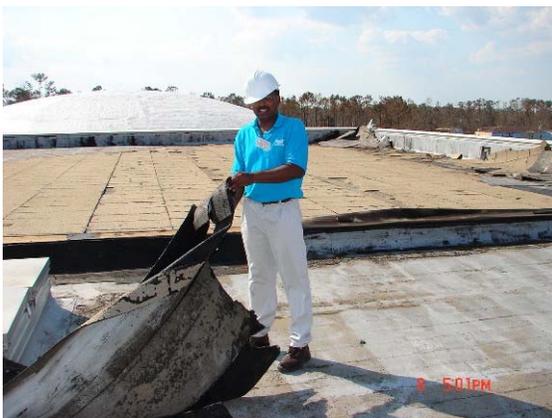
2.07-5. MaGee Auditorium. Some membrane remained on this roof. A polyurethane foam dome in background had no apparent damage.

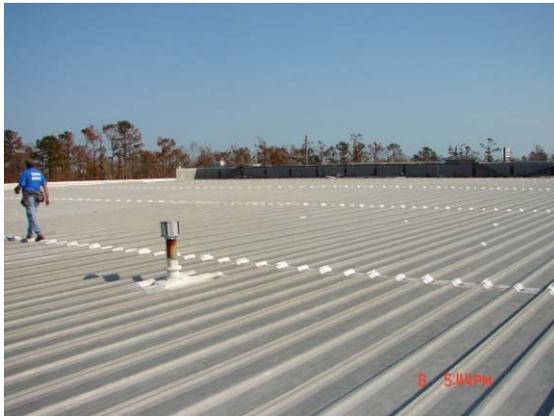
2.08-1. Winn Dixie Strip Mall. This is a wide-angle view of the main roof.

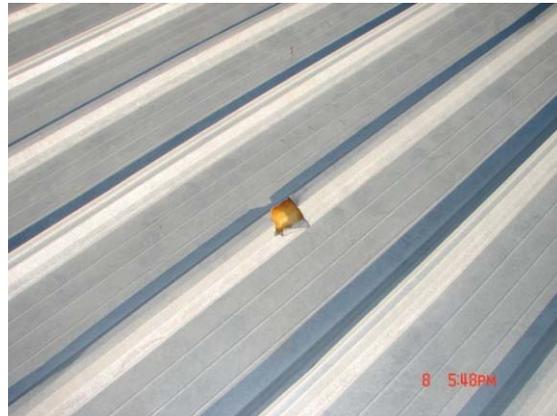
DAMAGE INITIATION AND PROPAGATION—Punctures through steel were caused by sharp debris. The section that blew off was pressurized when the glass wall failed, likely as a result of airborne debris. The metal clips were unable to withstand this additional load.

2.08-2. Winn Dixie Strip Mall. A torn metal rib can be seen.

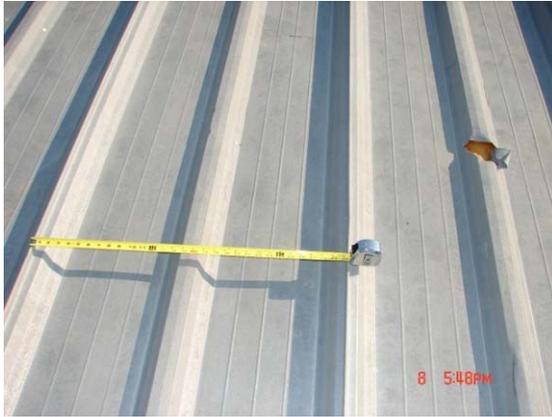
2.08-3. Winn Dixie Strip Mall. A tape measure shows rib spacing.

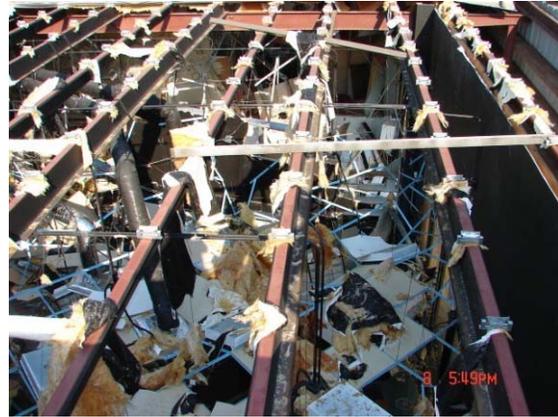
2.08-4. Winn Dixie Strip Mall. This is what a complete blowoff looks like in this corner area.

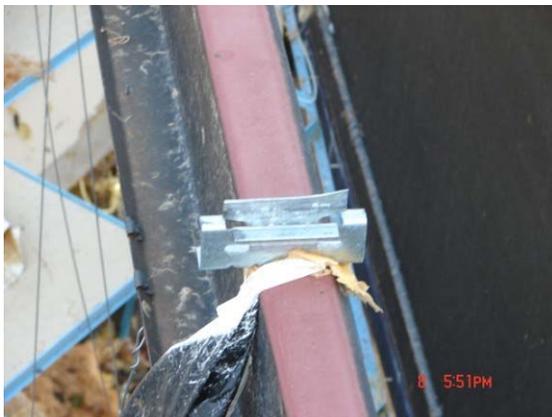
2.08-5. Winn Dixie Strip Mall. A clip is still attached to the purlin in this photo.

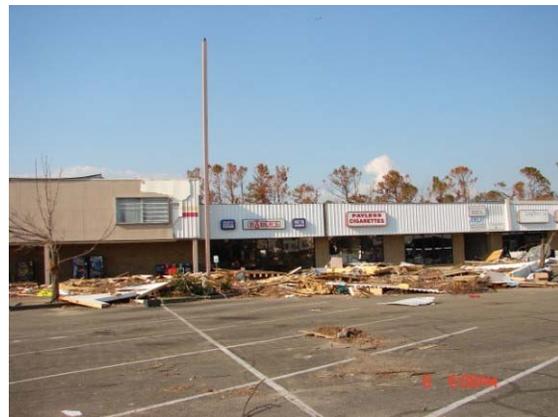
2.08-6. Winn Dixie Strip Mall. This is a corner area where the roof blew off.

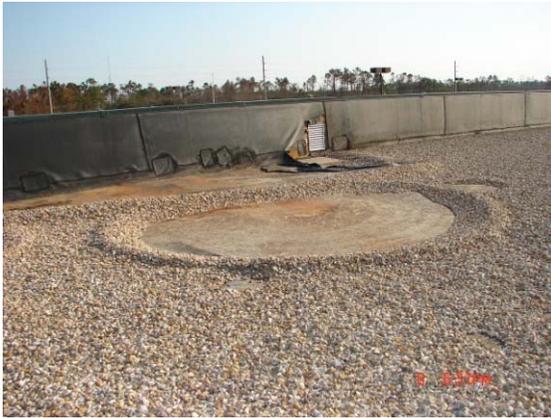
2.09-3. Sav-A-Center. The unusual scour pattern is likely from a vertical vortex (small tornado or unusual wind pattern due to the high parapet). The brown spots appear to be due to sun exposure prior to Katrina. Figure 2.09-5 also supports the vertical vortex theory.

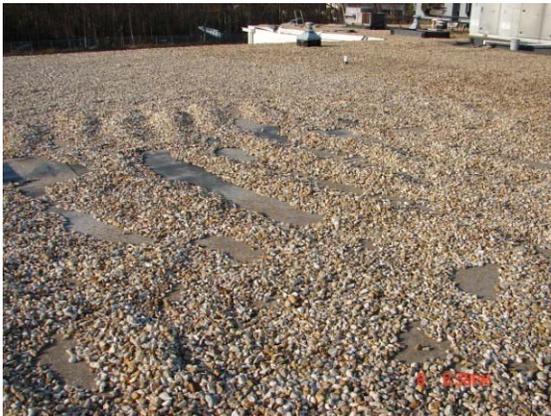
2.09-5. Sav-A-Center. Here is another unusual scour pattern. This pattern suggests a vertical vortex.

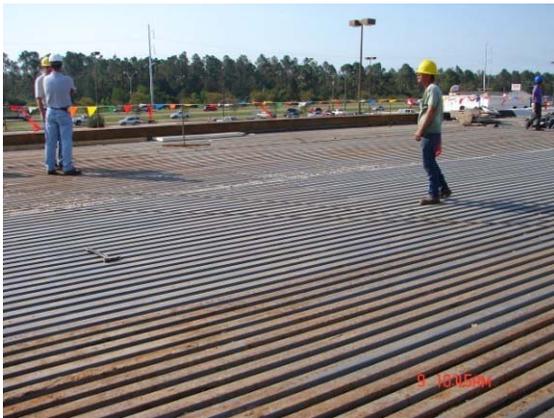
2.10-1. Manufacturing facility. This is an area where the membrane has been removed.

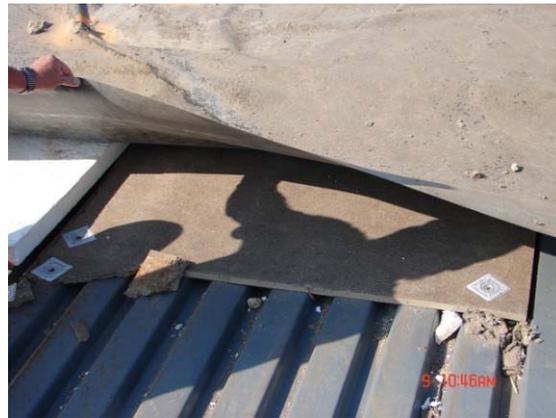
2.10-2. Manufacturing facility. An underlying tapered insulation system is visible here.
