Hurricane Katrina Wind Investigation Report

HURRICANE KATRINA INVESTIGATION REPORT

August 2007

The Roofing Industry Committee on Weather Issues, Inc. deployed six teams to investigate damage caused by Hurricane Katrina in the landfall regions in Louisiana and Mississippi. This report covers investigations conducted between September 7 and September 9, 2005.

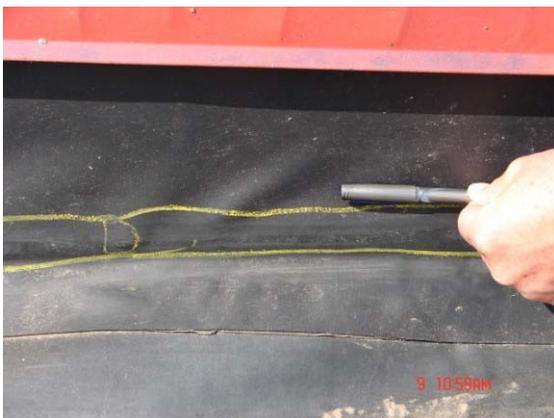
DAMAGE INITIATION AND PROPAGATION—Wind scour of ballast and air entering through parapet wall ballooned membrane, leading to blowoff and other damage.

2.10-3. Manufacturing facility. Perimeter securement high on this wall allowed air pressurization at the wall/roof interface.

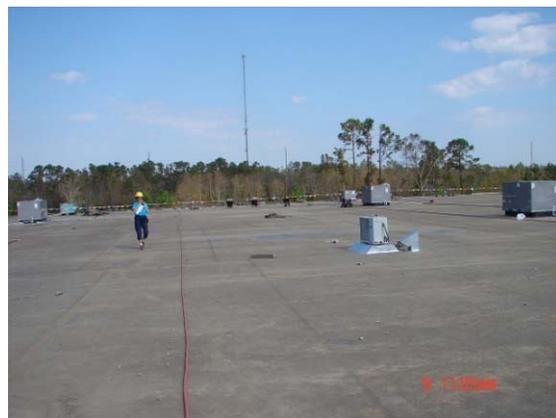
2.10-4. Manufacturing facility. This is a large area of undamaged roof.

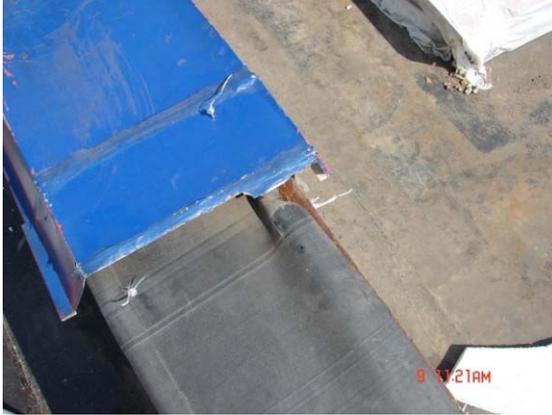
2.10-5. Manufacturing facility. Coping was displaced from this parapet.

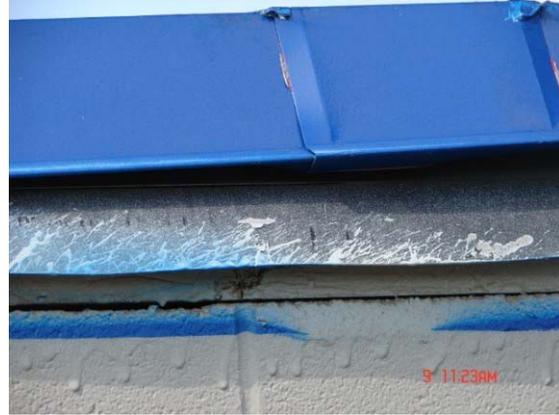
2.10-6. Manufacturing facility. Coping pulled loose from the cleat in this photo.

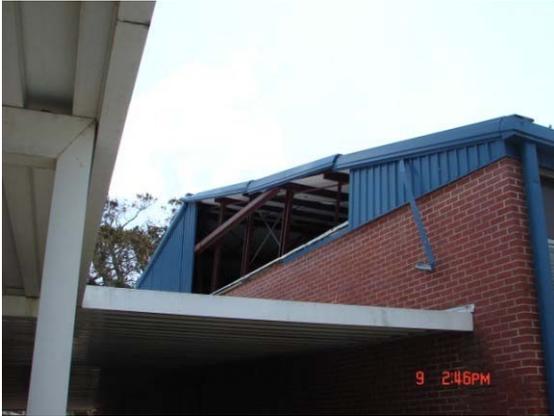
2.11-1. H. McCoughan Elementary. Wall and roof damage is visible on this building.

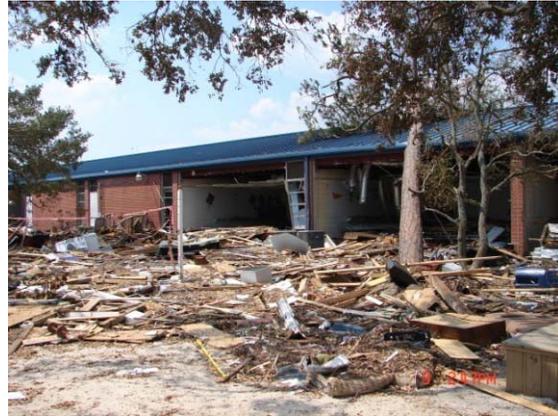
2.11-2 H. McCoughan Elementary. Storm surge debris covered the grounds around this building.

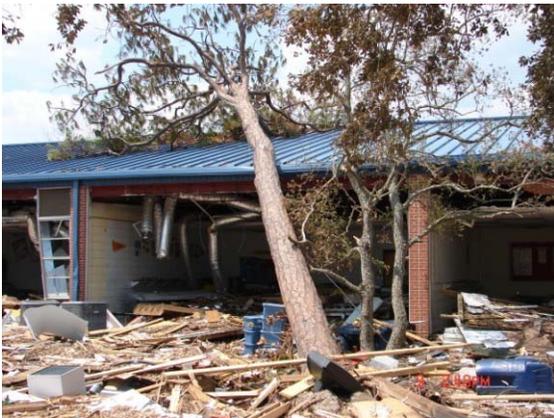
2.11-3. H. McCoughan Elementary. Trees were damaged by both high winds and storm surge.

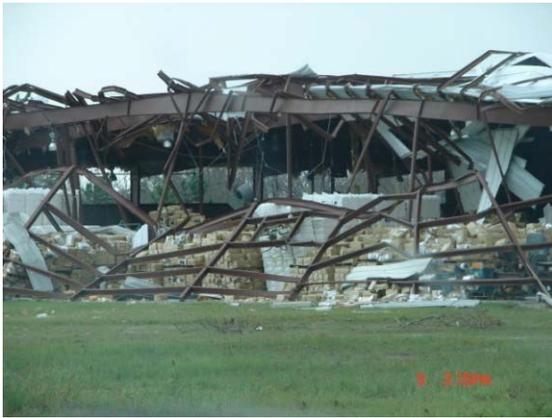
DAMAGE INITIATION AND PROPAGATION—Apparent wall failure led to building pressurization and final destruction.

2.12-1. Commercial Exchange. This photo shows the total collapse of a storage building.

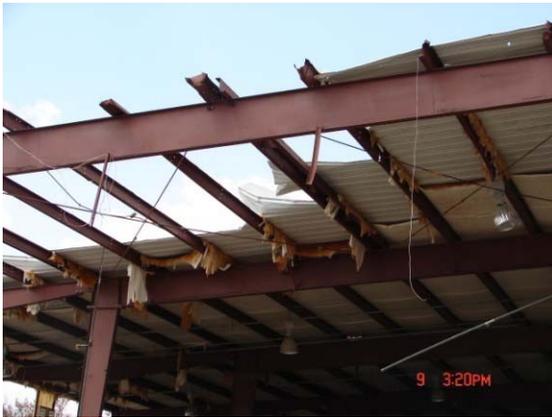
2.12-3. Commercial Exchange. Structural damage is visible in this photo.

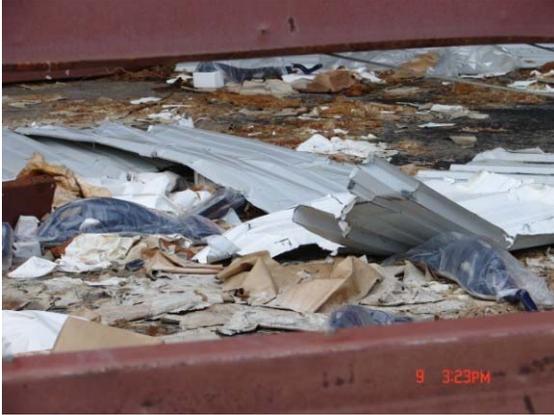
2.12-5. Commercial Exchange. This is what's left of a metal roof, with fasteners showing.

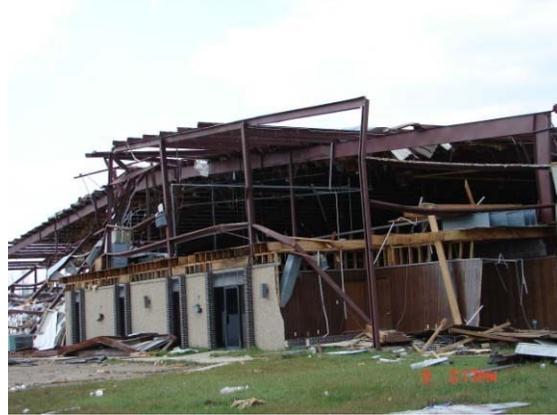
2.12-6. Commercial Exchange. Only the doors remain in place on this building.

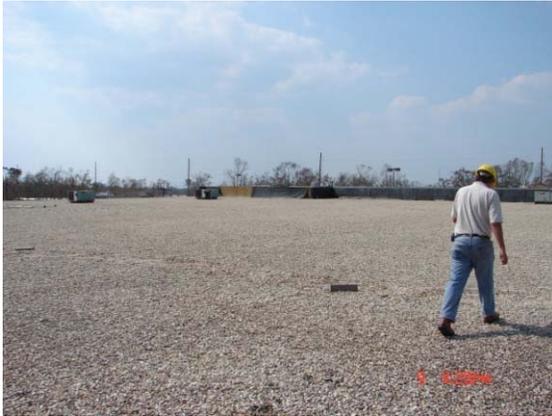
2.13-1. Sav-A-Center. This photo is typical of the roof areas at this site.

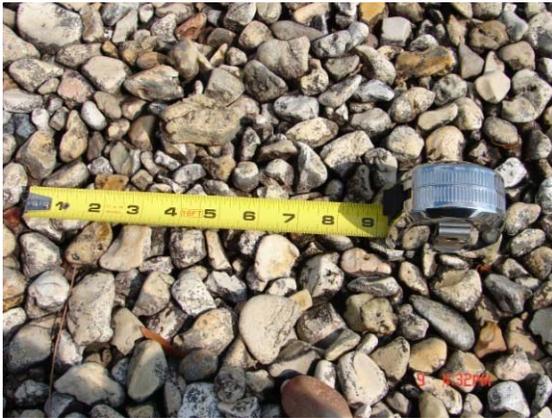
2.13-3. Sav-A-Center. This tape shows the typical stone size found here (ASTM D448#3).

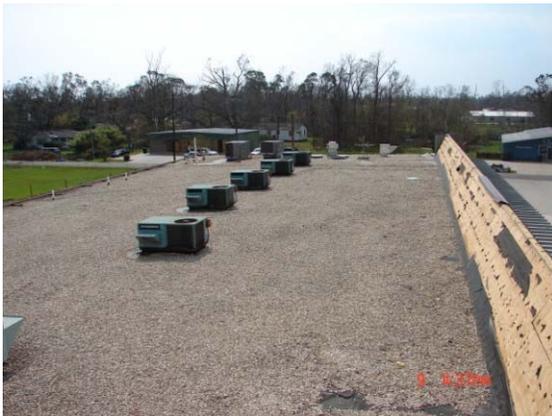
2.13-5. Sav-A-Center. More damaged wall flashing was noted here, although the membrane was intact.

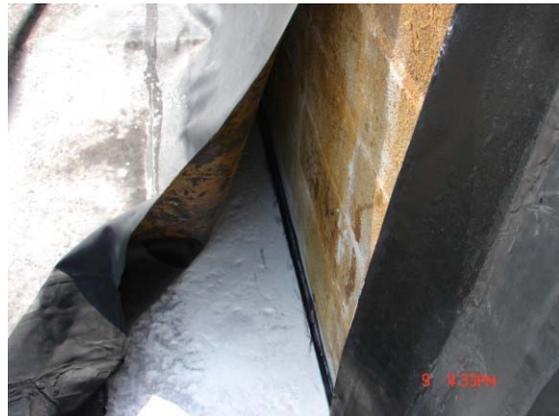
DAMAGE INITIATION AND PROPAGATION—Air gaps at the roof perimeter pressurized a space under the membrane. This led to detachment of wall flashing from the parapet in several areas, primarily in the downwind parapet/façade area.

2.13-6. Sav-A-Center. The air gap at this wall can result in internal pressure blowing off the roof.

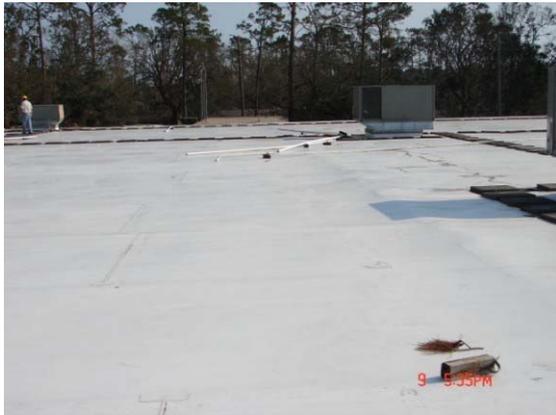
2.14-1 K-Mart. This roof exhibited no apparent damage.

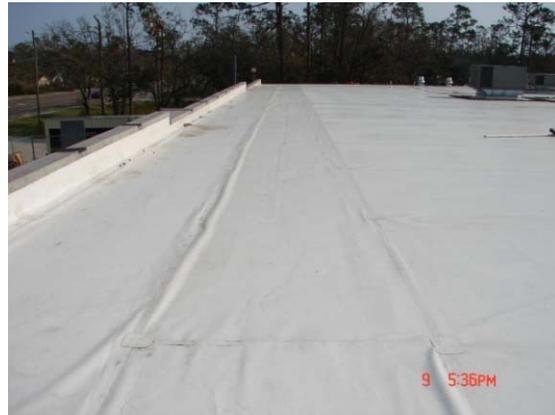
2.14-2. K-Mart. Slight wrinkling was found here.

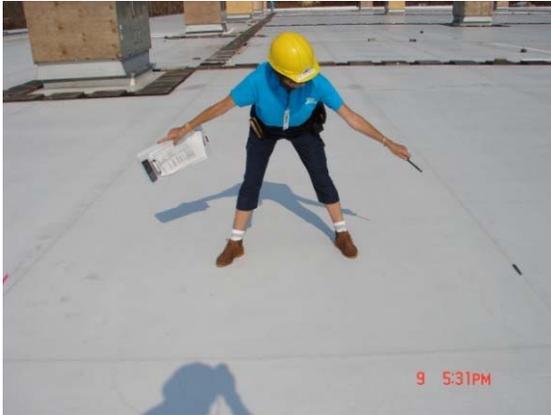
2.14-3. K-Mart. Batten bars in the field of this roof were 6 ft o.c.

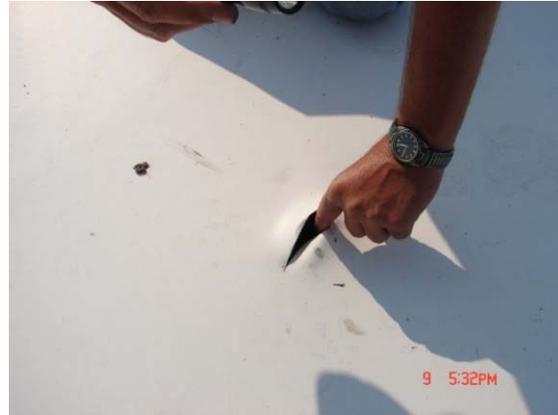
DAMAGE INITIATION AND PROPAGATION—Debris hitting roof

2.14-4. K-Mart. This photo shows a punctured single ply membrane.

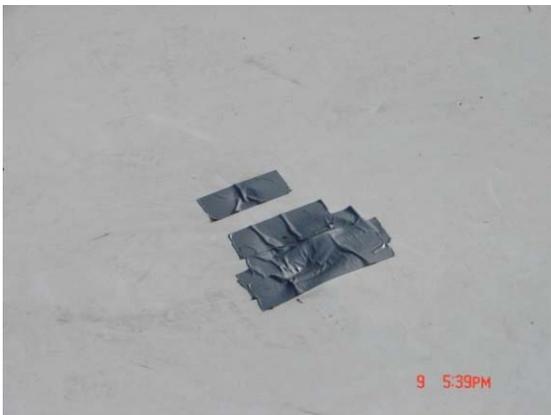
2.14-5. K-Mart. This is a temporarily patched puncture.

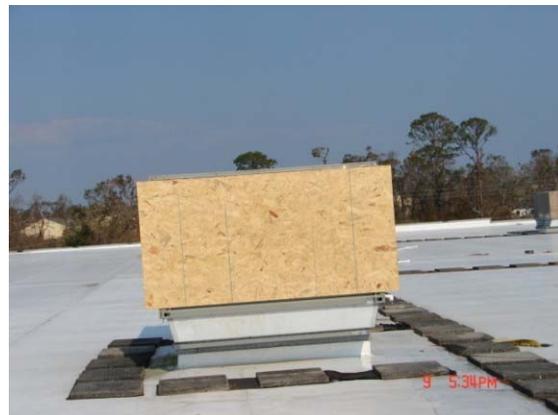
2.14-6. K-Mart. Plywood protects this HVAC unit encircled by pavers that were still in place.

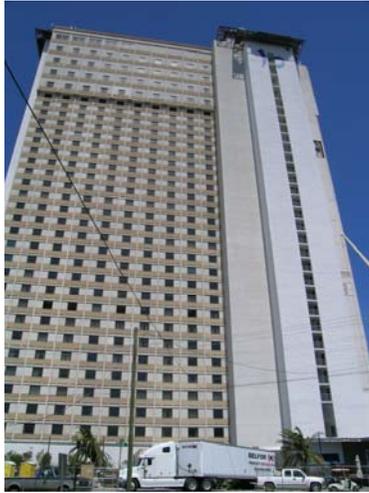
4.01-1. Imperial Palace Hotel Building 1. Southern exposure. Note the penthouse and the missing wall panels in the upper right.

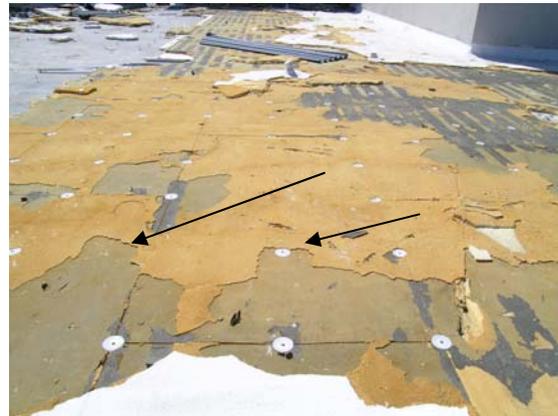
DAMAGE INITIATION AND PROPAGATION—Inadequate fastener quantity and improper fastening methods caused facer delamination, which resulted in total loss of roof assembly over much of the roof surface.

4.01-2. Imperial Palace Hotel Building 1. Plates are positioned between the 4 × 8 ft sheets of insulation, rather than through each board. This is an example of poor workmanship.

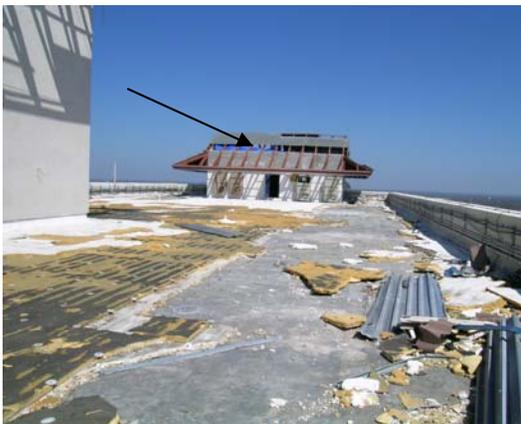
4.03-1. Imperial Palace Hotel Building 3.
Damage on main roof and small building atop main roof.

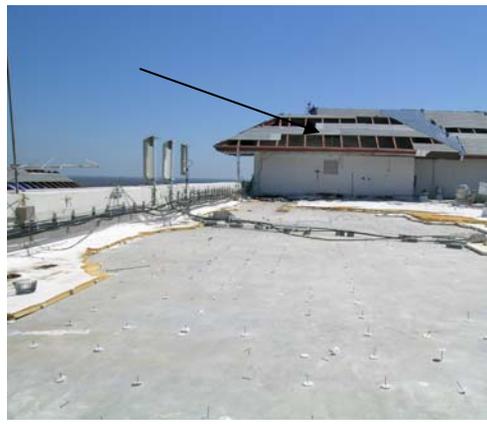
4.03-2. Imperial Palace Hotel Building 3.
Damage on main roof and small building atop main roof.

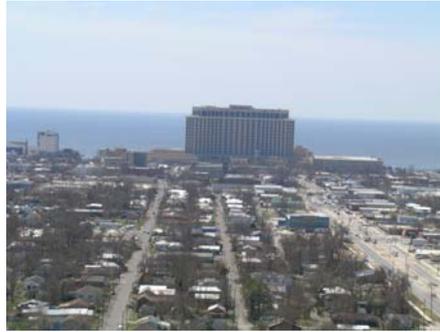
DAMAGE INITIATION AND PROPAGATION—Exhaust equipment apparently was blown the length of the roof, damaging the membrane as it dragged along the rooftop.

4.04-1. Beau Rivage Hotel. Overview.

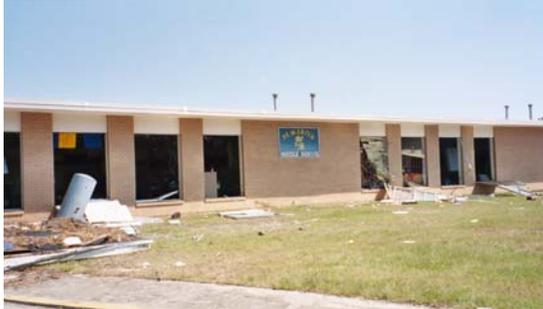
DAMAGE INITIATION AND PROPAGATION—The building was internally pressurized because the windows had blown in. This resulted in failure of the base sheet, membrane, and deck panels to remain attached to the structure. Wind pressure forced H-clips to pull free of the bar joints. Close inspection confirmed that remaining H-clips were not secure and were easily removed from the bar joint. Base sheet fasteners were inadequate to hold the base sheet in place.

4.05-1. Saint Martin Middle School. Windows blown inward at south elevation caused interior to be pressurized.

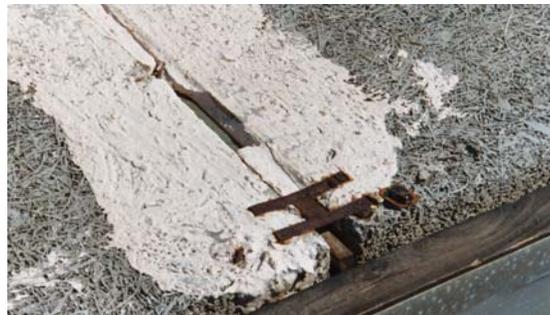
4.05-3. Saint Martin Middle School. Rusted "H" clip. Age, corrosion, and inadequate spacing, along with the internal pressurization, possibly caused the deck losses.

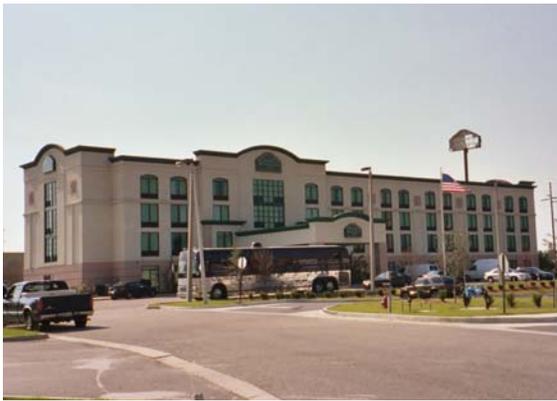
4.06-1. Wingate Hotel. North elevation.

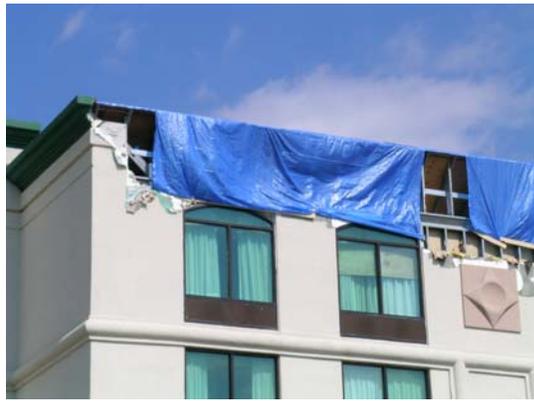
DAMAGE INITIATION AND PROPAGATION—The membrane had been fully adhered at the parapet, but a witness said it lifted and billowed up, pulling loose from the corner and parapet. The exterior EIFS wall at rooftop and parapet was blown out from internal building pressurization. Blowout damage occurred at the southwest corner, beginning at the exterior wall and eave.

4.06-2. Wingate Hotel. Southern elevation parapet façade made of EIFS on metal studs failed from internal pressurization (inside the façade) from the roof side of the parapet.

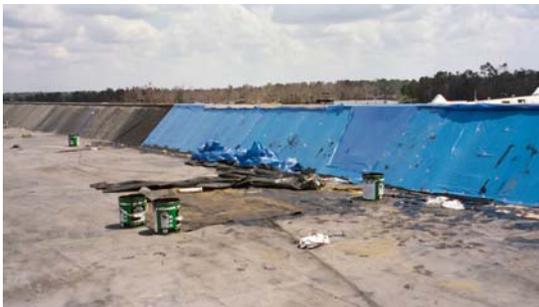
ADDITIONAL COMMENTS—Temporary repairs were done using an asphalt-based product that specifically states it should not be used on EPDM surfaces. Plastic tarpaulins were in use to temporarily cover and protect damaged spots. The parapet was 4 ft high.

4.06-3. Wingate Hotel. Temporary repairs.

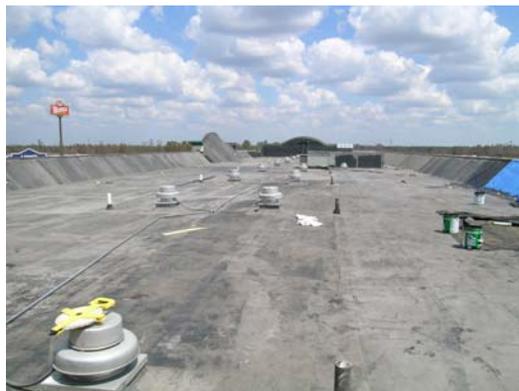
4.06-4. Wingate Hotel. Most of the roof had no damage.

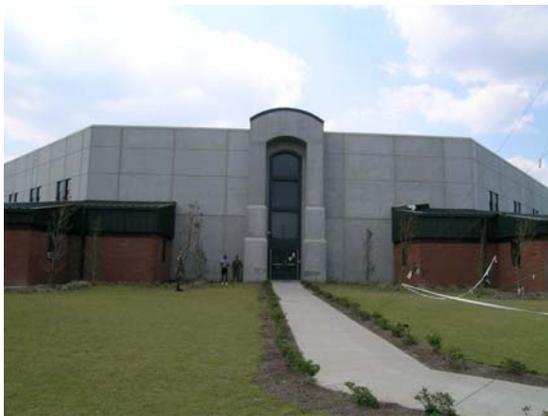
4.07-1. National Guard Airport. East elevation.

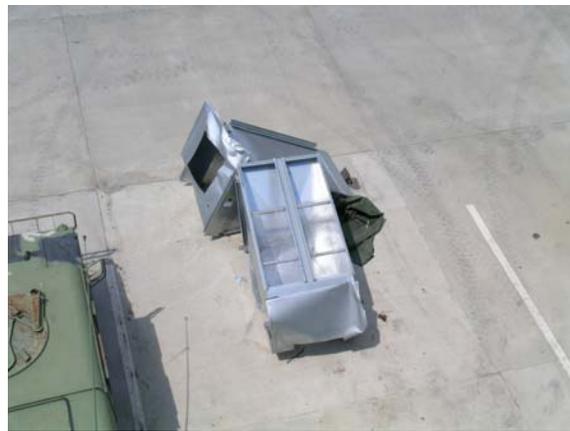
DAMAGE INITIATION AND PROPAGATION—Exhaust equipment in three areas blew off its supports and dragged across the roof, causing dents and scrapes. The exhaust unit housing was secured with only six screws, and they either tore through the sheet metal or sheared off. The exhaust equipment was found on the ground.

4.07-2. National Guard Airport. Large HVAC unit, curb, and duct blown off the roof.

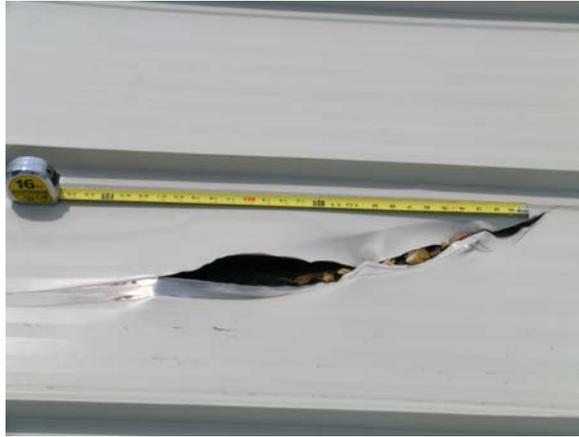
NOTED DAMAGE—One percent of the roof was damaged. Metal roof panels were damaged in two areas, and the underlying insulation was visible. Some edge details and gutters were detached and missing. Dents and scrapes were noted in several areas. Exhaust equipment was detached from its supports in three areas. Some building contents were damaged.

4.07-3. National Guard Airport. Large gash in the standing seam metal roof panel from the HVAC unit depicted in 4.07-2.

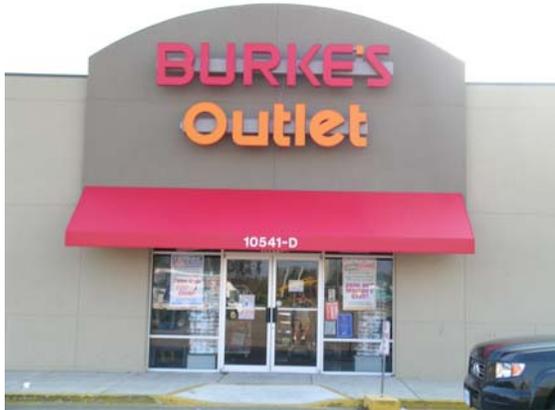
4.08-1. Burke's Outlet Building 1. North elevation.

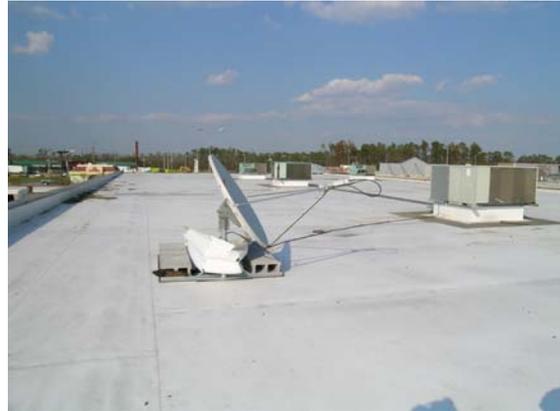
DAMAGE INITIATION AND PROPAGATION—Sheet metal was blown around on the roof and wedged into the satellite dish. The sheet metal cut the membrane as it was blown across the roof.

4.08-2. Burke's Outlet Building 1. Field of the roof shows small amount of sheet metal debris lodged in the satellite dish.

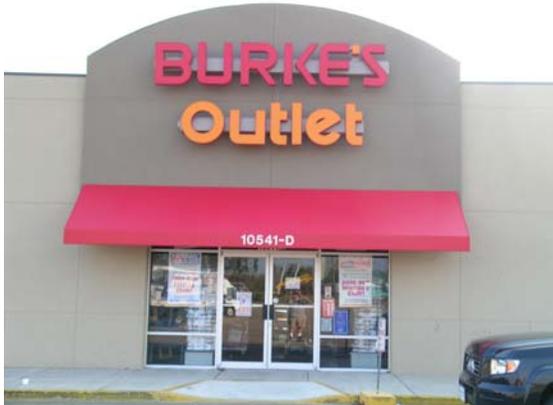
4.09-1. Burke's Outlet Building 2. North elevation.

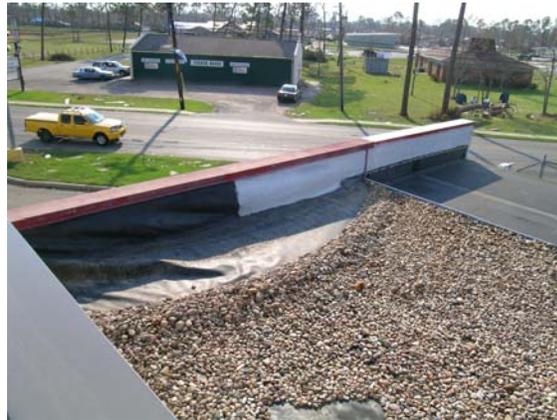
ADDITIONAL COMMENTS—This roof was the lowest one of the strip mall's connected roofs and stores. The membrane was entirely intact with little gravel remaining. However, the pea gravel was scoured in one corner. The system was 100% watertight.

4.09-2. Burke's Outlet Building 2. Wind scour in the southwest corner of the building.

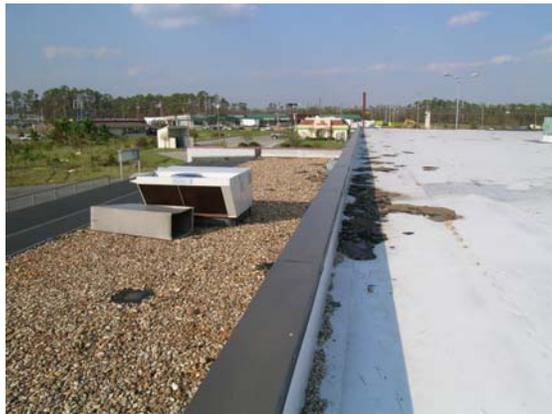
4.09-3. Burke's Outlet Building 2. Debris from the adjacent roof.

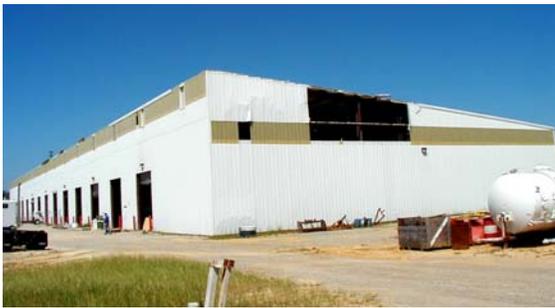
DAMAGE INITIATION AND PROPAGATION—It appeared that damage to the overhead rolling doors occurred initially. Next, an upper section of the east wall and some wall light-transmitting panels (LTPs) blew out (photo 5.01-1). This likely prevented roof blowoff despite internal pressurization because pressure was significantly reduced when the wall and LTPs blew out.

5.01-1. Keith Huber, Inc. This photo shows the southeast corner, which was in the face of the approaching wind.

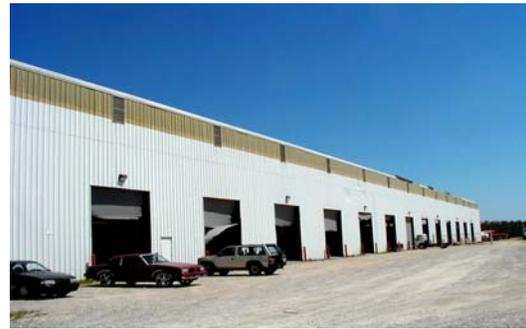
NOTED DAMAGE—All 14 overhead rolling doors (14 × 16 ft) blew in on the south wall of the building. (photo 5.01-2) Edge flashing was damaged in several locations (photo 5.01-3). Flashing fastener spacing was 3 ft o.c.

5.01-2. Keith Huber, Inc. All 14 of these overhead rolling doors on the south wall blew in.

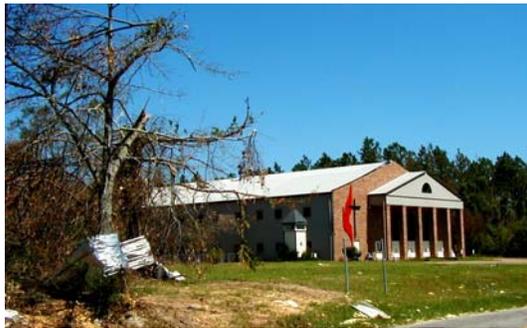
5.02-1. Gateway United Methodist Church. This is a view of the southwest corner.

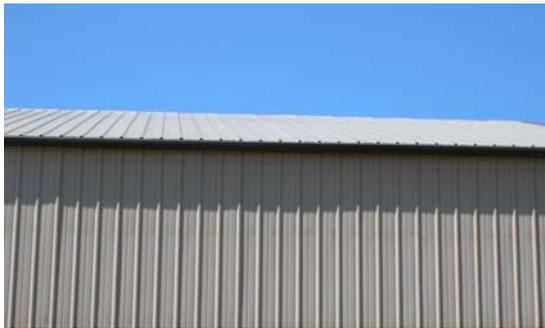
5.02-2. Gateway United Methodist Church. This through-fastened roof had no visible damage.

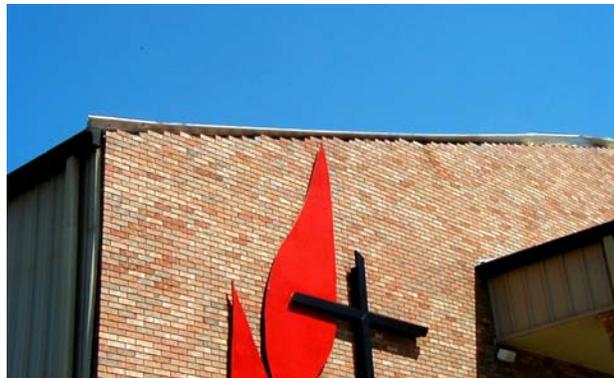
NOTED DAMAGE—The only observed roofing damage was to the rake flashing at the interface with the brick veneer front (photo 5.02-3).

DAMAGE INITIATION AND PROPAGATION—There did not appear to be any attachment of the rake flashing to the brick veneer. Consequently, the flashing detached because of the high winds.

5.02-3. Gateway United Methodist Church. Rake flashing damage is visible at the brick veneer front.

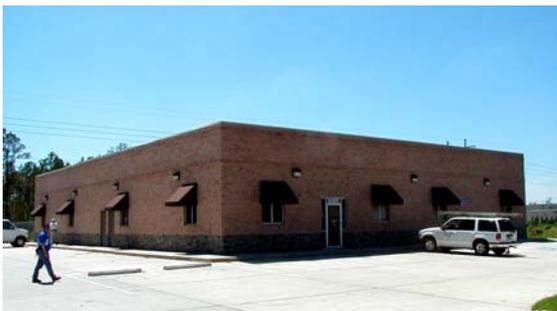
5.03-1. Kid Academy. Front (north) and side (east) walls shown here are brick veneer with parapets.

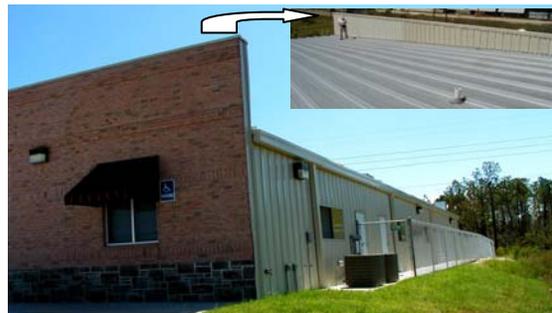
5.03-2. Kid Academy. At left is the west wall with parapet (inset is back of parapet showing roof slope from east to west side).

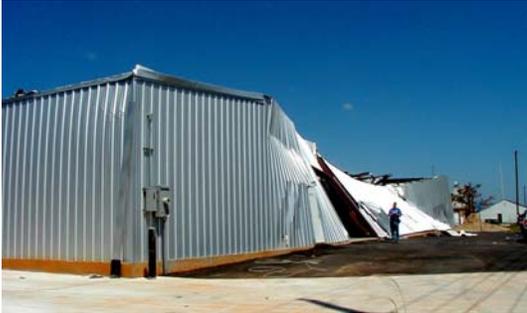
NOTED DAMAGE—The end bay roof structure was lifted up and folded back onto the roof. The end wall then blew into the building. The end wall that was damaged was facing east. The rest of the building had no damage. The building was well constructed except for the connection of purlins to end wall rafters.

5.04-1. Warehouse on Creosote Rd. Front (south) wall that failed inward.

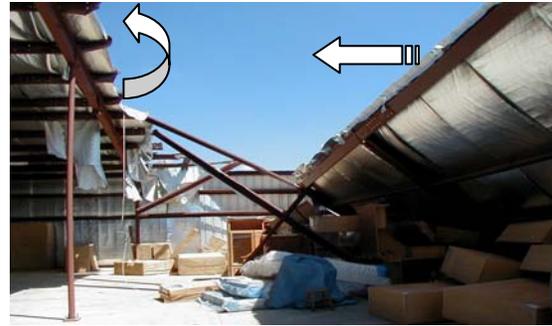
5.04-2. Warehouse on Creosote Rd. This front wall collapsed inward, then the roof purlins rolled back over the next frame.

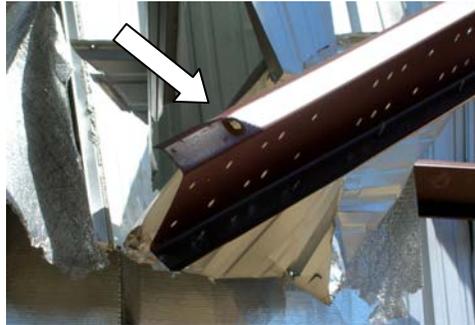
DAMAGE INITIATION AND PROPAGATION—The end bay roof structure was lifted up by the storm and then folded back onto the roof. The torch-cut holes in purlins were too large for the bolt heads. Some of the torch-cut holes showed no sign of deformation due to pulling over the bolt heads, indicating that the hole size was too large and washers were not used. Bolts were still attached to the end wall rafter.

ADDITIONAL COMMENTS—Incompatible components (possibly from more than one source) may have been the underlying cause of this sequence of damage.

5.04-3. Warehouse on Creosote Rd. A torch-cut hole in this purlin is where failure occurred at an end wall connection.

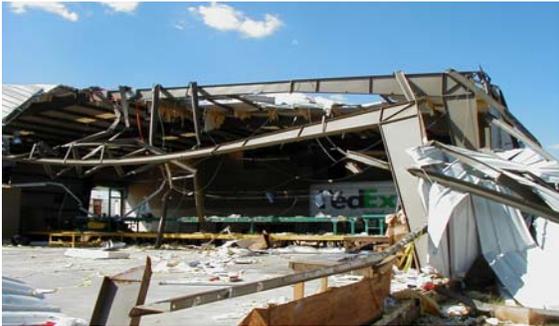
NOTED DAMAGE—Building 1 had two damaged end bays. Roof sheets were missing in the end bay and in one-half of the next bay. Building 2 had some wall sheets blown off the building at the south end and the southeast corner.

DAMAGE INITIATION AND PROPAGATION—It was difficult to determine how the damage initiated in Building 1. It is possible that the strut purlins in the end bay failed from combined axial and bending loads.

5.05-1. FedEx Warehouse. Building 1 with severe damage to the end wall.

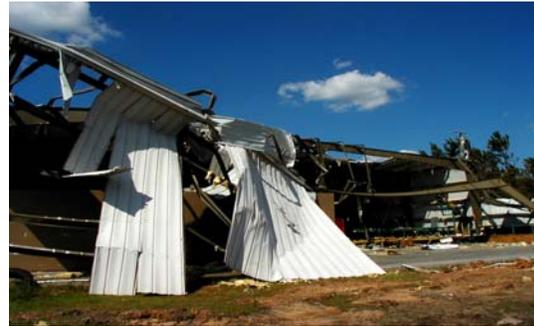
5.05-2. FedEx Warehouse. Another view of wall damage.

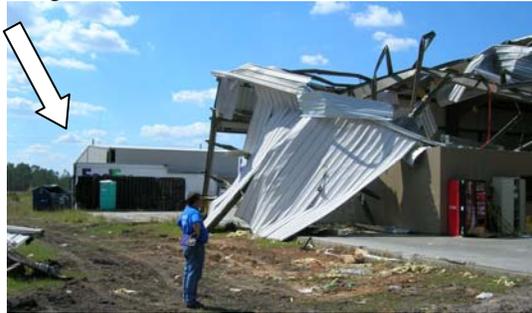
5.05-3. FedEx Warehouse. An adjacent building, which was similar to Building No. 1, can be seen in the background and with only minor damage.

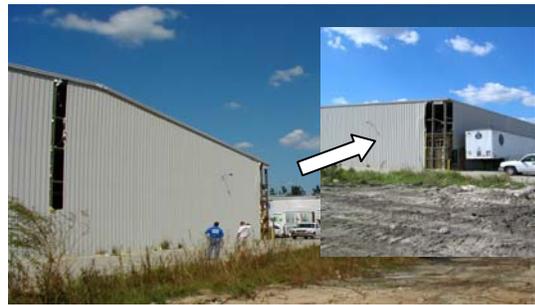
5.05-4. FedEx Warehouse. Building 2 with minor end wall and corner wall damage.

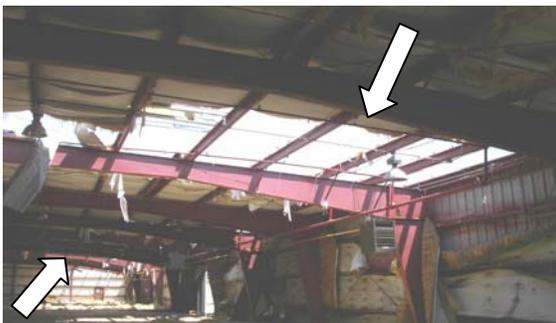
5.06(a)-1. Keesler Warehouse Bldg. 4422. This view from below shows two areas of missing roof at the corner (left) and middle of the building.

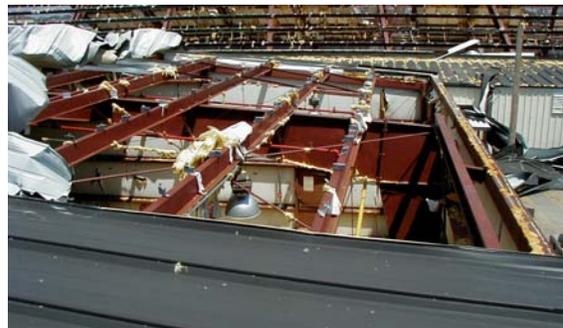
NOTED DAMAGE—The roof at the southeast corner peeled back about halfway to the peak. This damage appears to be due to failure of the eave detail.

DAMAGE INITIATION AND PROPAGATION—Roll-up overhead doors on the south side of the building blew in, causing internal pressurization that likely initialized peeling back of roof panels.

5.06(a)-2. Keesler Warehouse Bldg. 4422. The windward corner of the building is shown with the standing seam roof peeled back.

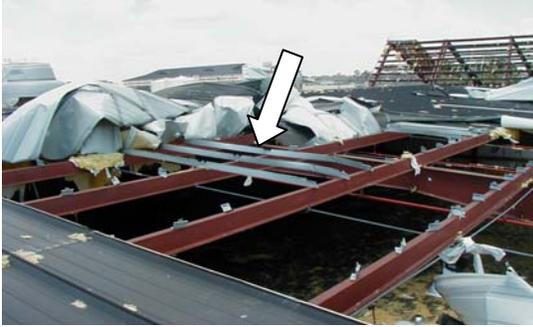
5.06(a)-3. Keesler Warehouse Bldg. 4422. This blowoff included some unusual metal panel failure along the rib. The arrow indicates where the vertical leg of the rib is still attached after the rest of the panel was torn off.

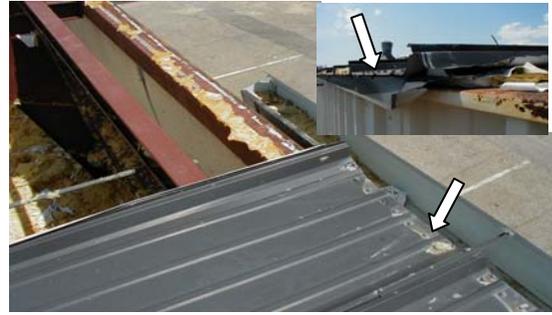
5.06(a)-4. Keesler Warehouse Bldg. 4422. These two views of poor eave detailing show that fasteners did not penetrate the eave strut.

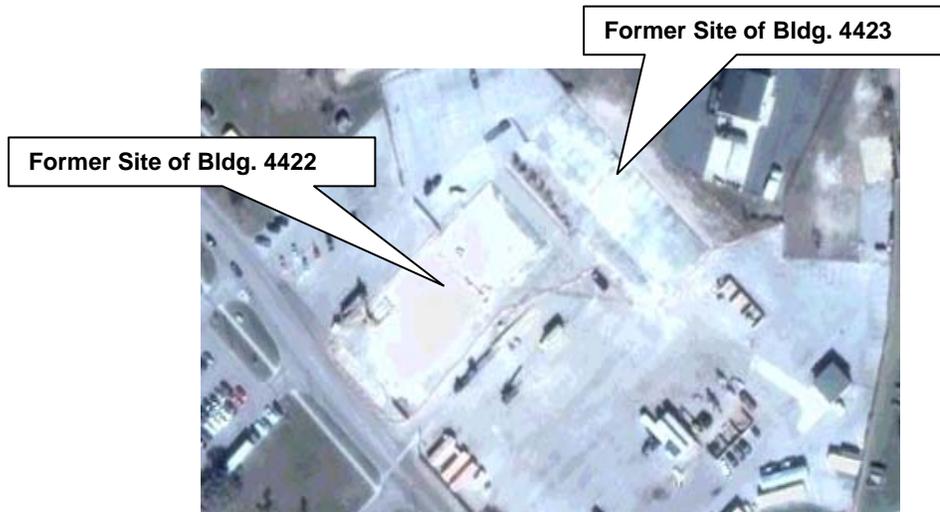
Figure 1. A post-Katrina satellite image shows these buildings have been demolished. (Photo courtesy of GoogleEarth)

ADDITIONAL COMMENTS—This building was subsequently demolished, as shown in Figure 1.

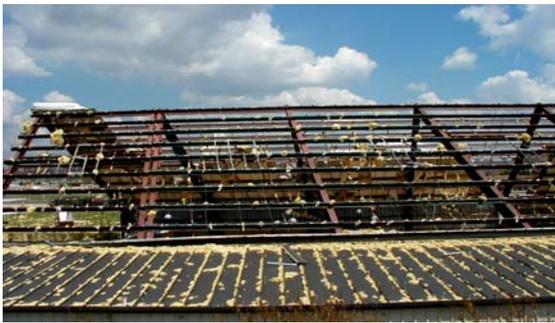
NOTED DAMAGE—Most roof panels were missing and the building was leaning toward the north end wall. The north end wall had detached from the rest of the building and was on the ground.

DAMAGE INITIATION AND PROPAGATION—Connection of the end wall column to the roof system was through one 3 in. long fillet weld, which was of poor quality. This is likely the reason the end wall detached from the building.

5.06(b)-1. Keesler Maintenance Bldg. 4423. This standing seam roof was totally blown away. This older building suffered severe damage.

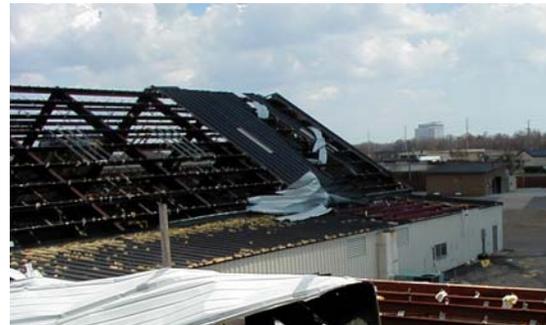
5.06(b)-2. Keesler Maintenance Bldg. 4423. Another view of standing seam roof failure on an older building.

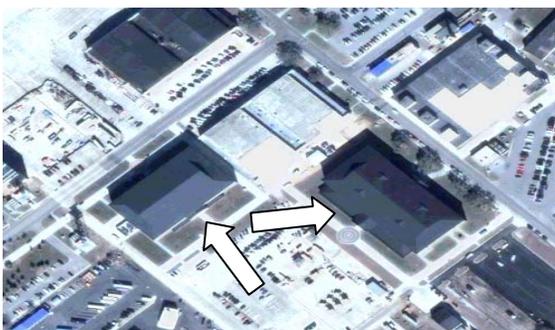
5.06(c)-1. Post-Katrina satellite photo. Keesler Thomson Hall is at left, with Bldg. 4214 at right. Arrows show next two photo orientations.

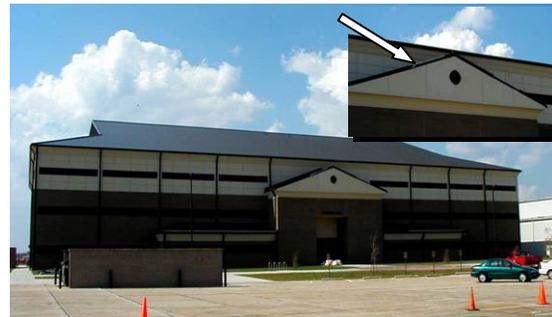
5.06(c)-2. Keesler Thomson Hall (Bldg. 4213). The only damage noted was to the trim on this roof (see inset).

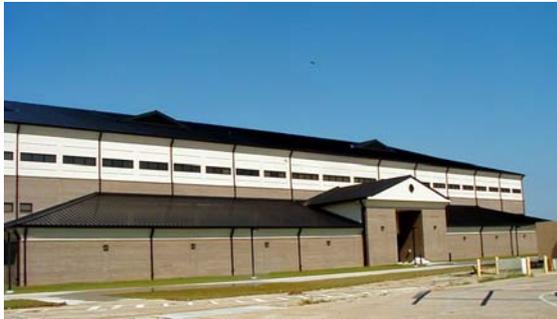
5.06(c)-3. Keesler Bldg. 4214. No damage was noted on this architectural standing seam roof.

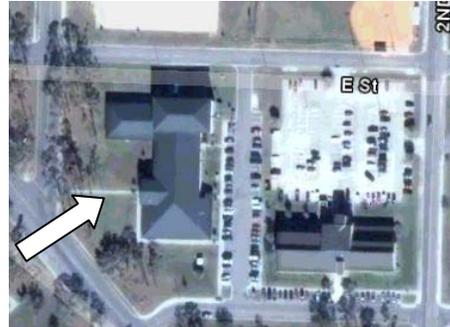
5.06(d)-1. Post-Katrina satellite photo. This photo shows Keesler's Lott Hall, at left, and Vosler Hall, at right.

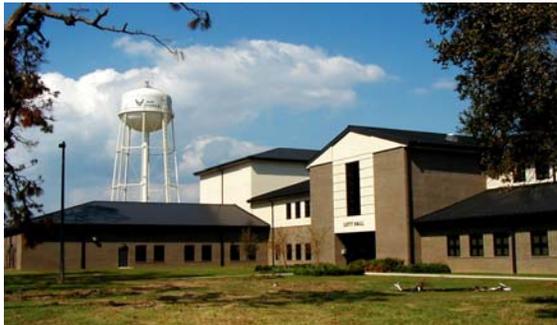
5.06(d)-2. Lott Hall. The only damage noted on this architectural standing seam roof was to the soffit area shown in photo 5.06(d)-3.

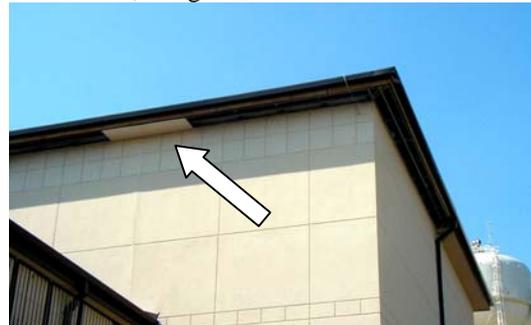
5.06(d)-3. Lott Hall. Soffit damage can be seen.

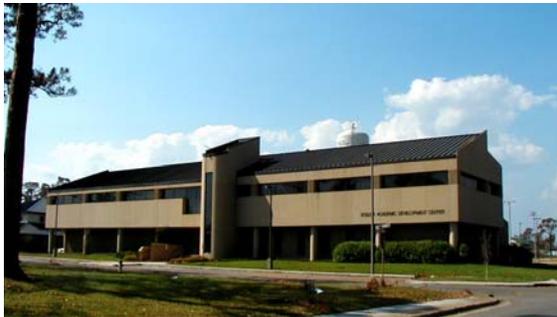
5.06(d)-4. Vosler Hall. The only damage noted on this architectural standing seam roof was to the trim, as shown in photo 5.06(d)-5.

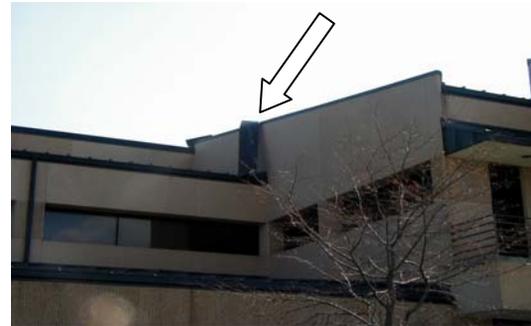
5.06(d)-5. Vosler Hall. Trim damage is shown.

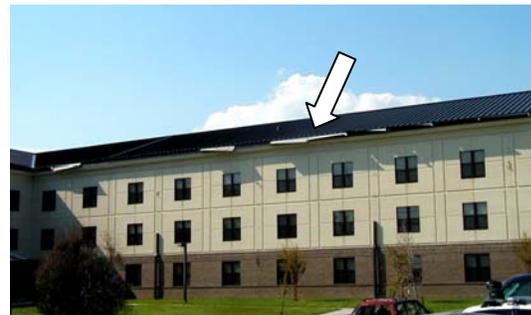
5.06(e)-2. Student Dormitory. Gutter damage is visible (at arrow).

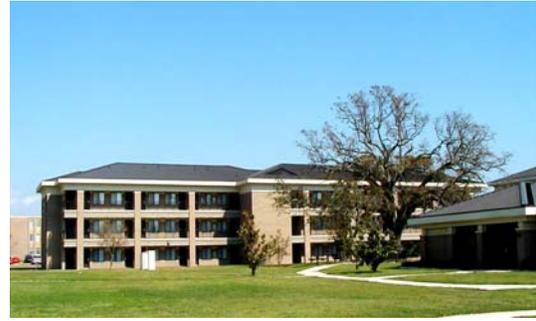
5.06(f)-2. Keesler Building 2505. No roof damage was observed on this architectural standing seam roof.

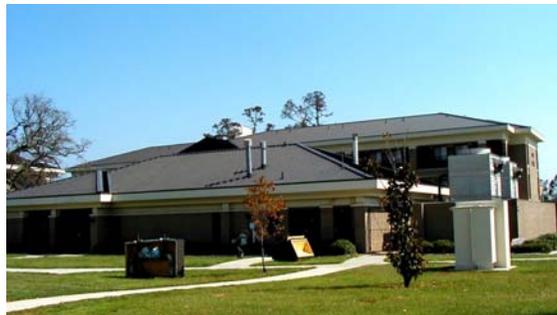
5.06(f)-3. Keesler buildings near 2505. No roof damage was observed on these architectural standing seam roofs.

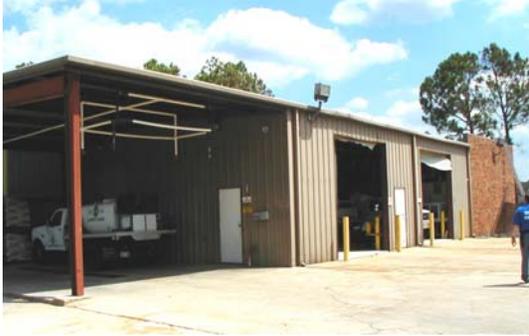
5.07-1. Sunplex Industrial Park. The overhead doors at this Liqui-Chem building failed as a result of high winds.

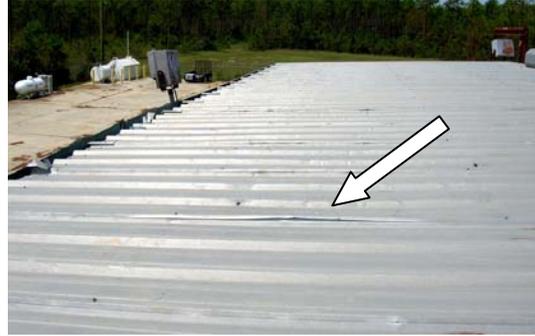
Conclusion: It appears that through-fastened roofs may be more resistant to the sudden pressurization of a building than are standing seam roofs.

5.07-2. Sunplex Industrial Park. On this Liqui-Chem building, several standing seams blew open as a result of high internal pressure.

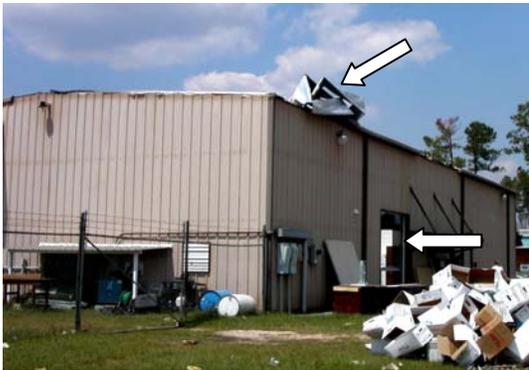
5.07-3. Sunplex Industrial Park. Superior Optical experienced substantial standing seam roof blowoff (upper arrow). The lower arrow shows a failed overhead door.

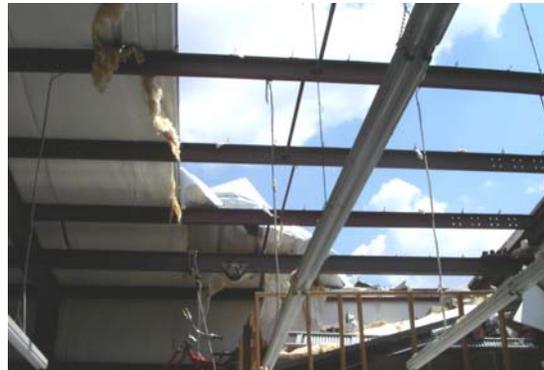
5.07-4. Sunplex Industrial Park. This photo shows a standing seam roof failure at Superior Optical. Clips remain attached to purlins.

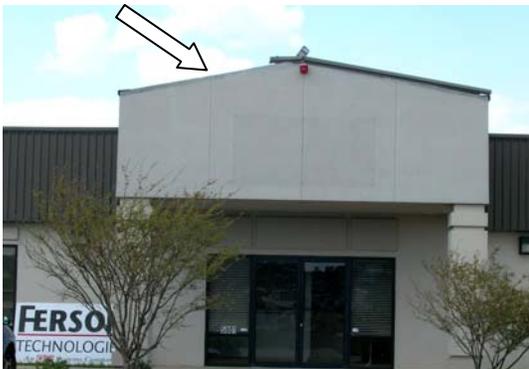
5.07-5. Sunplex Industrial Park. At the Ferson Building, failed flashings can be seen.

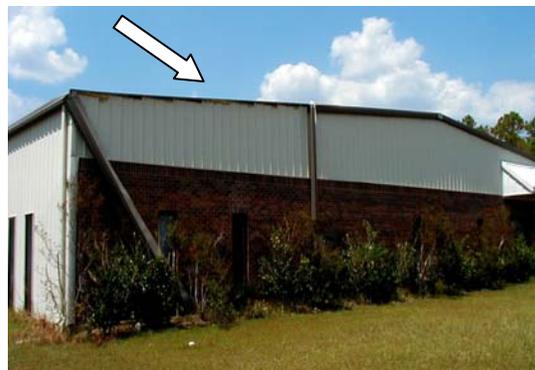
5.07-6. Sunplex Industrial Park. The RTS Building gutter and flashing failure occurred at the front of the building.

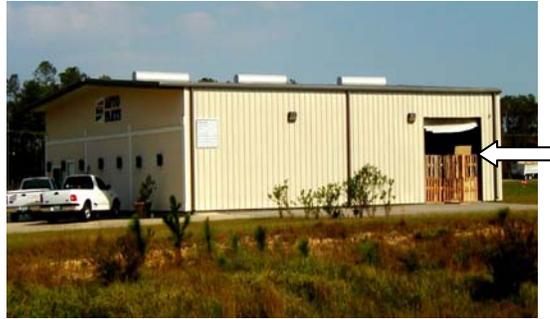
5.07-7. Sunplex Industrial Park. Mighty Auto Parts had a failed overhead door, but the through-fastened roof survived intact.

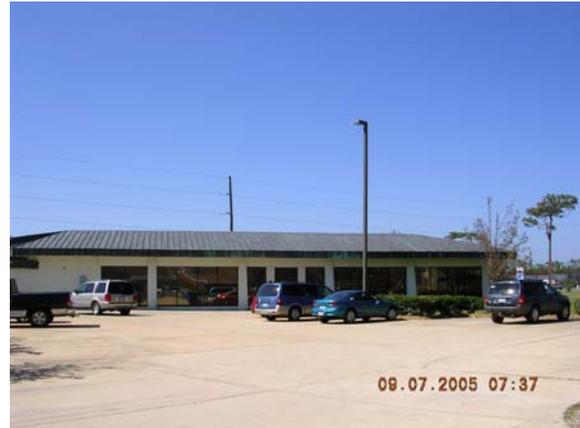
3.02-2. USA Insurance Building. This is another view of the undamaged copper roof.

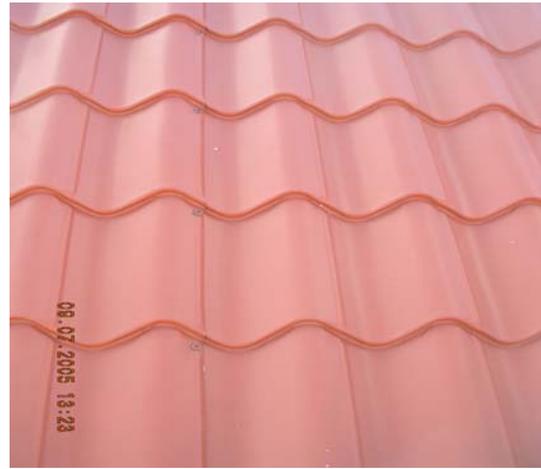
NOTED DAMAGE—A metal coping flashing piece was lost on an otherwise undamaged roof.

DAMAGE INITIATION AND PROPAGATION—A flashing piece was lost as a result of an attachment issue.

3.04-2 Church of the Vietnamese Martyrs. This is a closer view of field panel attachment.

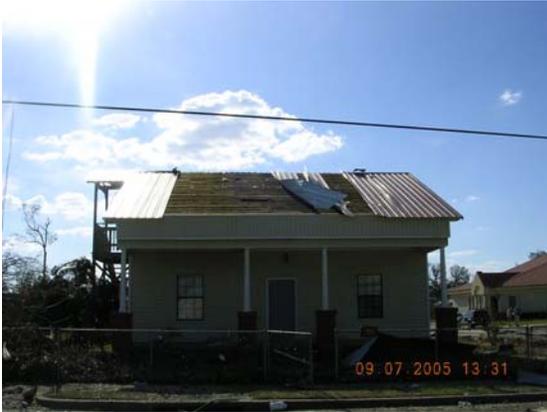
NOTED DAMAGE—Approximately half of the vertical panels were blown off the roof.

DAMAGE INITIATION AND PROPAGATION—Damage initiated from the perimeter edge and was aided by internal pressurization through spaced board sheathing.

3.05-1. Church of the Vietnamese Martyrs. This photo shows steel “R” panels pulled loose from spaced sheathing boards.

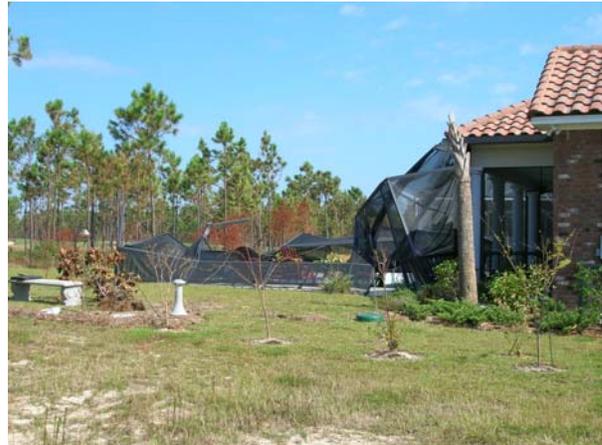
ADDITIONAL COMMENTS—Pool screen at rear of house and an adjacent shingle roof were damaged.

3.08-2. Residence. This photo shows a destroyed pool screen formerly connected to this undamaged concrete tile roof.

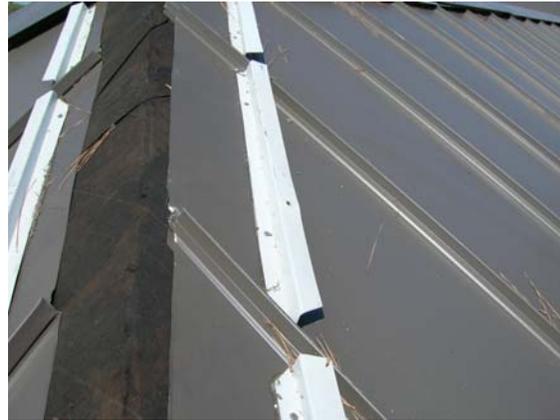
NOTED DAMAGE—Two hip panels were missing.

DAMAGE INITIATION AND PROPAGATION—The hip pieces came loose from Z-members that were not spaced sufficiently apart to engage hip pieces.

3.11-2. News Office Building. These “Z” supports were spaced too closely to adequately secure trim pieces.

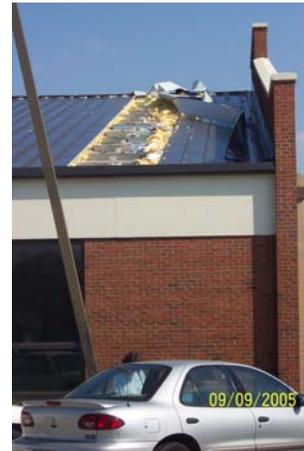
NOTED DAMAGE—Three panels were lost. Panel clips were attached to steel studs running horizontally across the old metal roof. New metal roof was installed over the old one.

DAMAGE INITIATION AND PROPAGATION—Mechanical seaming stopped 18 in. from the eave; i.e., seaming was incomplete.

ADDITIONAL COMMENTS—The failure occurred in close proximity (within 9 ft) to the end wall that extended 5 ft above the roof surface. This type of roof and others with similar characteristics often incur significant damage in close proximity to dormers, parapets, or other disconformities.

3.14-2. Post Office. A closer view of the panel seam delamination shown in previous photo.

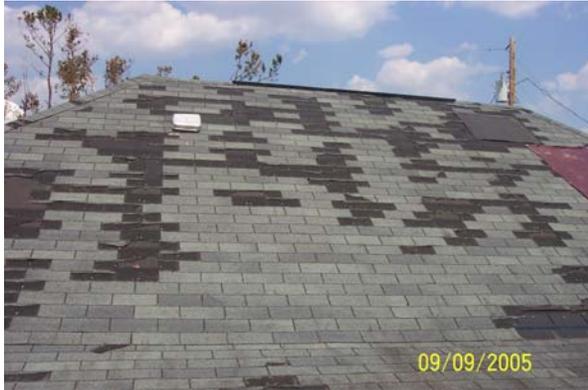
NOTED DAMAGE—Shingle edges of every other course were not fastened and ripped loose.

DAMAGE INITIATION AND PROPAGATION—Un-nailed shingle edges ripped tabs loose.

ADDITIONAL COMMENTS—The typical “racking” installation method was used here.

3.15-1. Residence. This roof was installed using a vertical “racking” installation method, which resulted in significant damage to many of the 3-tab shingles.

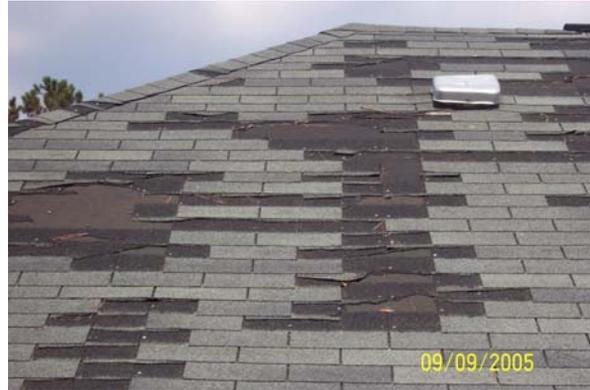
3.15-2. Residence. Fasteners were missing on alternating courses of shingles.

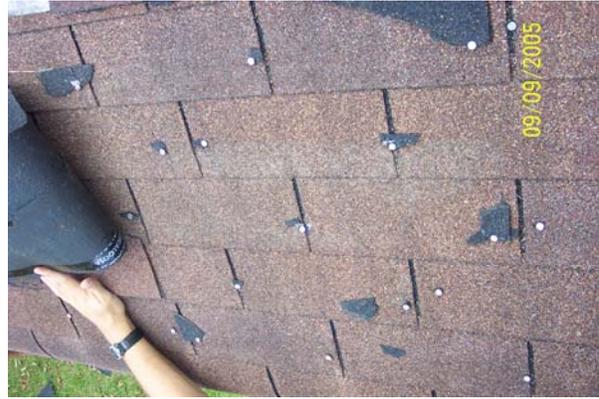
NOTED DAMAGE—Some shingles were missing around perimeter and hips.

DAMAGE INITIATION AND PROPAGATION—Shingles tore loose from leading edge.

3.16-2. Residence. Shingles on this section and others tore from nails at leading edge.
