Hurricane Katrina Wind Investigation Report

HURRICANE KATRINA INVESTIGATION REPORT

August 2007

The Roofing Industry Committee on Weather Issues, Inc. deployed six teams to investigate damage caused by Hurricane Katrina in the landfall regions in Louisiana and Mississippi. This report covers investigations conducted between September 7 and September 9, 2005.

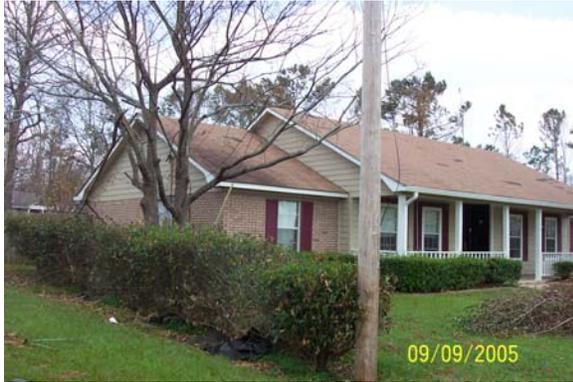
NOTED DAMAGE—A few missing shingles

DAMAGE INITIATION AND PROPAGATION—Damage was limited to a few tabs lifting and tearing loose.

3.17-1. Residence. A few shingles were missing from this 4-year-old roof.

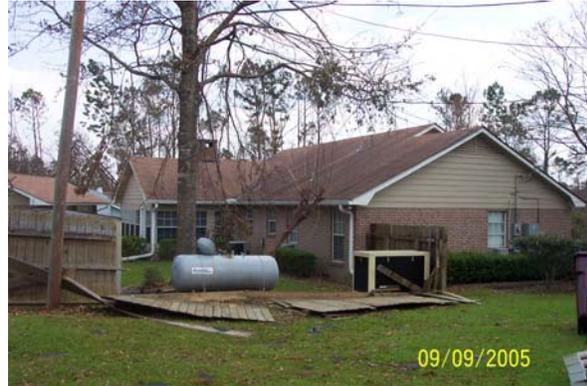
ADDITIONAL COMMENTS—Wind knocked down fencing and damaged adjacent roofs.

3.17-2. Residence. Fence damage at this residence.

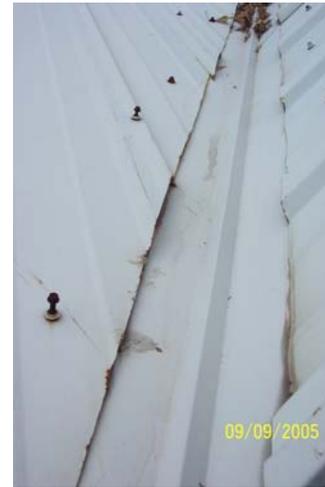
3.20-2. Residence. The loose fasteners are the result of the cyclic nature of the loading in the hurricane winds.

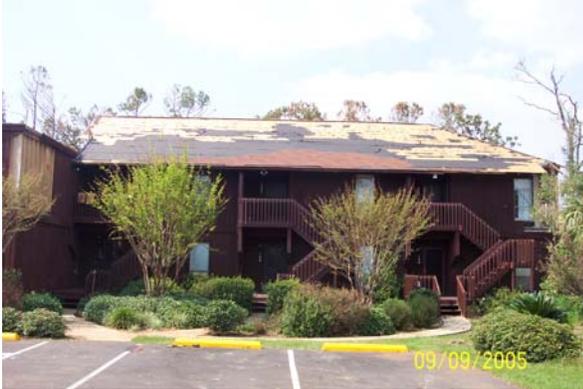
3.21-1. Lanai Village HOA. Major roofing damage is visible on this two story homeowner's association building.

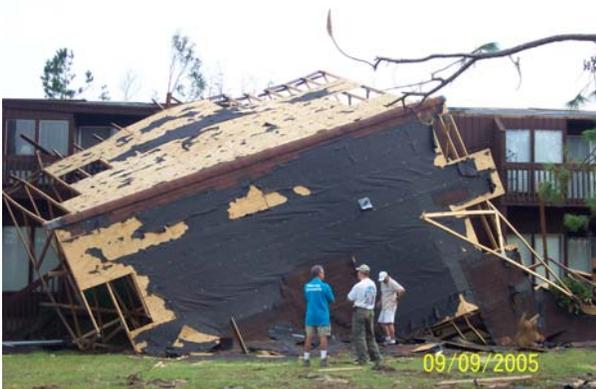
3.21-3. Lanai Village HOA. This entire retrofitted gabled roof section, originally installed as a unit, by crane, was displaced by winds.

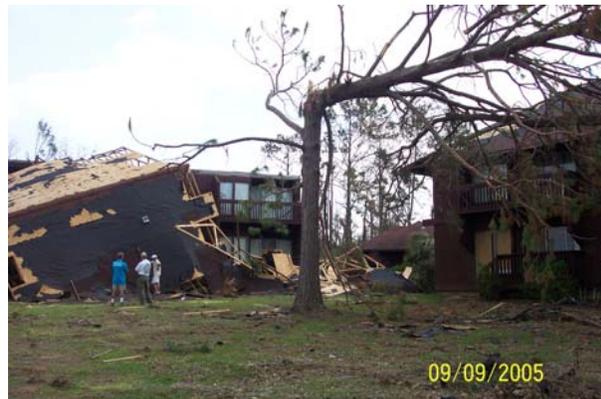
3.21-4. Lanai Village HOA. This is a wider view of the same roof section (at left). An adjacent hip roof, at right, remained in place despite the strong winds.

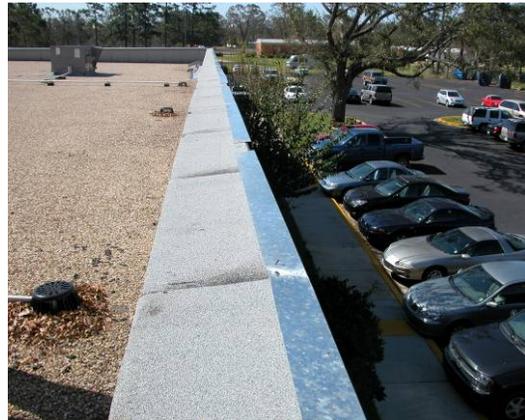
ADDITIONAL COMMENTS—This building was located on hilly terrain. The parapet metal coping was fastened with three 1 in. screws (on roof-facing side) into wood blocking. The front face of the coping was clipped onto a 26-gauge galvanized cleat (too light for this purpose), fastened 4 ft o.c. (should be continuous) with 1½ in. shingle nails on top of the parapet nailer. The modified bitumen membrane, used for wall flashing, remained intact on the wall and was wrapped over the parapet nailer and front face.

6.01-2. Community Medical Center. Metal coping was missing from the parapet.

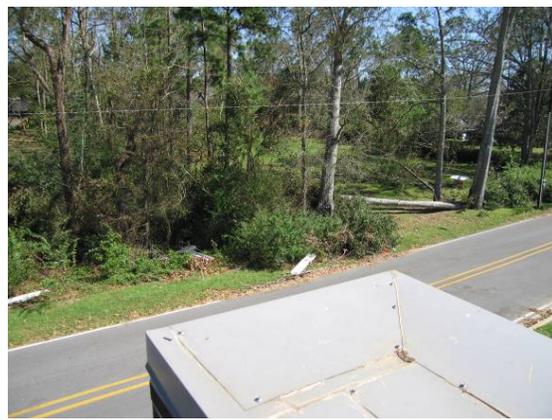
6.01-4. Community Medical Center. Note the location of windborne debris and the direction of tree fall (looking north across the road from the subject property).

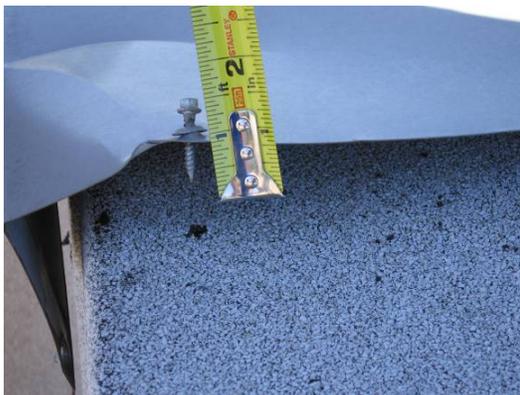
6.01-5. Community Medical Center. Close-up of a fastener used to hold coping in place.

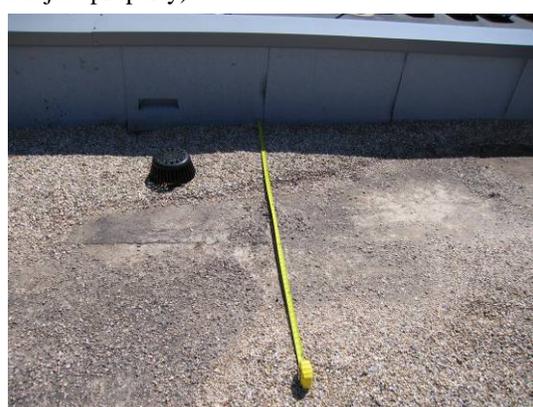
6.01-6. Community Medical Center. Evidence of wind scour damage to aggregate layer is evident.

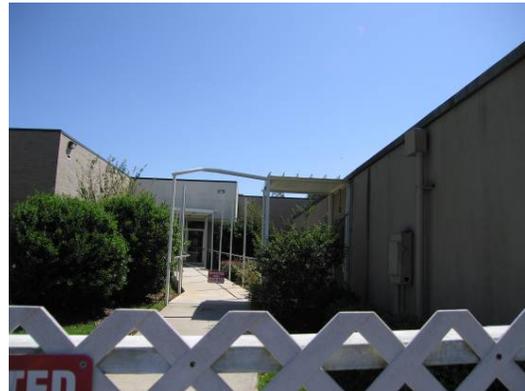
6.02-2. George County Hospital. The covered walkway structure shown is missing its roof covering.

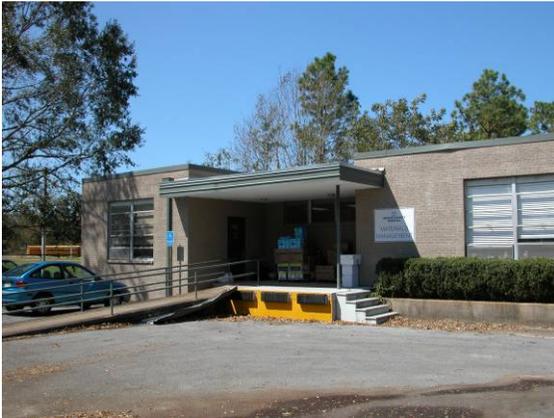
NOTED DAMAGE—Metal coping and wall flashing at the southeast corner; loose membrane in the field of the roof.

DAMAGE INITIATION AND PROPAGATION—Air infiltration at the wall/deck juncture caused wall flashing to pressurize, followed by blowoff of some of those components. This infiltration appears to have been exacerbated by a poor bond of APP flashing membrane to parapet.

6.03-1. George County Hospital Maintenance Building. View of the front elevation. Note beginning of coping failure to the right of the canopy.

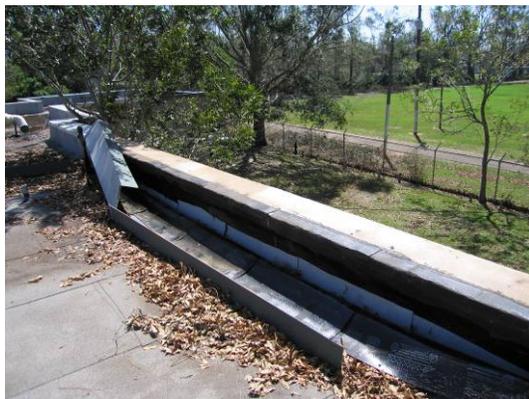
6.03-2. George County Hospital Maintenance Building. Photo shows coping and flashing attachment failure along this section of parapet.

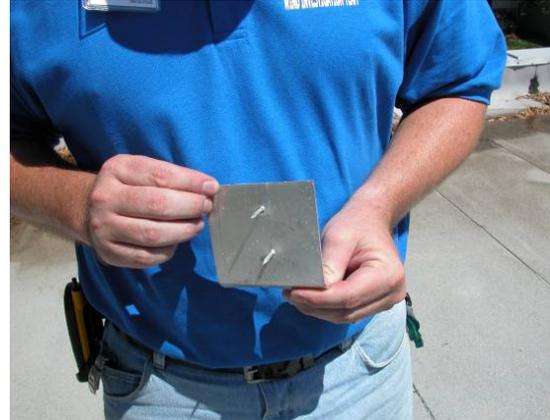
ADDITIONAL COMMENTS—The torch-grade granulated flashing membrane was loose-laid on the wall and tacked in place 4 ft o.c. with a 4 × 4 in. aluminum plate and two 1 in. concrete screws. This construction method is inadequate for a hurricane zone.

6.03-4. George County Hospital Maintenance Building. Pull-out failure was seen in clips such as this one that were used to attach flashing to brick. Flashing was modified bitumen membrane to the concrete cap. This .032 aluminum clip was also used as the catch cleat, 4 ft o.c., for the aluminum coping cap that blew off.

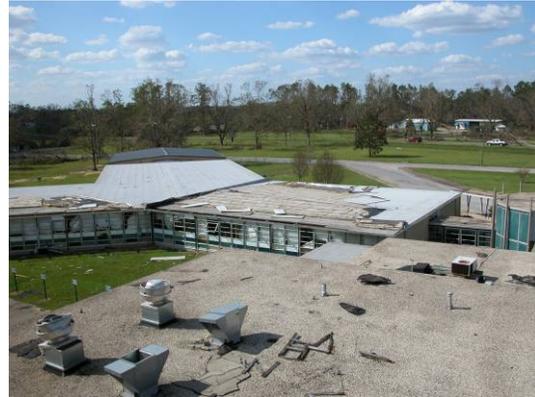
DAMAGE INITIATION AND PROPAGATION—CWF deck panels in the classroom roof section A [photos 6.04(a)-1 thru 6.04(a)-4] with membrane attached blew completely over the width of the roof and landed upside down in front of the building. The membrane was separated from the perlite as a result of a combination of strong uplift forces and cohesive failure of this inherently weak insulation material. The separated membrane peeled away and was expelled into the front yard. *Observation:* 2-ply SBS membrane delaminated from the perlite cover board interior roof; perimeter edge base sheet insulation and modified membrane blew off 18 ft back from the perimeter.

6.04 (a)-2. Stone Elementary School roof A. Southwest corner damage is shown from a different angle. Note the damaged HVAC units on the roof of the gymnasium (foreground).

Recommended repairs to the lower classroom roof would start with removal of all remaining roofing assembly down to the CWF decking and then properly securing all CWF deck panels.

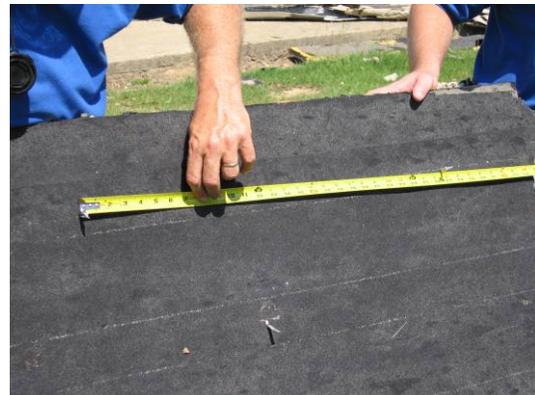
ADDITIONAL COMMENTS—The building was located on generally smooth and level terrain. The perimeter edge did not have a secure perimeter termination nailer for the membrane and the gravel stop edge. Lower classroom structural attachment of CWF panels at the perimeter eave overhang was deficient.

6.04 (a)-4. Stone Elementary School roof A. Fasteners pulled out of Tectum.

In repairing the system, the CWF should be attached more securely, and provision should be made to limit air infiltration that causes pressurization under the SBS finished roof membrane.

Hot-mopping or slow-rise adhesive foam application of a membrane to the Tectum deck to stop air infiltration will mitigate future wind uplift damage to the roof assembly; then a new roof could be installed.

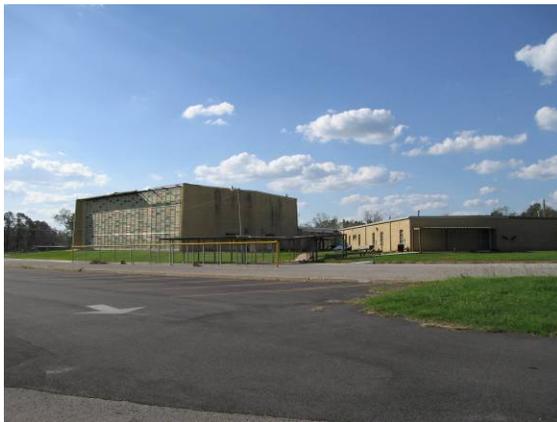
The upper gymnasium roof (35 ft high) was damaged at the southeast corner. Along the south and east overhangs, CWF panels (and attached roof membrane and insulation) were pulled out of the bulb Ts structural framework, folding the entire assembly back onto the roof edge. Unlike the lower sections, the upper gymnasium roof folded back onto itself a short distance from the perimeter edge.

6.04 (b)-1. Stone Elementary School Gymnasium roof B. The view from southeast to northwest.

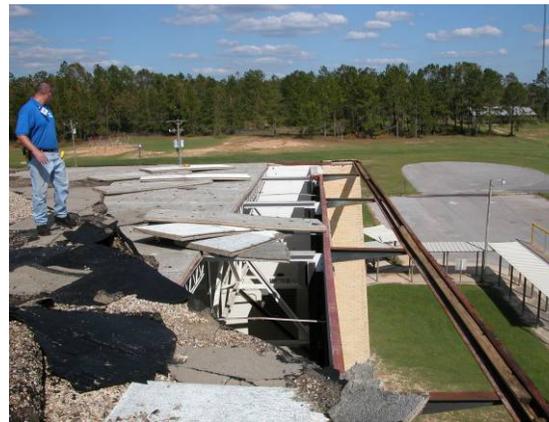
DAMAGE INITIATION AND PROPAGATION—Perimeter overhang of CWF decking blew back with two roof assemblies. On top, there was no hot-mopping of the top roof's insulation boards to the underlying gravel surface; i.e., the second roof was loose-laid, making it more prone to blowoff.

6.04 (b)-2. Stone Elementary School Gymnasium roof B. Southeast corner damage, including missing deck panels, is shown.

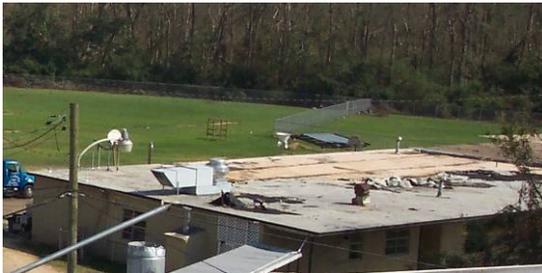
NOTED DAMAGE—Approximately 25% of the roof membrane was damaged.

6.05-1. Lumberton School. Looking down from the administration building, large areas of roofing are missing below.

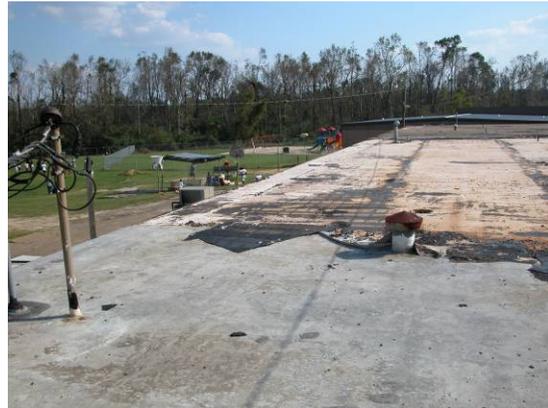
6.05-2. Lumberton School. A closer look at the roof (north to south).

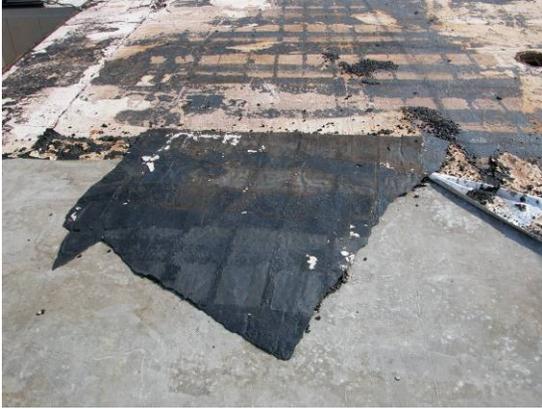
DAMAGE INITIATION AND PROPAGATION—It appears that the BUR on the south half of the building separated from the substrate, starting at the southeast edge, then peeled back. The separation was likely due to poor adhesion of the BUR to concrete.

ADDITIONAL COMMENTS—The concrete deck surface had no evidence of concrete primer, and less than 10% of asphalt remained adhered to the concrete. Primer is normally used to ensure good adhesion.

6.05-3. Lumberton School. View of the BUR peeled back from the decking.

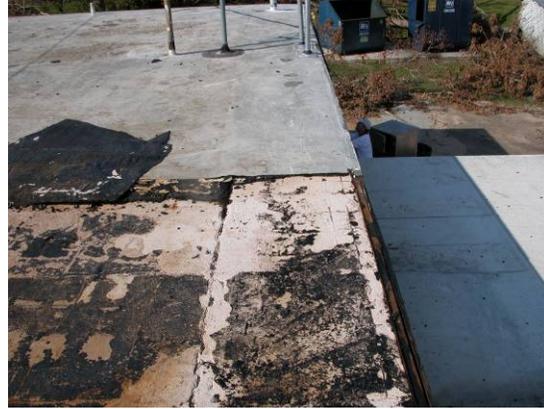
6.05-4. Lumberton School. Close-up view of the roof edge.

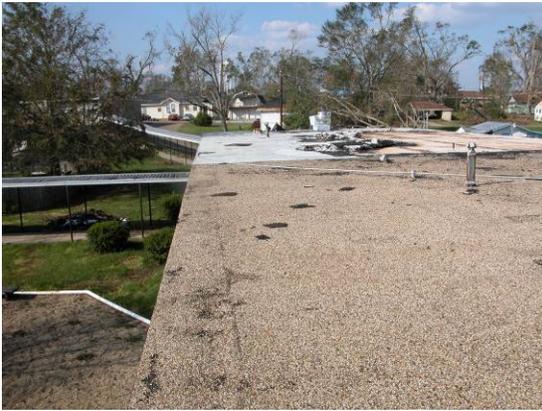
6.05-5. Lumberton School. A south to north view shows some relatively unscathed gravel-surface BUR.

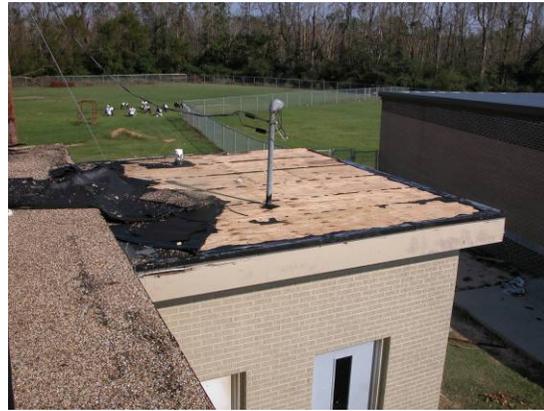
6.05-6. Lumberton School. This entrance roof was blown off.

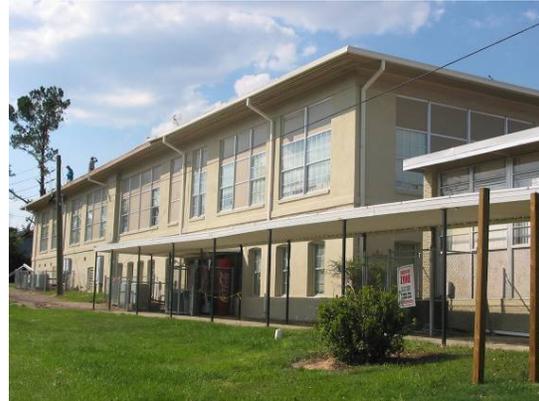
6.06-2. Lumberton School Administration Building. The south elevation has more windows and soffit exposure.

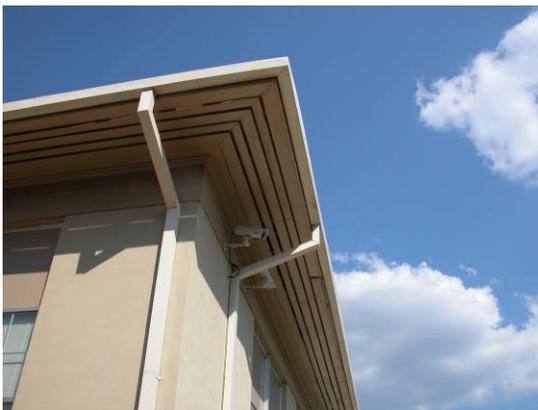
DAMAGE INITIATION AND PROPAGATION—Initial failure appears to have occurred at the south roof edge where approximately 25 ft of gutter and edge nailer separated from the structure. A vented 3 ft deep soffit may have contributed to the damage by pressurizing the space between deck and roof assembly. However, the roof assembly may have been pressurized by failure of the south roof edge.

6.06-3. Lumberton School Administration Building. View of the soffits.

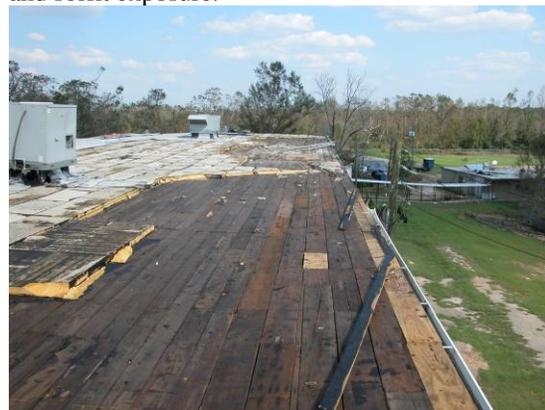
NOTED DAMAGE—Approximately two-thirds of the roof membrane was blown off the roof. About one-third of the tapered roof insulation was blown off. No deck damage was noted. There was significant interior water damage.

6.06-4. Lumberton School Administration Building. Looking west to east, considerable roof damage is visible.

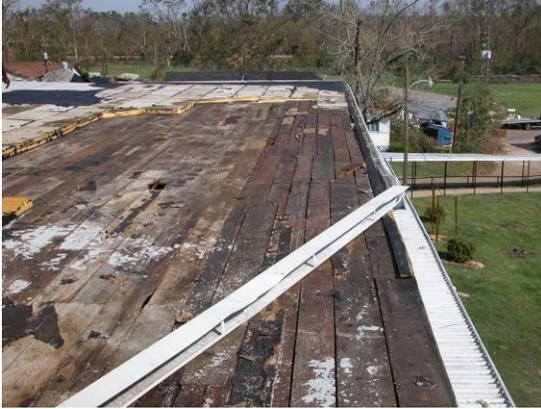
6.06-5. Lumberton School Administration Building. South side roof edge failure is visible.

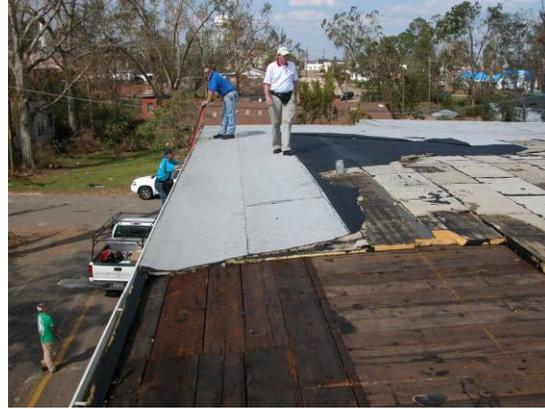
6.06-6. Lumberton School Administration Building. Looking north across the roof shows some roof assembly that remained in place.

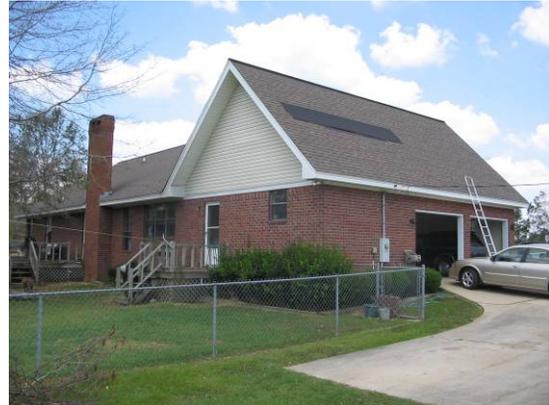
NOTED DAMAGE—There was minor shingle loss on the east face of the garage roof. Temporary repairs had been performed. There was some minor vinyl siding damage on the north gable end of the garage.

6.07-2. Residence. The east elevation of the garage.

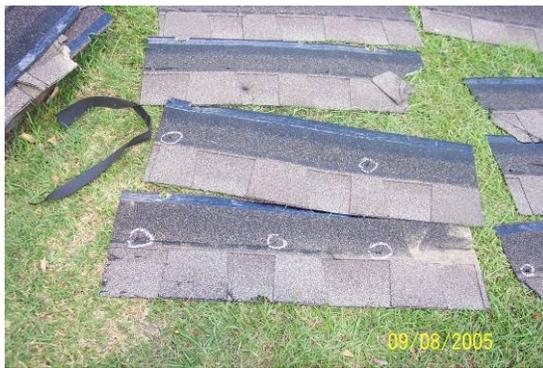
DAMAGE INITIATION AND PROPAGATION—Some of the asphalt shingles that blew off appeared to have been inadequately fastened, with only two or three nails per shingle in some cases. This does not allow the seal strip to function adequately to resist the wind loads.

6.07-3. Residence. Encircled spots show where shingles pulled free of nails and the lack of nails.

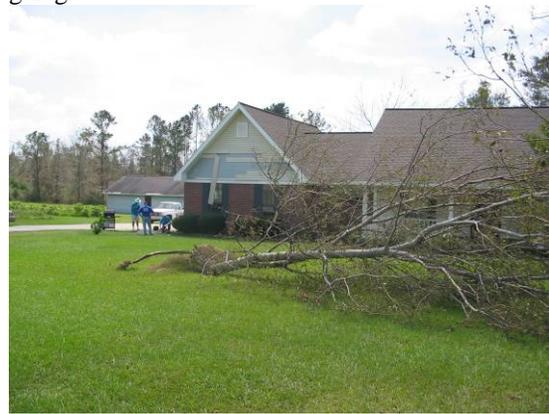
ADDITIONAL COMMENTS—Based on downed trees, it appears the strongest winds came out of the east. While the property sits on the edge of a large wooded area to the south, the house is in a generally open exposure.

6.07-4. Residence. A downed tree shows the hurricane wind direction.

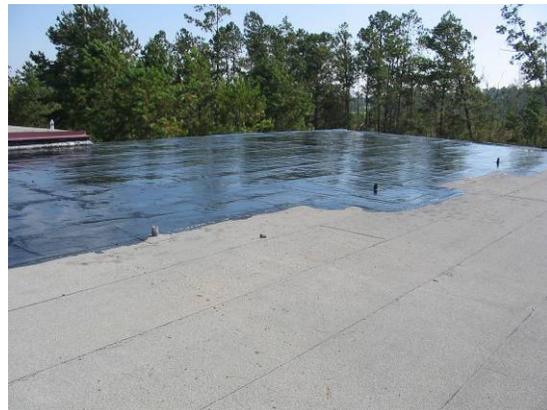
DAMAGE INITIATION AND PROPAGATION—Damage began at the northeast corner gravel stop, which was not anchored to a cleat. Edge metal pulled free of the nailer and peeled back the BUR and cap sheet membrane in a 20× 30 ft area.

6.08-2. Perry County High School. This is a southwest to northeast view of damaged roofing. The mineral-surface cap sheet (foreground) appeared relatively undamaged.

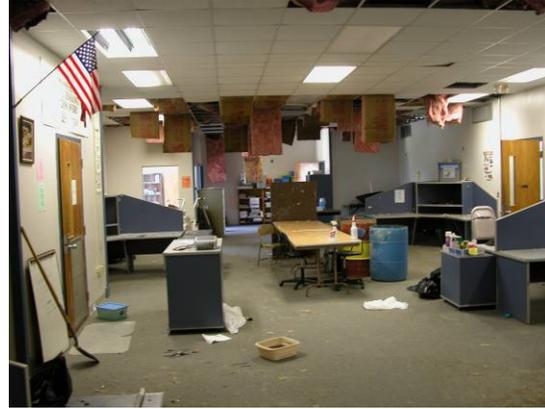
NOTED DAMAGE—Roof membrane blowoff on east section of the main campus building. Repair work had already begun. Damage area was less than 10% of the total roof area on the main building. There was also interior water damage.

6.08-6. Perry County High School. Interior water damage is visible.

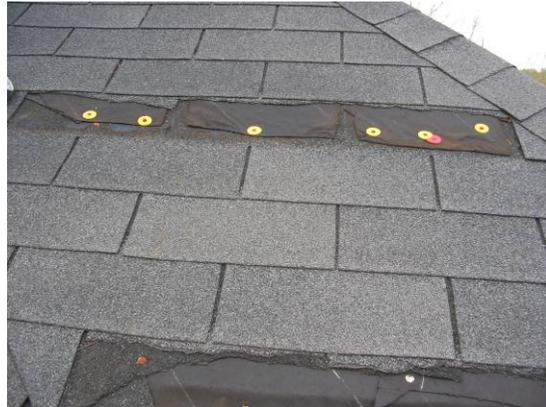
NOTED DAMAGE—Shingle damage was limited to between 10 and 25% of the total roof area. No other damage was noted, other than possible screen damage at the rear patio.

6.09-4. Residence. Ripped shingle tabs have been temporarily repaired in this photo.

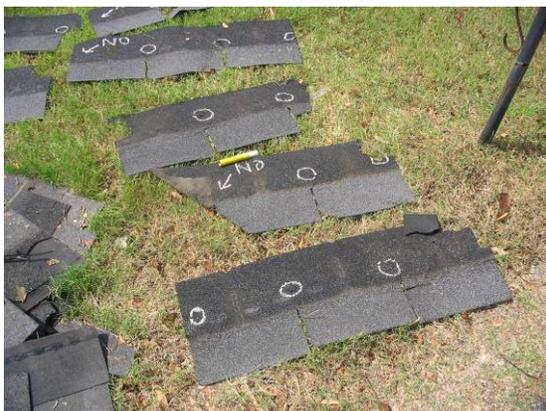
DAMAGE INITIATION AND PROPAGATION—Missing nails resulted in excess stress on shingle seal strips. This is an example of the typical failure due to the racking method of installation that often limits the shingles to three nails. The shingles are installed in a pattern that starts at the bottom of the slope and goes to the top of the roof in a vertical line, instead of the diagonal stair-stepped pattern recommended by manufacturers.

6.09-5. Residence. Missing nails and nail pull-through anomalies are marked with chalk.

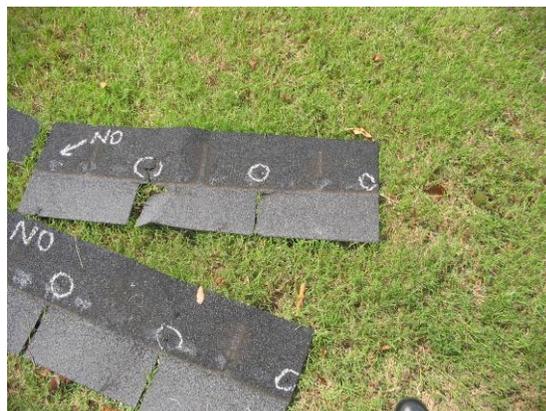
6.09-6. Residence. Missing nails and nail pull-through spots help determine cause of failure.

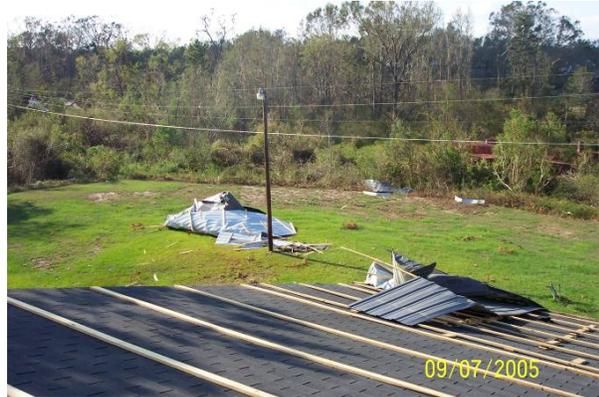
Failure appears to have been inadequate fastening of nailers to the deck. Loss of nailers was due to the combination of insufficient fasteners and their low pull-out resistance. Nailers were attached to the deck only with pairs of nails at 4 ft intervals. Since the metal roof panels were only connected to nailers 4 ft o.c. vertically, each pair of nails had to resist uplift forces developed over approximately 16 ft².

6.10-2. Baptist Church. Boards remaining on the roof were "stiffeners" between nailers lost to wind.

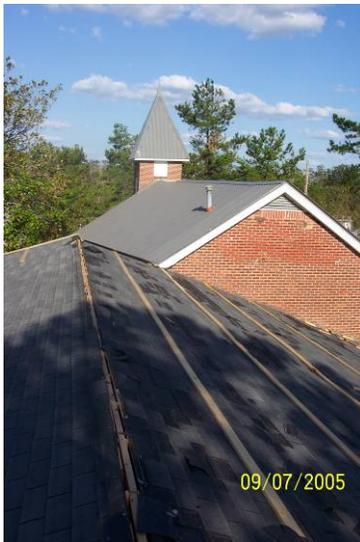
NOTED DAMAGE—Main church roof had no damage. Church annex roof was a total loss. The metal roofing was completely uplifted on the windward (south) side, and many panels were missing on the leeward side. Some older shingles (underlying roof covering) were uplifted, primarily on the windward side.

6.10-3. Baptist Church. The annex roof with no remaining metal panels. The metal roof on the adjoining church (in background) sustained no damage.

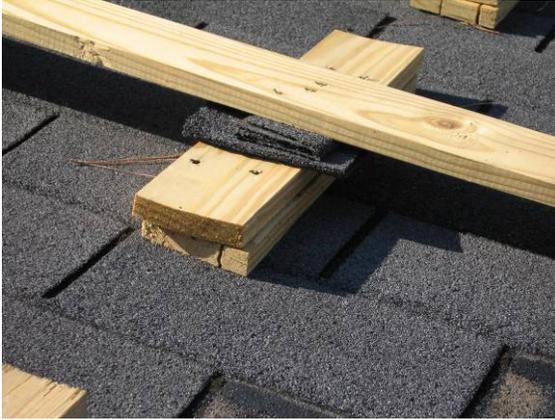
6.10-5. Baptist Church. The underlying shingle roof appeared to have low spots. Nailers were shimmed out in an unorthodox manner (with scrap asphalt shingles) to provide a level base for the metal roofing.

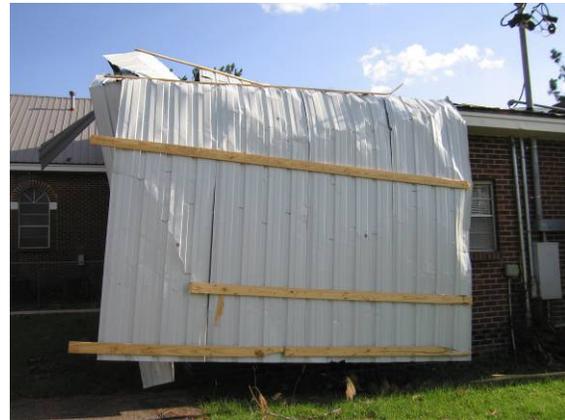
6.10-6. Baptist Church. In one location, the nails used to secure nailers pulled free, leaving nailers attached to the metal roofing. This was a good lesson in proper fastener selection and placement.

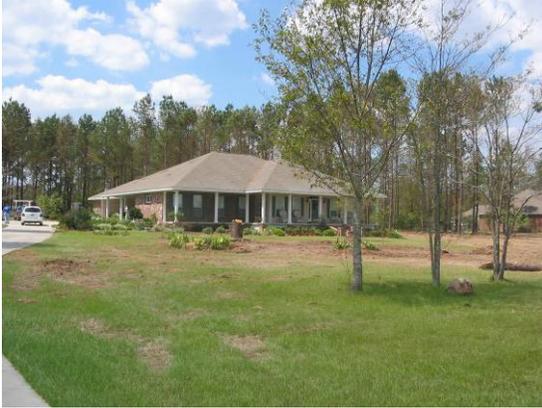
6.11-1. Residence. This is a west-facing view.

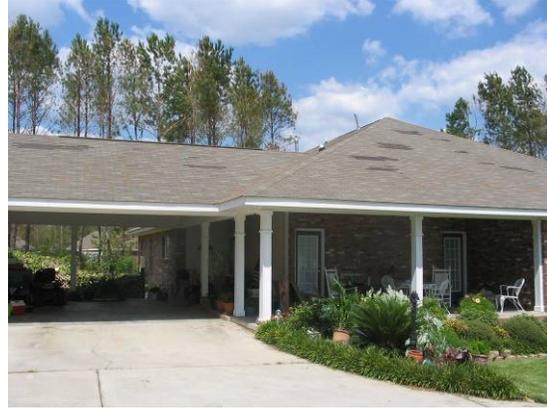
ADDITIONAL COMMENTS—Based on observations of downed trees near the home, it appeared the strongest winds came from the east. It appears that wind direction played a role in shingle failure. This roof performed well based on the wind speeds.

6.11-2. Residence. A view facing north. Shingle damage can be seen clearly.

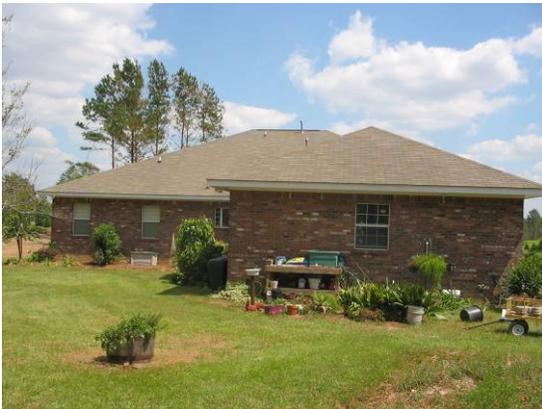
6.11-3. Residence. Facing east, these sections show no roof damage.

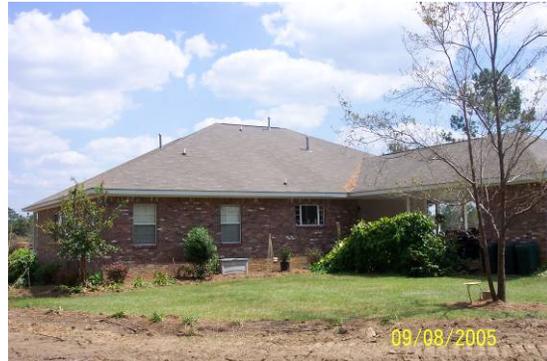
6.11-4. Residence. Facing northeast, this residence also shows no obvious damage.

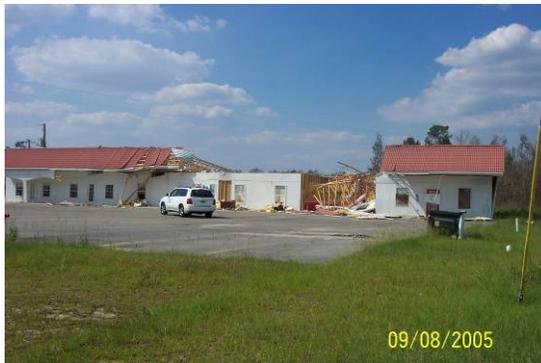
NOTED DAMAGE—The building suffered major structural damage. Large portions of the metal roofing were blown off. Some trusses were displaced. A middle portion of the building collapsed.

6.12-1. Strip mall. Facing north, damaged buildings are clearly in evidence.

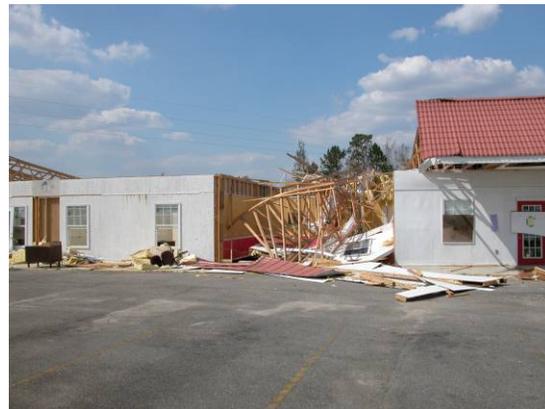
DAMAGE INITIATION AND PROPAGATION—It is likely that wind from the south collapsed the lightweight metal soffit over the front elevation. This caused uplift over the roof. The combined forces of uplift (negative pressure) from wind blowing over the structure and wind blowing up on the bottom side of the roof (positive pressure) caused the wood roof trusses to separate from the tops of the bearing walls. Separation of trusses from walls caused the center portion of the building to collapse.

6.12-2. Strip mall. The center section collapse on the south elevation can be seen in this closer view.

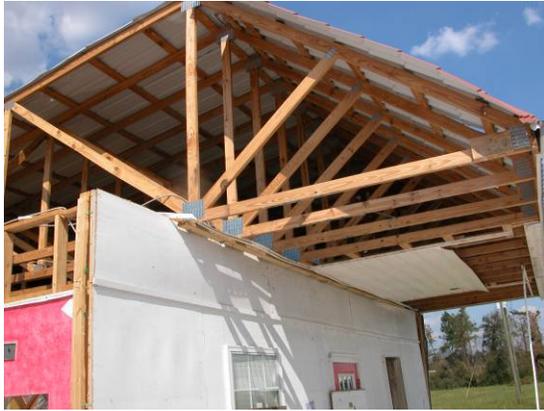
The lightweight soffit materials appear to have played a major role in this building failure. However, if they had not blown in, other cladding elements, like the metal roofing, may have failed at some point.

6.12-3. Strip mall. The soffit damage on the south side is visible in this photo.

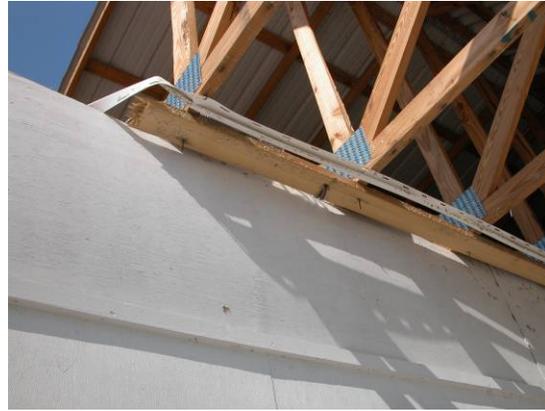
Where the major building collapse occurred, the truss-to-wall connection failed for one of two reasons:

- Direct withdrawal from the end grain of the wood studs; i.e., the double top-plate, to which the trusses were toe-nailed, separated from the wood studs. This type of connection is assumed to have no uplift resistance.
- As a result of separation of the double top-plate, the top 2 × 4 in. separated from the bottom 2 × 4 in. because the nails joining them pulled loose because of uplift.

6.12-4. Strip mall. This photo shows a wall top-plate failure.

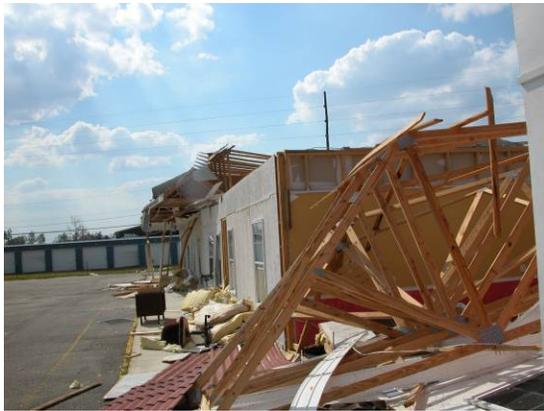
6.12-5. Strip mall. Damage was severe to this strip mall.

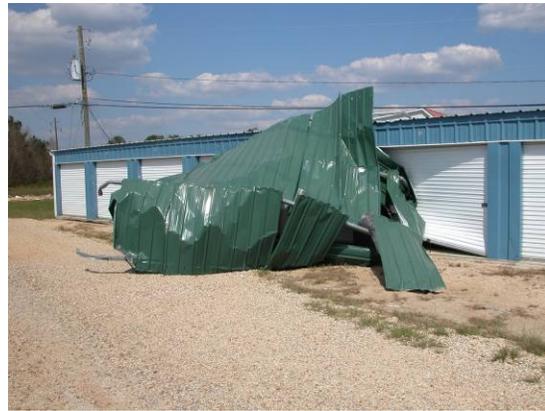
In other locations, the metal roofing came loose from trusses and blew out into the adjacent areas. The roof trusses remained upright. In some of these portions of the building, roofing separated from the top chord of the roof trusses.

6.12-6. Strip mall. A large section of metal roofing came to rest against a nearby storage locker facility.
